# DIESEL PARTICULATE MATTER

# COAL DIESEL EXHAUST GAS EVALUATION/ISSUES

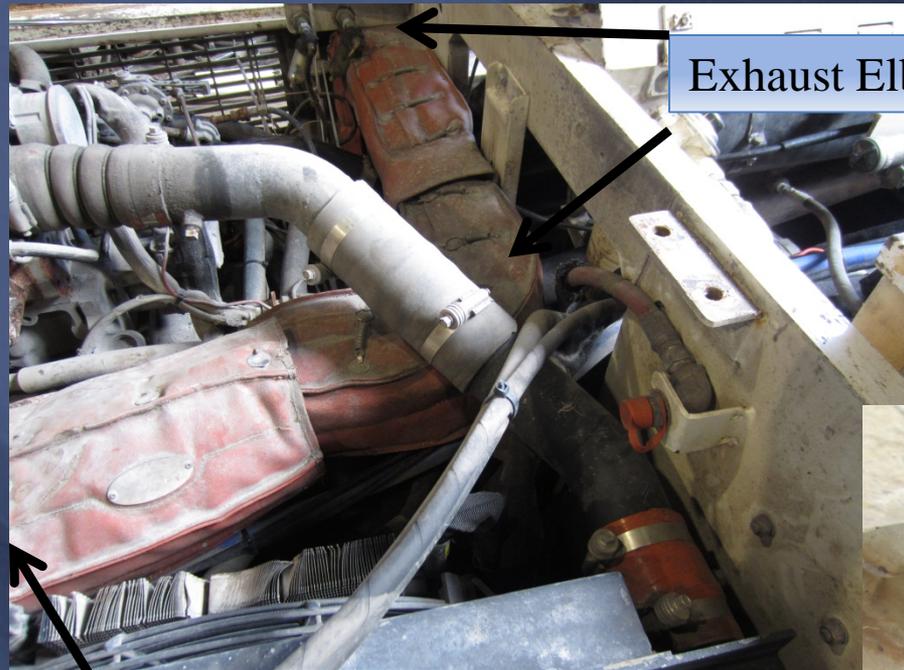
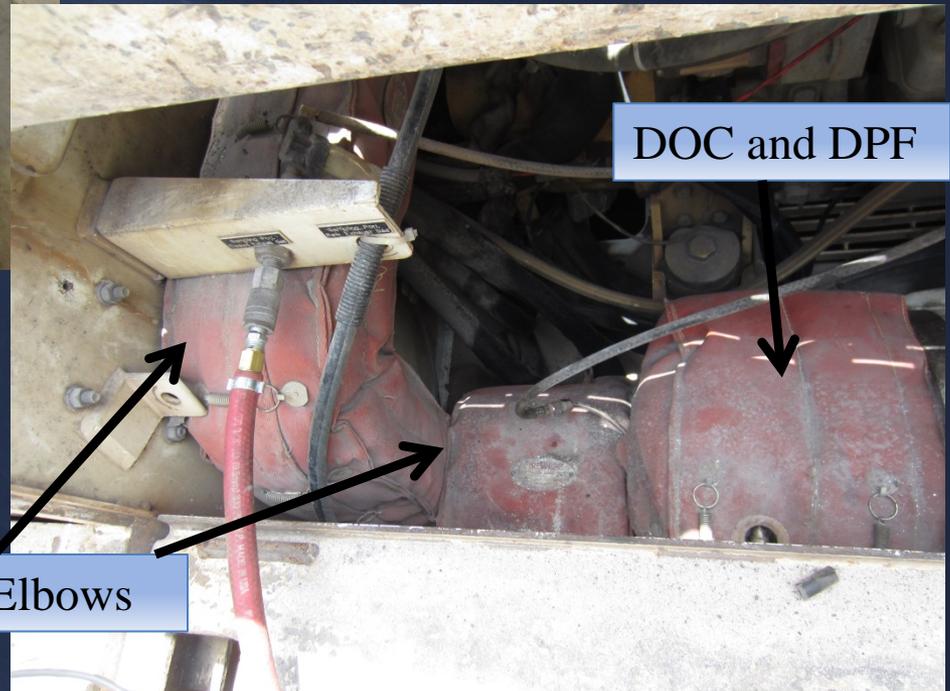
# Oversized DPF to Maintain BP due to Exhaust Route

- ▣ Current issues related to an aftertreatment that is improperly sized for the engine
- ▣ Larger aftertreatment device is producing more NO<sub>2</sub> than needed in handling DPM resulting in excess NO<sub>2</sub> being released into the mine environment
- ▣ Configuration of exhaust system may contribute to problem of using wrong size aftertreatment due to concerns for engine backpressure limits

Exhaust Elbows

Engine Out

DOC and DPF

- ▣ Mine operators test diesel equipment outfitted with a platinum catalyst aftertreatment
- ▣ Remove from service those not meeting the approval; correct deficiencies
- ▣ Ensure DPF purchased is appropriate for the engine
- ▣ Can contact the following persons at MSHA's Approval and Certification Center for assistance in the selection of appropriate diesel aftertreatment.
  - ▣ Phil McCabe                      304-547-2315
  - ▣ Jeffrey Moninger                304-547-2324
