METAL / NONMETAL Near Miss Incident

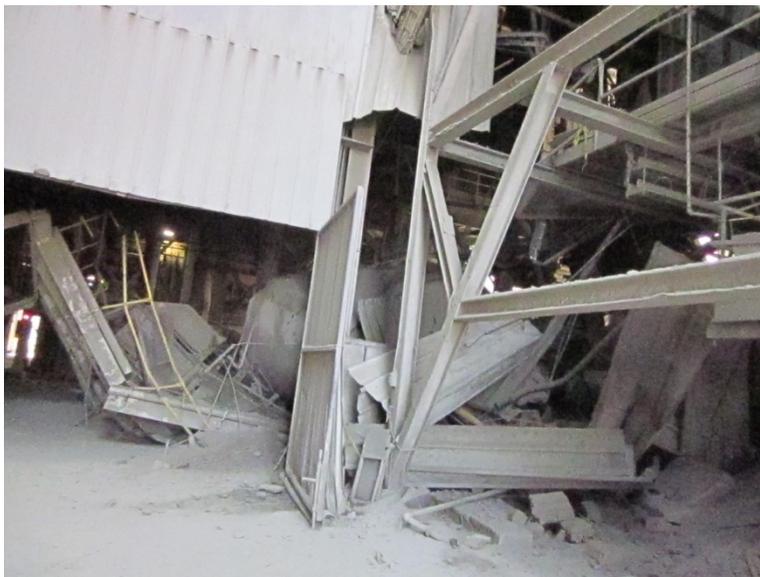
Cement Plant – A 200 ton bin fell through the floor. There were five miners under this bin on the bottom level just 10 minutes prior to the failure. MSHA's Technical Support Division identified visible abrasion damage, resulting in loss of strength, during the investigation. The company did not have a preventative maintenance program and did not conduct any preventive maintenance on this 40 year old bin.

- Examine your work places for all possible hazards and correct them before you perform work.
- Conduct structural inspections periodically.
- Routinely examine metal structures for indications of weakened structural soundness (corrosion, fatigue cracks, bent/buckling beams, braces or columns, loose/missing connectors, broken welds, etc.).
- Keep corrosive material spillage/build-up removed from metal structures.
- Report all areas where indications of structural weakness are found.
