## METAL / NONMETAL Near Miss Accident

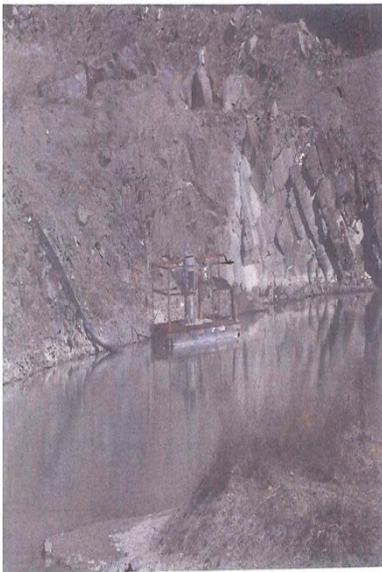
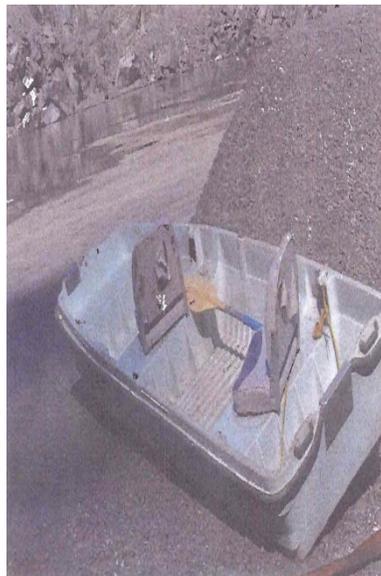
Surface Sand & Gravel - June, 2015 – Two miners were servicing a floating pump platform. The miners used a boat to access the pump platform. One miner got on the pump platform and while leaning over the pump motor, the pump platform capsized. When he entered the water, he found himself under the pump platform and was briefly held underwater when his lifejacket snagged on a handrail. Also when the pump platform capsized, it struck the underside of the boat causing it to capsize as well tossing the other miner into water. The second miner was able to reach the boat and paddle to shore where he called for assistance to retrieve the other miner. The miners were not injured in the incident.

- Task train all persons to recognize all potential hazardous conditions and ensure they understand safe job procedures for elimination of the hazards before beginning work.
- Always wear a life jacket where there is a danger of falling into the water.
- Pull pump station out of the water while performing maintenance work.
