**Independent Review of MSHA's
Actions at Crandall Canyon Mine
Genwal Resources, Incorporated
Huntington, Emery County, Utah**

Earnest C. Teaster, Jr.

Joseph W. Pavlovich

July 21, 2008

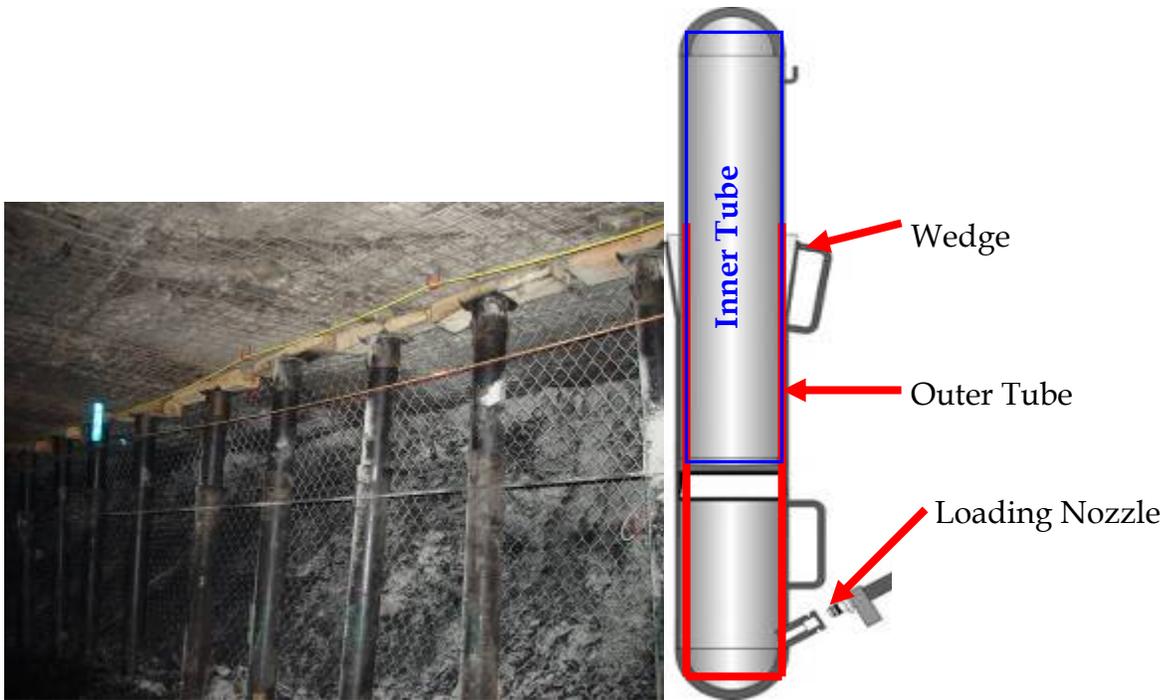
RocpropsTM are hydraulic cylinders that are extended against the mine roof and floor by pumping water or other hydraulic fluid into the cylinder. Once the cylinder is set, a locking collar transforms the cylinder into a friction prop which maintains peak loading during yield. The RocpropTM was developed and manufactured in South Africa for deep level mining applications in gold mines. RocpropsTM are used as primary vertical roof support in gold mines and are installed close to the working face. The entries are advanced by drilling the rock faces and loading and shooting explosives which fragment the rock material containing the gold. According to the manufacturer, the support is capable of successfully withstanding lateral forces from explosive blasts 4 ½ feet from the face. RocpropsTM are imported into the United States and exclusively distributed by Strata Products®.

Rocprops™ were chosen by the operator due to their capability to be pressurized between the roof and floor, thus making them an active support. Rocprops™ had been used by the company at its Aberdeen Mine for rib protection in bounce-prone, longwall headgate entries. Chain link fence and one wire rope were used in conjunction with the Rocprops™ at the Aberdeen Mine. The wire rope was either wrapped around the coal pillar or anchored in some manner in the crosscuts to prevent the Rocprops™ from being dislodged in the event of a bounce. However, at the Crandall Canyon Mine the wire ropes could not be wrapped around the coal pillars and were anchored only on one end in the outby crosscuts due to the blockage from the coal rubble. Three wire ropes were used to secure each Rocprop™ to the adjoining Rocprops™, which essentially tied them together.

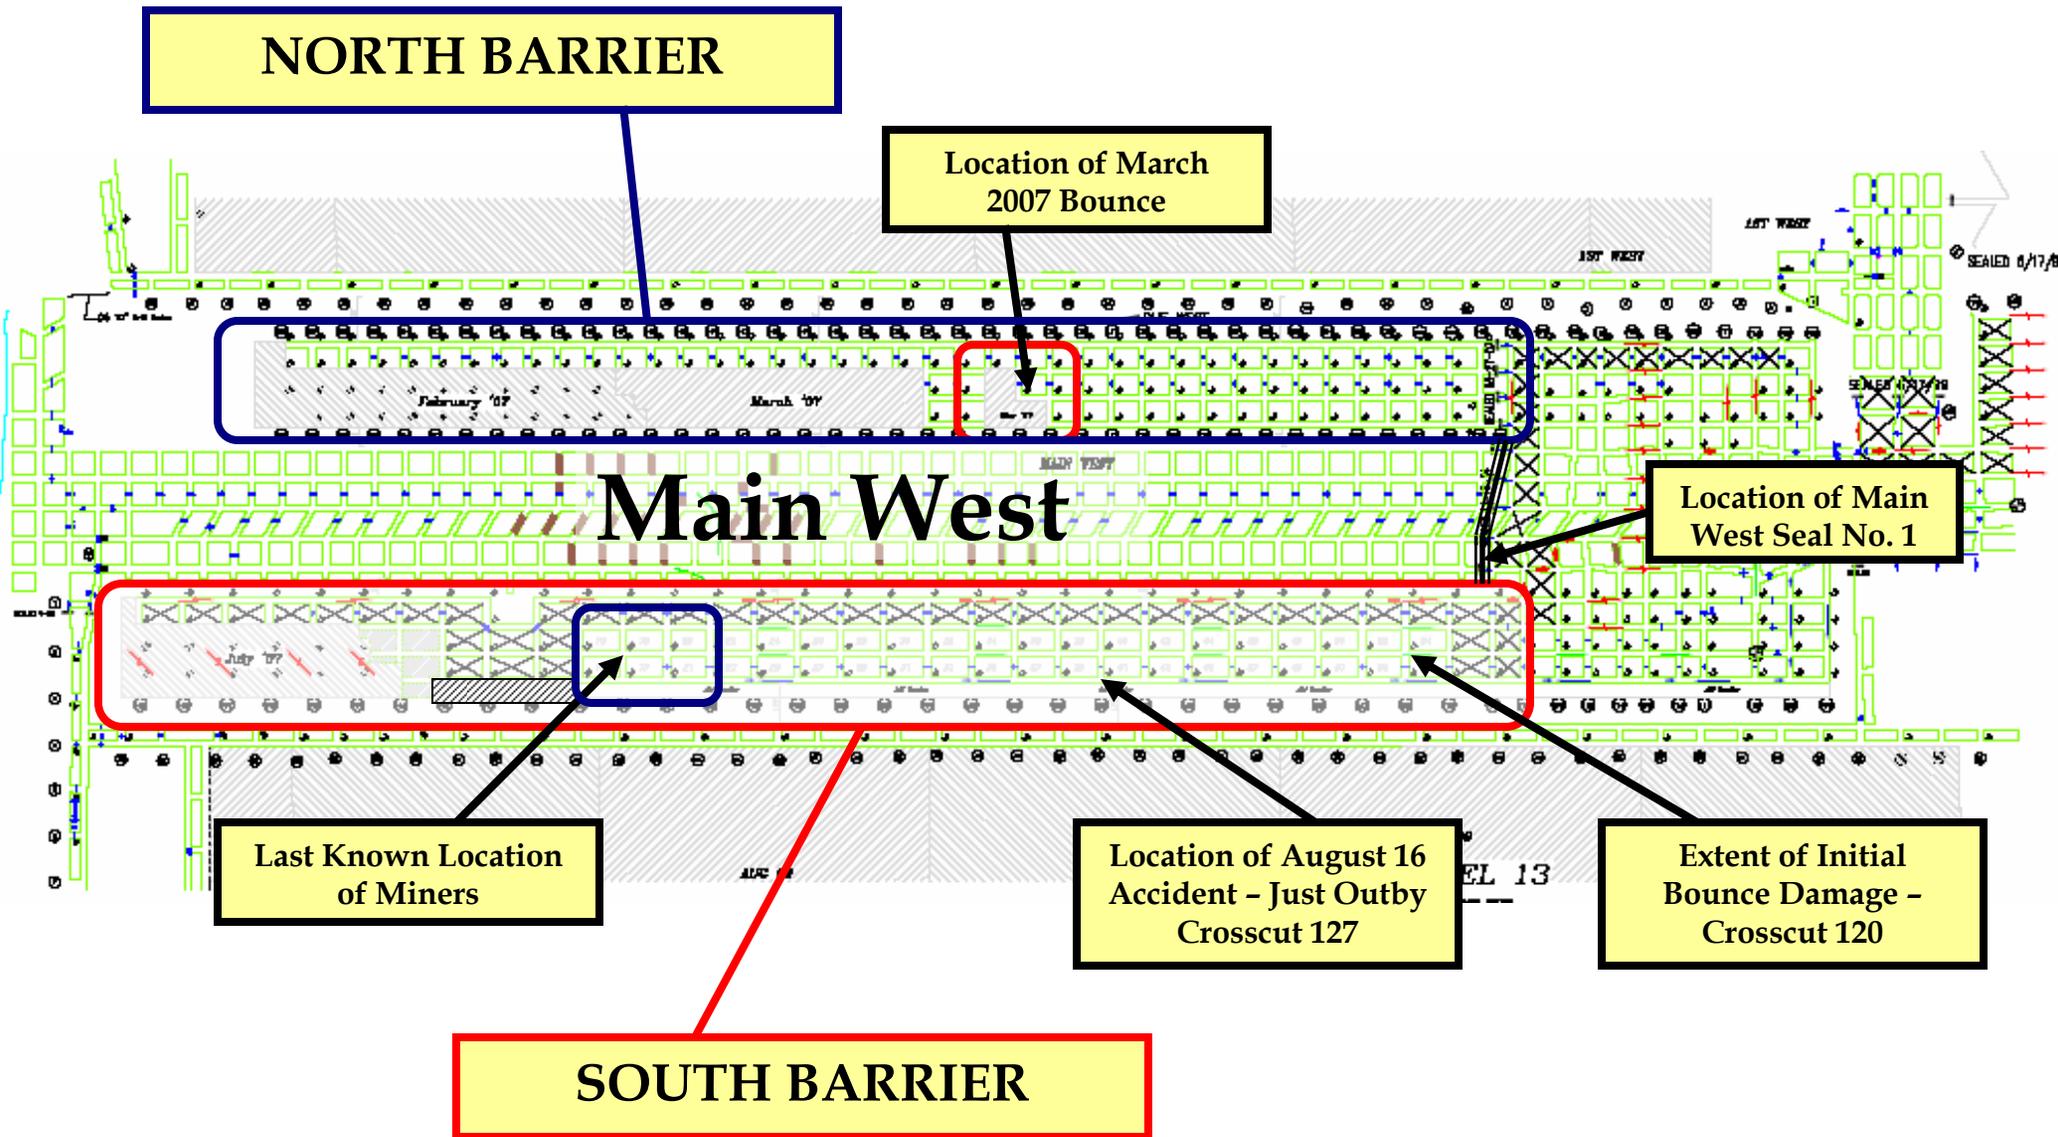
Extent of Initial Bounce Damage - Crosscut 120

In the early morning hours of August 6th, a violent bounce of coal pillars occurred in the South Barrier section of the Main West area of the Crandall Canyon Mine. The bounce registered 3.9 on the Richter scale, as measured by the University of Utah in Salt Lake City. (All bounce magnitudes listed in this report are local Richter scale magnitudes.) At the time of the accident, six miners were in the process of extracting coal on the section near crosscut 139. The bounce was so catastrophic that the coal pillars failed outby crosscut 139 to crosscut 120, a distance of approximately 2600 feet. Ventilation controls were damaged or destroyed outby to crosscut 95, approximately 4500 feet from crosscut 139. The six miners were entrapped on the section.

MSHA was notified of the accident by mine management and responded with personnel and equipment to help facilitate a rescue operation. The Company mine rescue team and other area teams were also notified and responded. Upon the initial exploration by MSHA and rescue team personnel, they found all four entries of the South Barrier section filled with rubble beginning at crosscut 120.
