## DISTRICT 2 – COAL MINE NEAR MISS

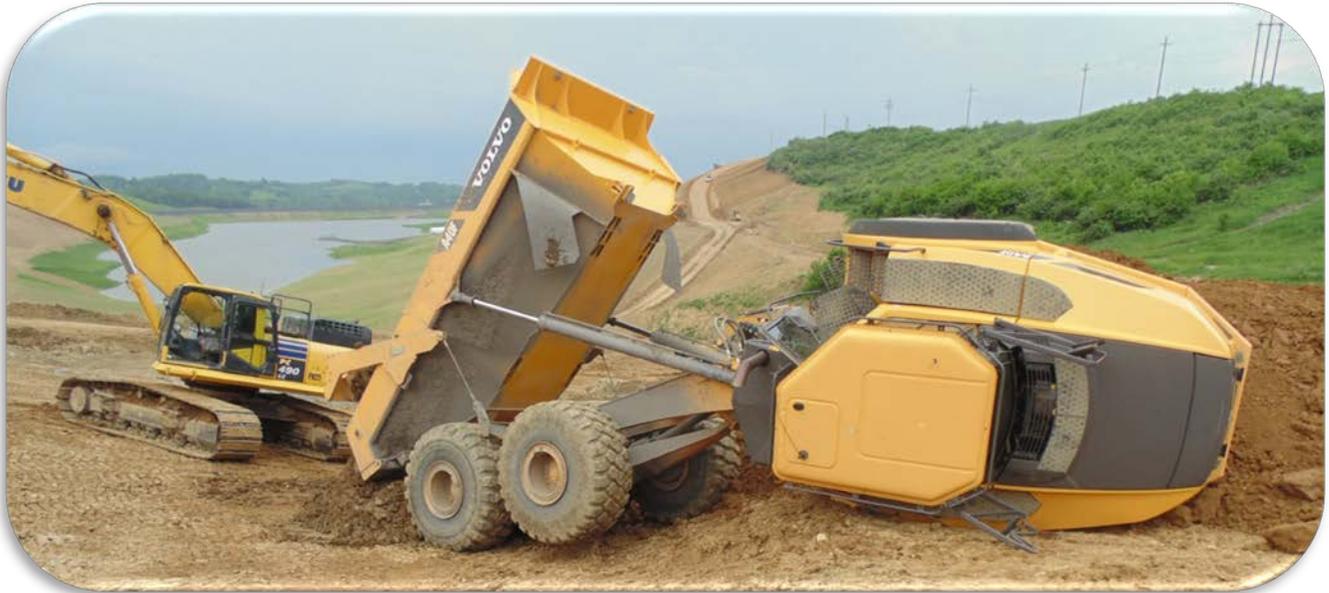
A non-injury accident occurred when an articulating truck driver was dumping a load of clay. A portion of the load remained stuck in the front of the bed until the bed was fully raised. The material loosened and struck the tailgate, lifting the cab of the truck off of the ground, allowing the cab to rotate and settle onto its right side. The operator was wearing his seatbelt, sustaining no injuries.

- Operate equipment within its design limitations.
- Install roll-over-protection (ROPS) and wear seatbelts at all times.
- Before dumping, place the machine parallel to the slope.
- Evaluate the material to be dumped for sticking and load accordingly
- Use a spotter while dumping.
- Dump with the front of the machine facing down the slope.
- Train miners to operate equipment as per manufacturer recommendations.
