DISTRICT 2 – COAL MINE NEAR MISS

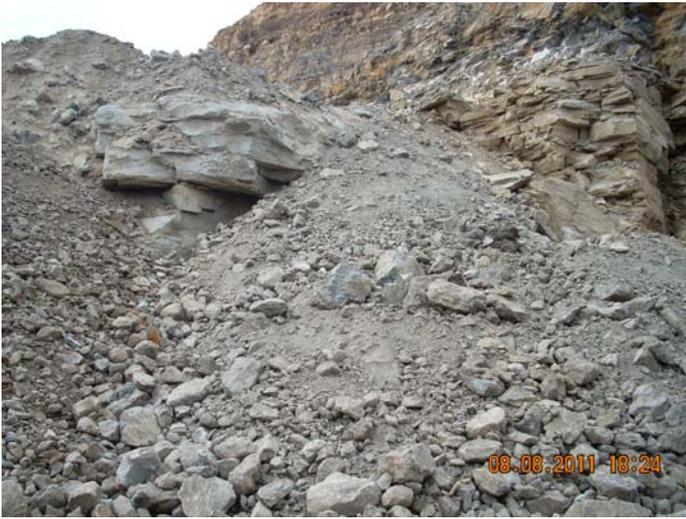
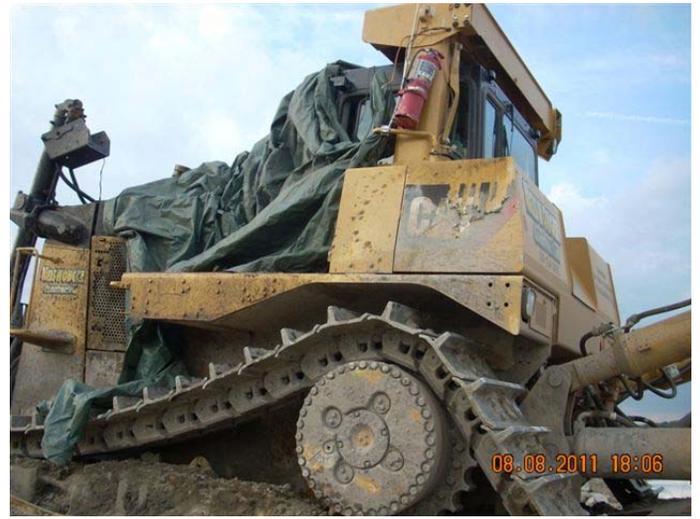
An accident occurred on August 8, 2011 when a dozer operator was removing shot material from a bench to uncover the coal seam. He positioned the dozer on a 45 degree angle to the highwall to clear the wall of protruding rocks. The dozer turned parallel to the bench causing the right track to hang over the highwall. The dozer slid down to the right overturning once, landing on its tracks at the bottom of a 35 foot highwall. The operator sustained fractures to his, back, pelvis and left leg.

- Do not exceed the equipment's capabilities, operating ranges, and safety features.
- Always wear a seatbelt when operating mobile equipment.
- Adequately task train miners on the equipment they will operate.
- Conduct pre-operational safety checks of all mobile equipment.
- Train all employees on proper operation procedures, hazard recognition, and avoidance.
