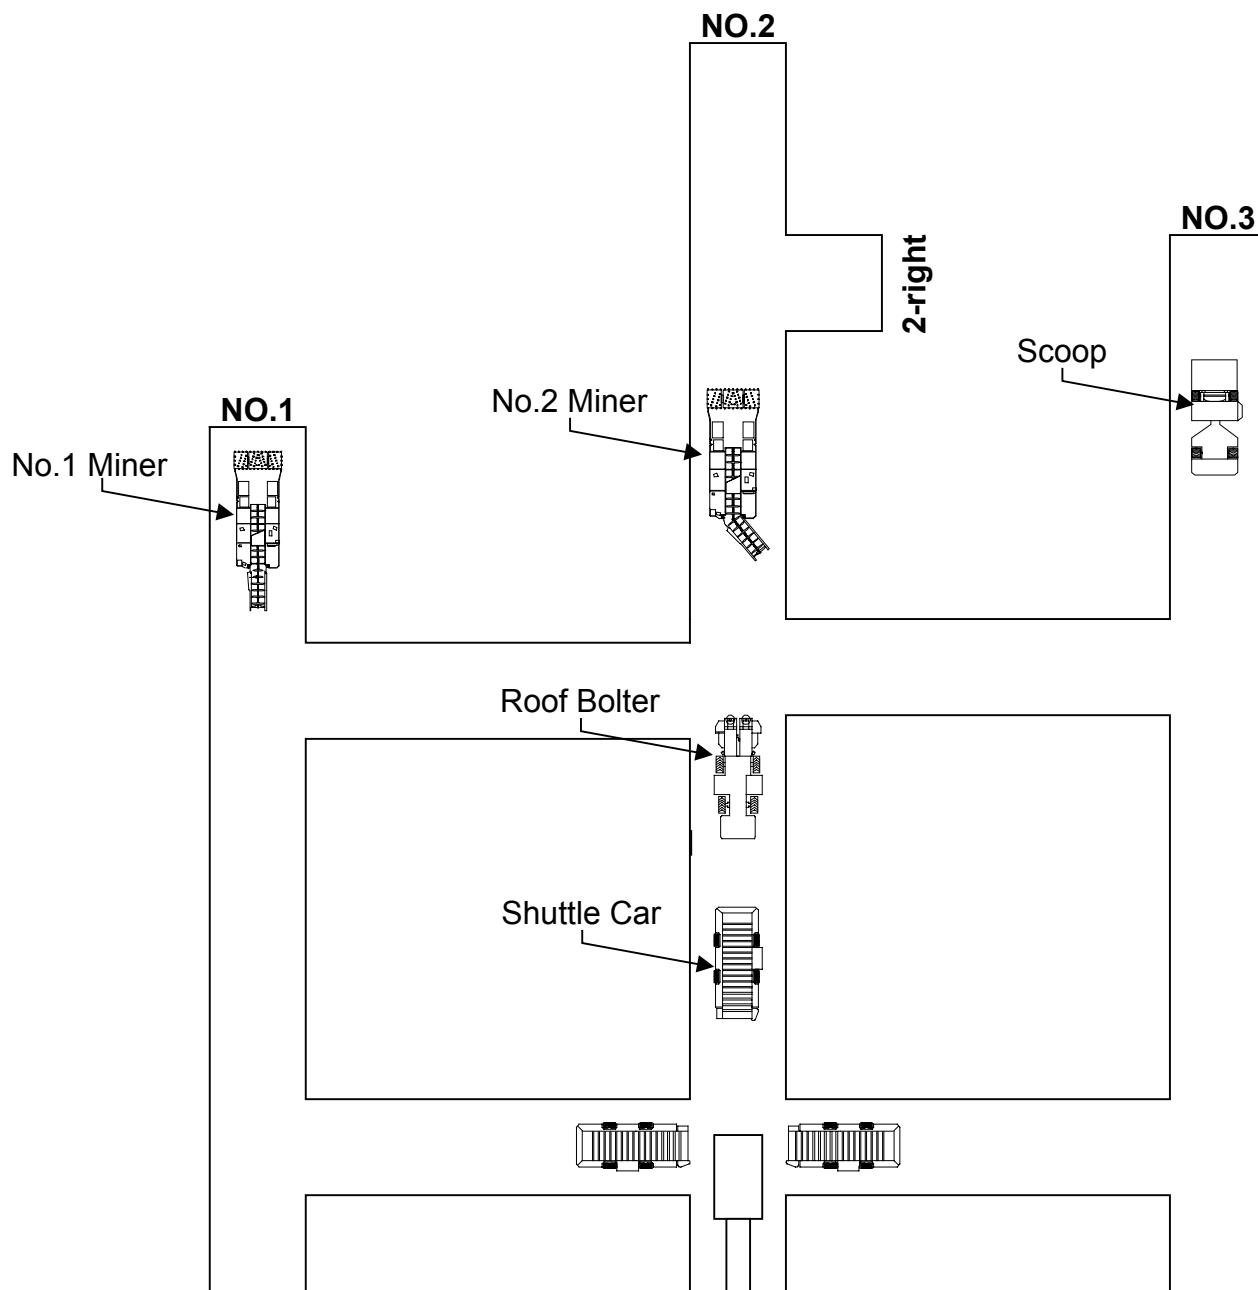
Figure 1 - No.2 Miner parked in entry after completing cut in 2-right crosscut. Roof bolter waiting to pull into 2-right to begin installing roof supports.

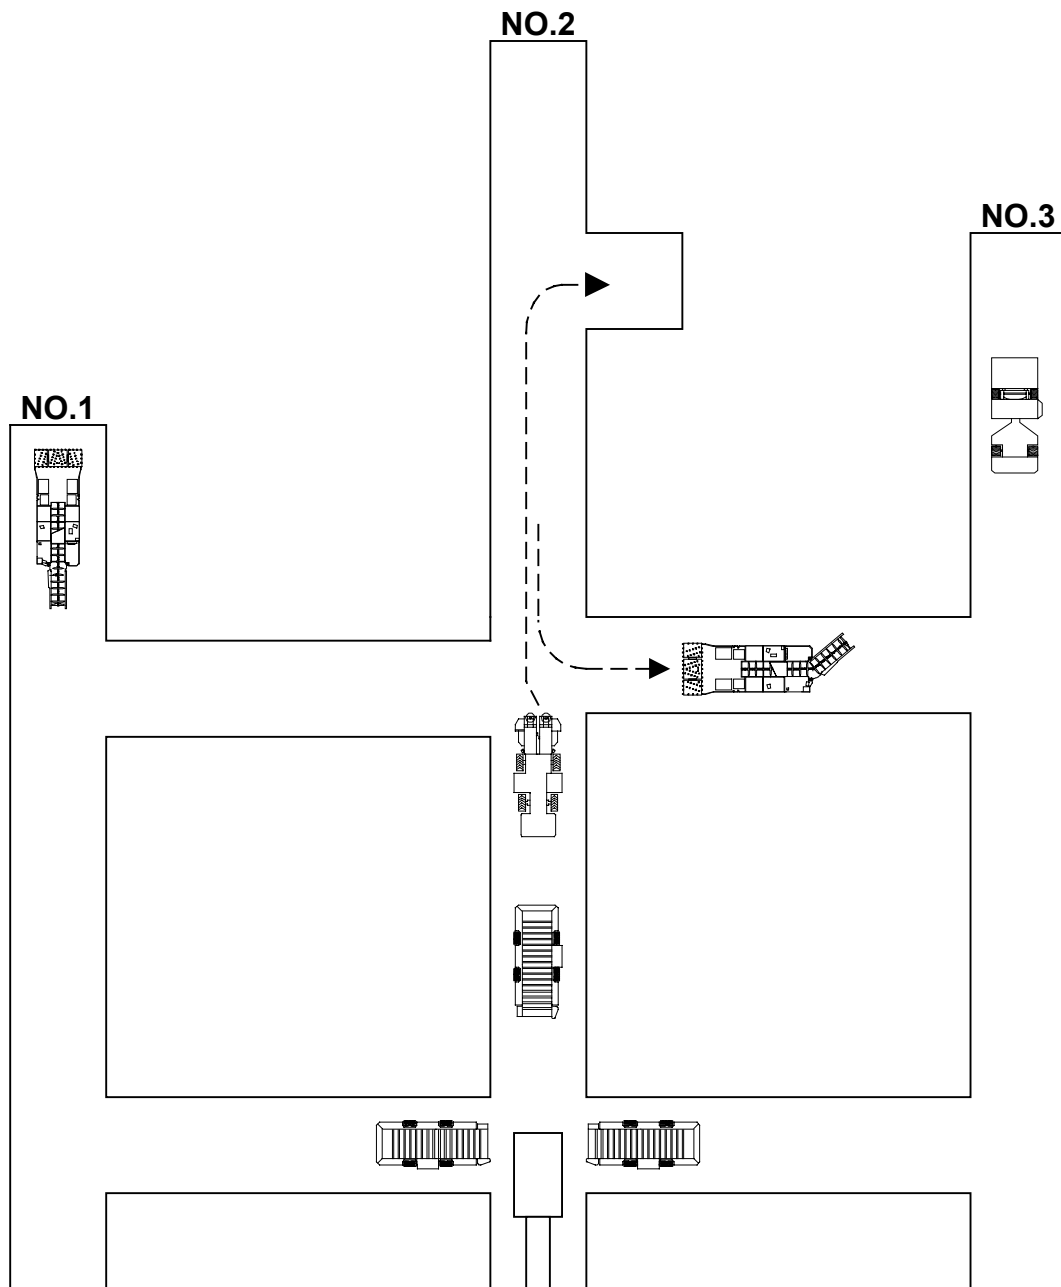
Figure 2 - No.2 miner backed into last open crosscut to allow roof bolter to be moved into 2-right crosscut.

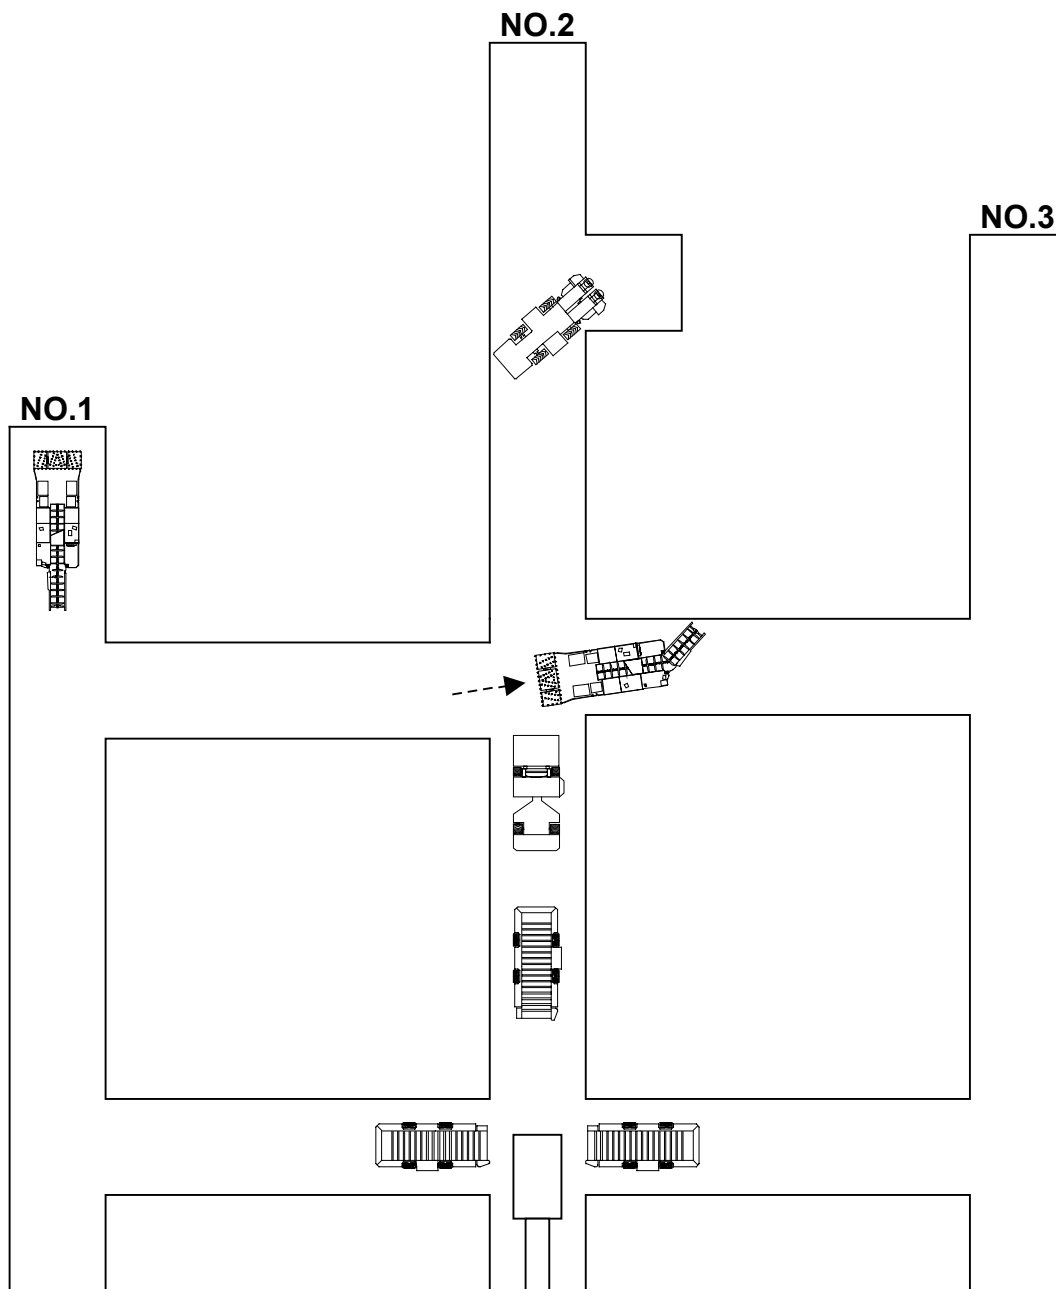
Figure 4 - No.2 miner moved back across intersection to allow scoop to proceed inby in the No.2 entry. The accident occurred during this move.
