REPORT OF INVESTIGATION

FATAL MACHINERY ACCIDENT

June 9, 2003

Mine No. 4
Calvary Coal Co. Inc.
Smilax, Leslie County, Kentucky
I.D. No. 15-16349

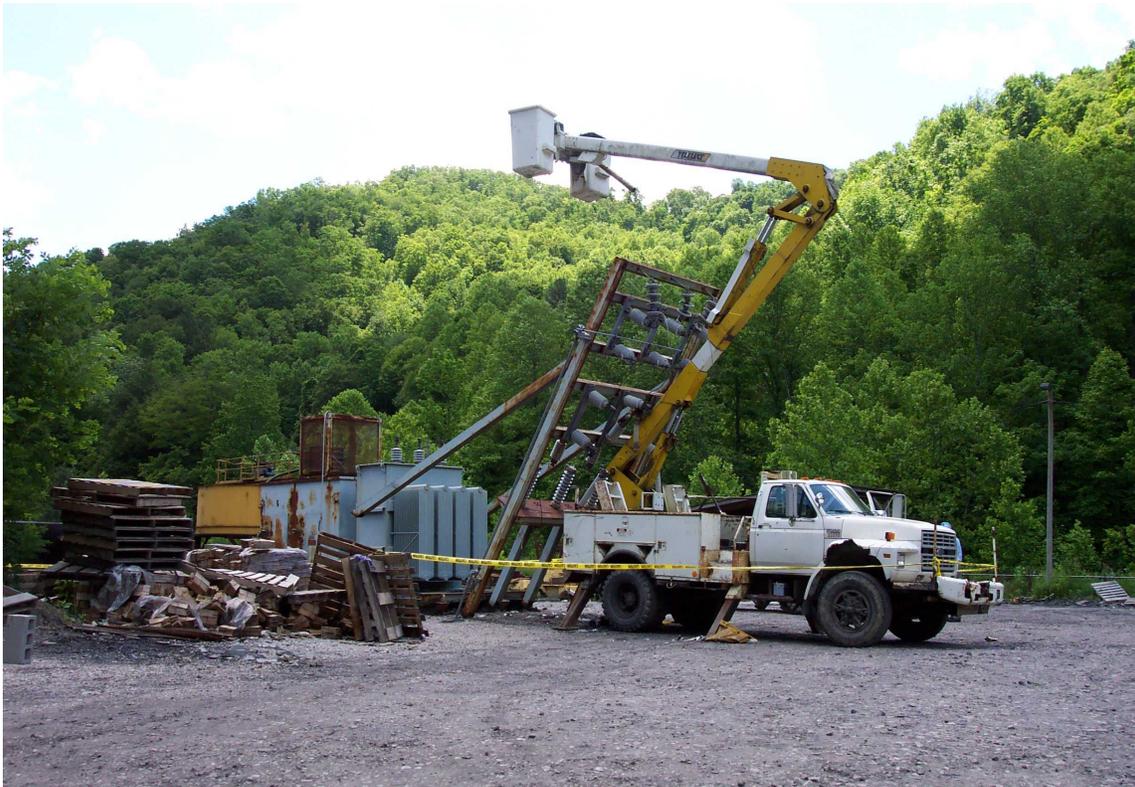
Accident Site

This image shows the steel structure which was lifted off the Pemco electrical substation by this bucket truck. The structure is lying against the boom of the bucket truck after the fall.

The beam the rope was placed around at the time of the accident was a 5 inch wide flange beam with a weight of approximately 15 pounds per linear foot. The flange on this beam was approximately ¼ inch thick. During the accident, the rope failed where the rope wrapped around the bottom corner of the beam farthest from the aerial bucket truck. The edge of the flange of the beam was bent upward approximately ¼ inch in the area where the rope was attached to the beam.

The fatality occurred because the aerial device was used to lift a load which exceeded its capacity. The load rating chart (located on the bucket control console) was illegible. The rope used to lift the load was attached without a suitable hitch or sling. A safety belt or harness was not used to keep the victim from falling from the aerial bucket.

Corrective Action: Mine Management should issue policy that ensures the use of a suitable hitch or sling when lifting heavy loads.

Corrective Action: Policies and procedures should be enforced to ensure that employees use safety equipment.

Corrective Action: Mine Management should issue policy that equipment be used only in accordance with manufacturer's suggested recommendations.
