REPORT OF INVESTIGATION
Surface Coal Mine

Fatal Powered Haulage Accident
September 17, 2003

Twilight MTR Surface Mine
Progress Coal
Twilight, Boone County, West Virginia
ID No. 46-08645

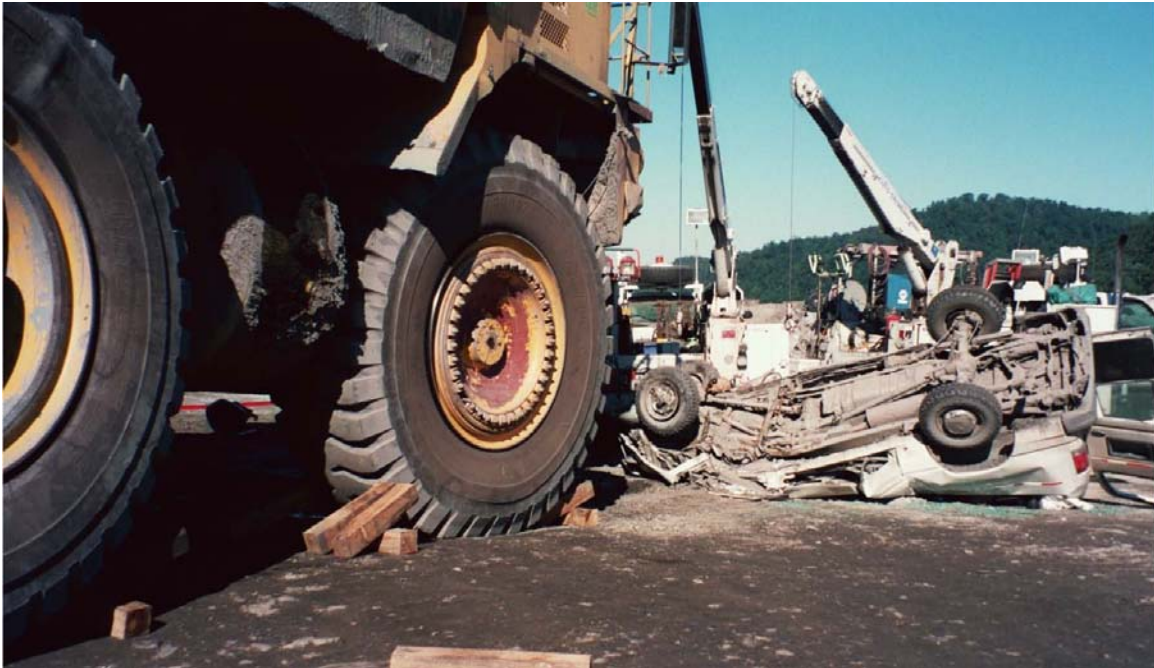
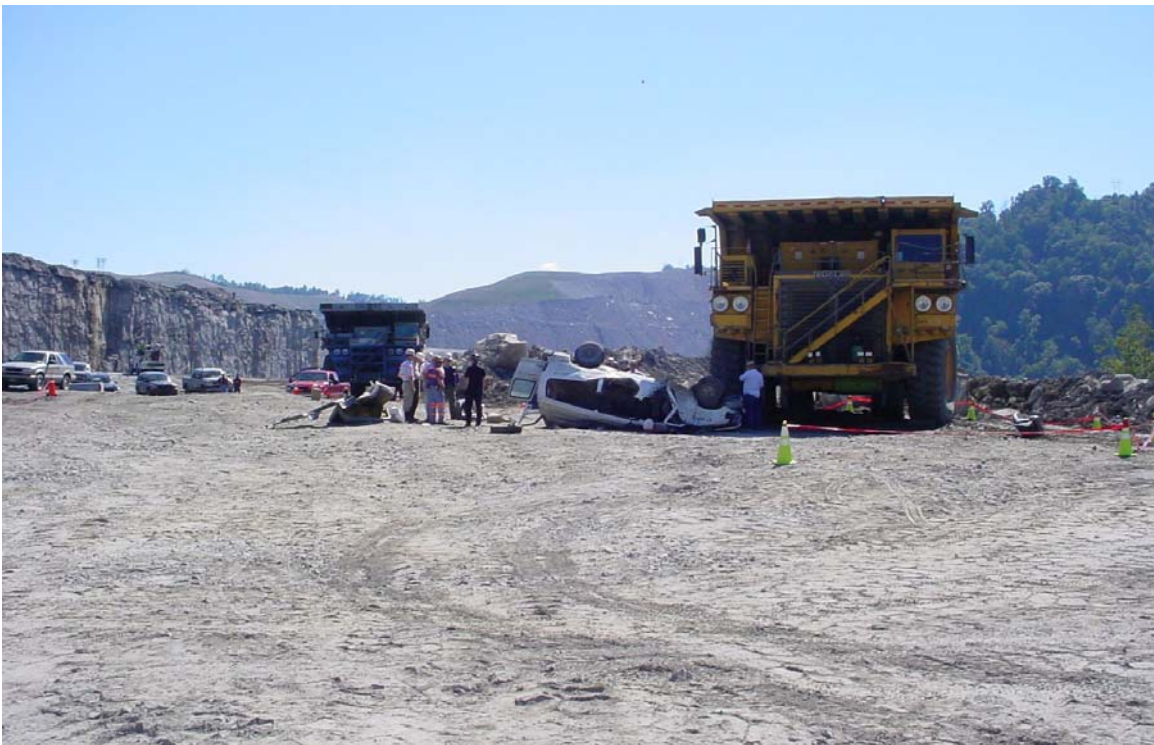
Pictures of the Euclid R190 Rock Truck and the Ford E-350 Portal Van

When the rock truck moved forward, its front bumper contacted the driver’s side door of the portal van. An indentation in the driver’s door matched the width of the access ladder that hangs down approximately 35 inches from the bottom of the truck’s bumper. The ladder was constructed of steel and rubber belting. White paint was observed on the ladder.

As the rock truck continued forward, the van was rolled over onto its roof and crushed under the rock truck’s bumper/frame and the right front tire. Observations and measurements of tire tracks from the rock truck and portal van indicated the rock truck had moved forward approximately 32 feet before stopping. This is approximately one revolution of the rock truck’s tires.

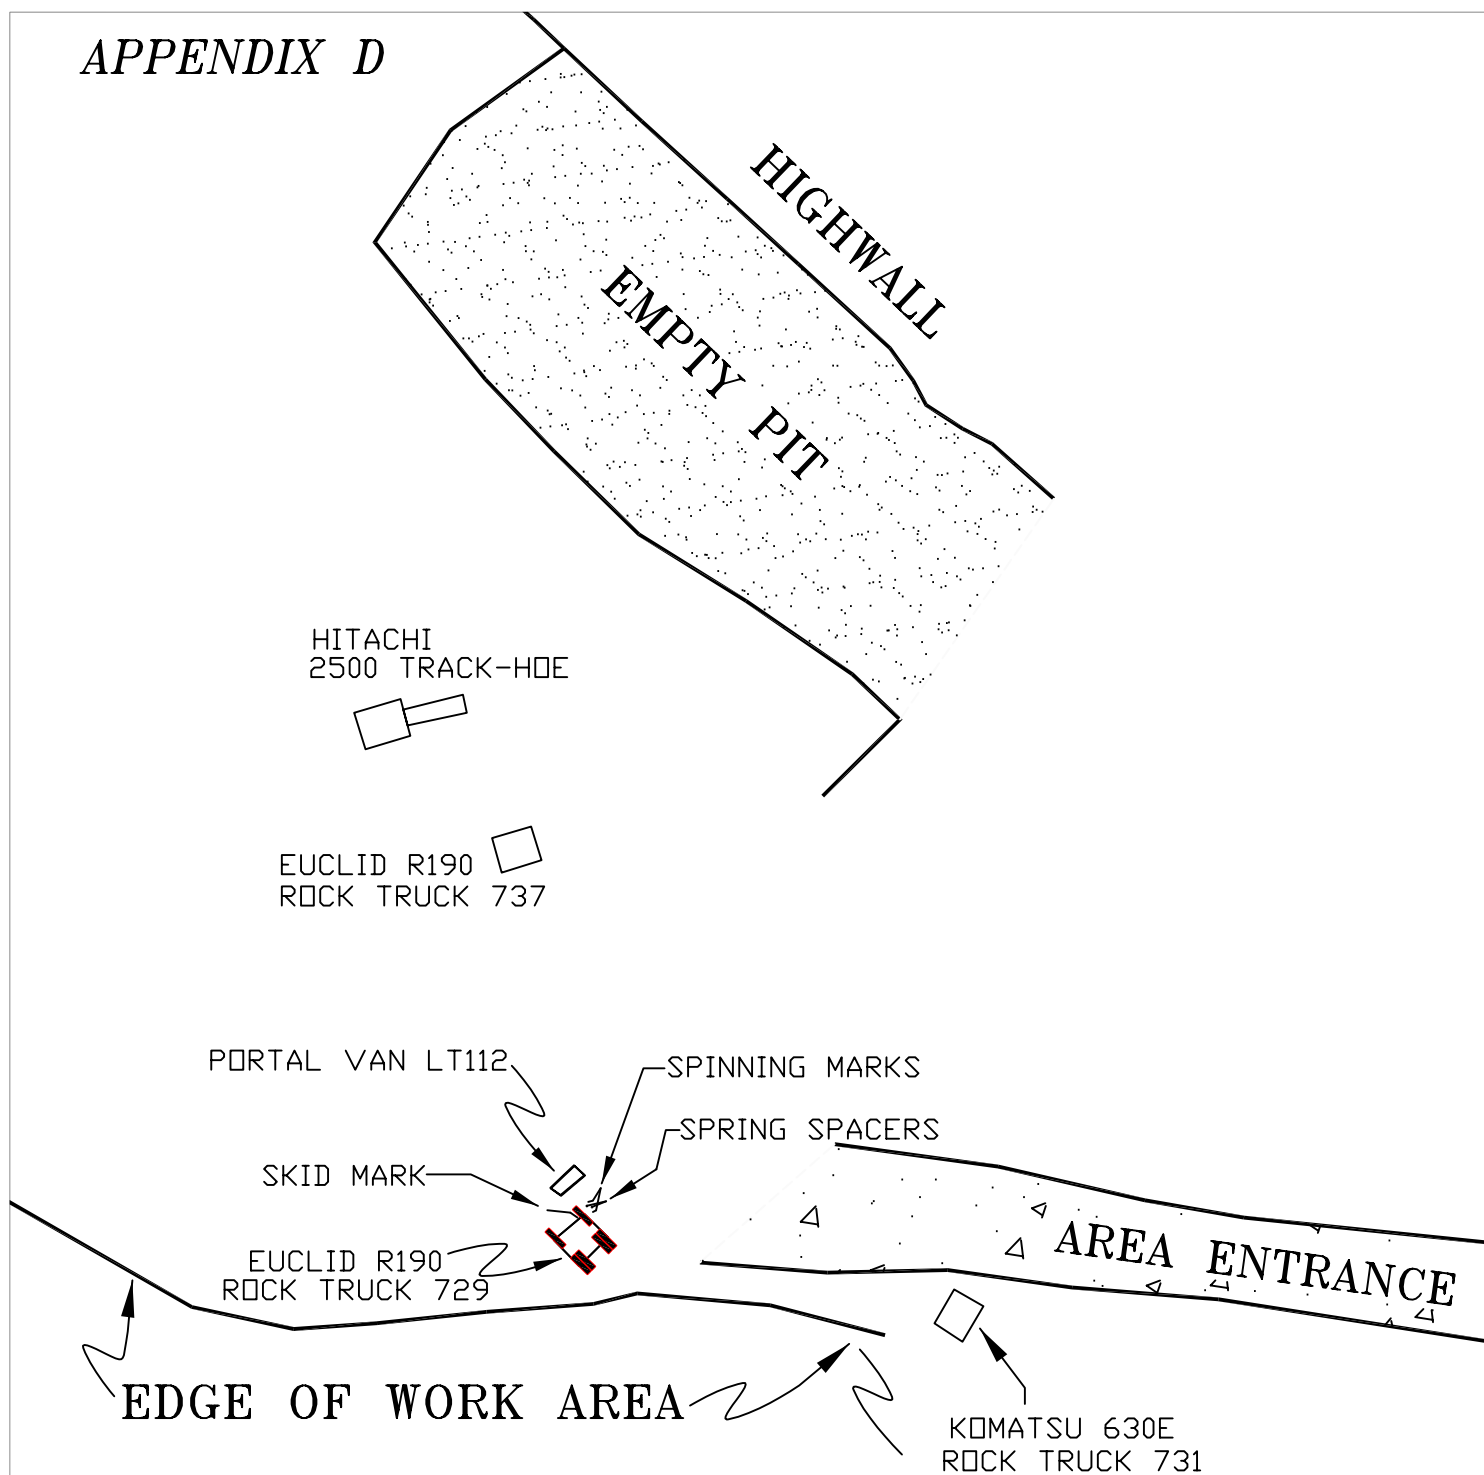
APPENDIX D

The rock truck involved in the accident was parked on a bench, off the pit travelway, approximately 15 feet from the bermed edge. It was facing the direction of the Hitachi Model 2500 Track-hoe, which was approximately 270 feet from the truck. The track-hoe’s dome light and entrance light had been left illuminated following maintenance which was performed prior to the accident.

NOTE: EQUIPMENT LOCATION
AT TIME OF INVESTIGATION.
