Coal Mine Fatal Accident 2004-05

Operator:	Raw Coal Mining Company, Inc.
Mine:	Cucumber Mine
Accident Date:	February 10, 2004
Classification:	Powered Haulage
Location:	District 4, McDowell County, WV
Mine Type:	Underground
Employment:	39
Production	650 tons/day

Coal Mine Fatal Accident 2004-05 Powered Haulage

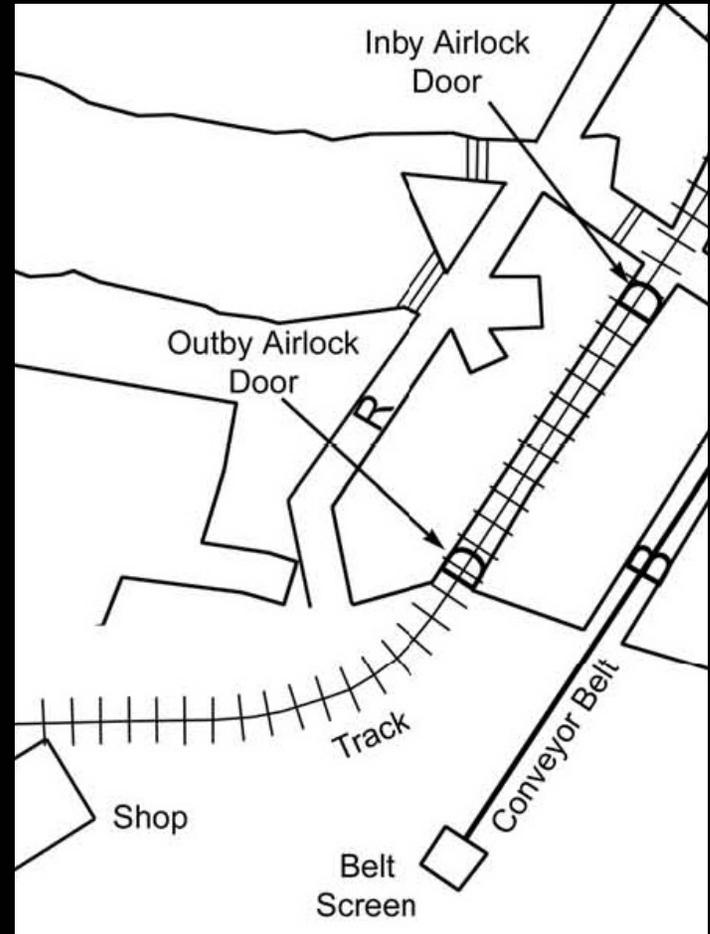
- During the midnight maintenance shift on February 10, 2004, routine maintenance was performed on the personnel carrier.
- Maintenance on the personnel carrier included using compressed air to blow out any wet sand in the pots and discharge hoses.
- At the start of dayshift, the victim filled the two sanders on the inby end of the personnel carrier, immediately before 6 other miners boarded the machine.
- A surface miner opened the outby airlock door which allowed the personnel carrier to enter the mine without stopping to operate the electric door hoist.
- The personnel carrier entered the mine at a faster than normal speed.

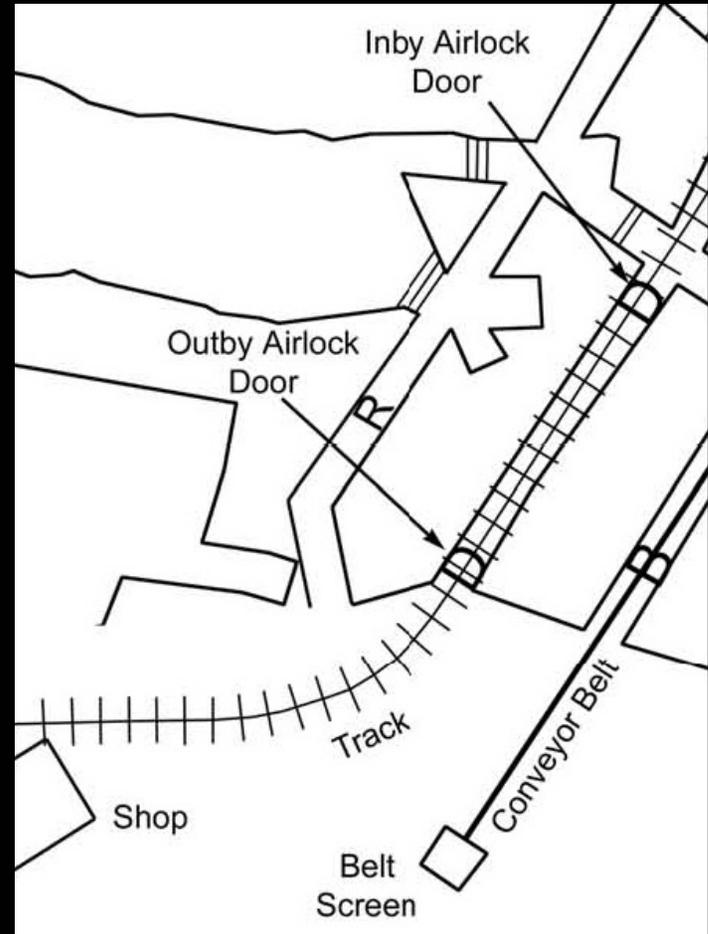
- Continuing to gain speed, the victim shouted a warning to passengers on the personnel carrier while approaching the closed inby airlock door.
- The victim was fatally injured during impact with the airlock door – before the personnel carrier continued traveling approximately 320 feet on the track before derailing.
- Observing that the victim was seriously injured, one of the passengers notified the surface.
- The damaged door was cleared from the track and medical assistance was provided.
- The victim was transported to Welch Community Hospital where he was pronounced dead at 8:37 a.m.
