Coal Mine Fatal Accident 2004-7

Operator:	Brooks Run Mining Co., LLC
Mine:	Mercer Deep Mine
Accident Date:	April 3, 2004
Classification:	Machinery
Location:	District 4, Webster County, WV
Mine Type:	Underground

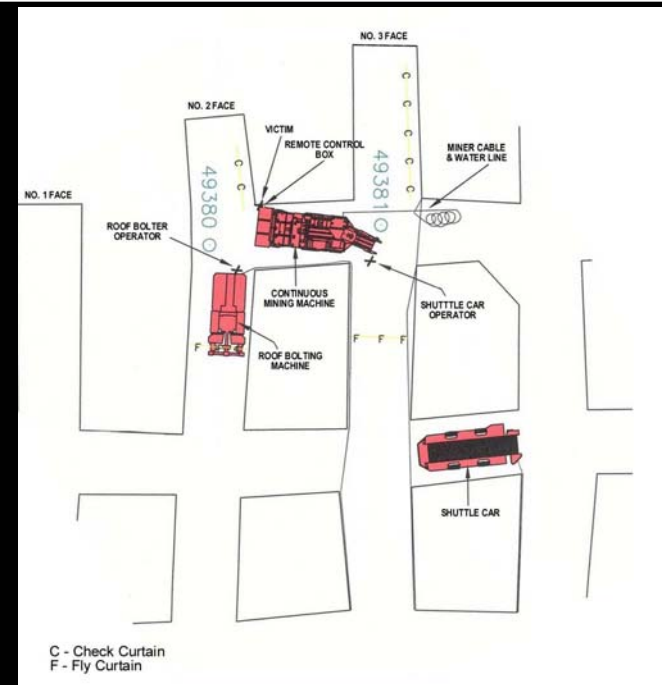
- At 11:40 p.m., on Saturday, April 3, 2004, a 47-year old continuous mining machine operator with 29 years of mining experience was fatally injured while the continuous mining machine was being trammed in high speed.
- The victim was positioned in a hazardous location and was pinned between the ripper head of the continuous mining machine and the right (inby) coal rib of the No. 3 left crosscut.
- The accident occurred because the victim was positioned in a hazardous location while tramming the continuous mining machine in high tram speed. The victim's position resulted from a failure to comply with approved roof control plan.

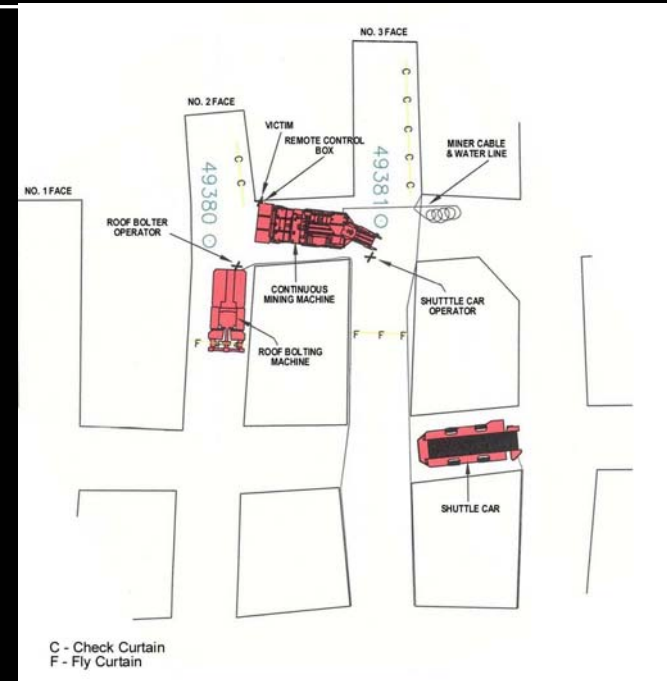
- On Saturday, April 3, 2004, at approximately 4:00 p.m., the No. 1 section evening shift crew entered the mine via the track entry, accompanied by the section foreman.
- After the right side miner finished mining, the left side continuous mining machine operator, (victim) began mining in the No. 2 face.
- Approximately 40 minutes prior to the accident, Brady backed the left continuous mining machine out of the No. 3 left crosscut and into the No. 4 left crosscut.
- The left side roof bolters then installed bolts in the No. 3 left crosscut.
- After installing the bolts, they trammed the bolting machine into the No. 2 entry and began installing a ventilation curtain in the No. 2 entry along the right rib.

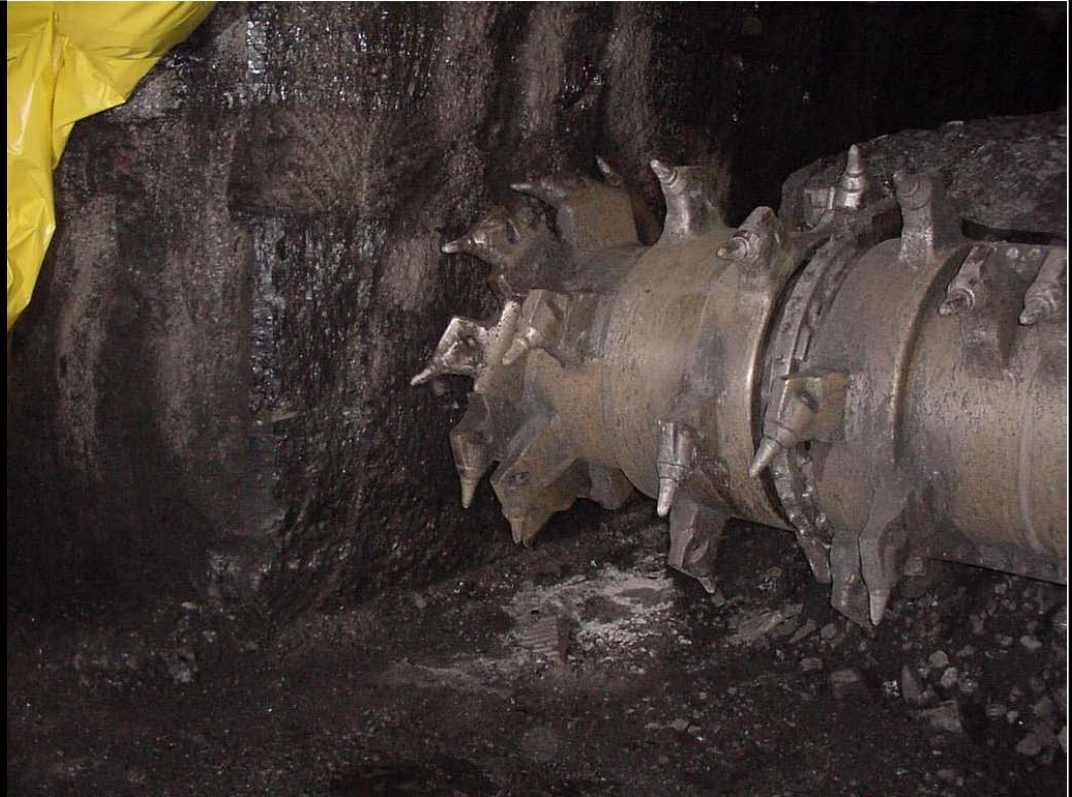
- The victim began tramming the continuous mining machine to mine the No. 2 left crosscut. This location was directly in front of the machine.
- The roof bolters heard the continuous mining machine start up and rumble three times, as though it was in fast speed and immediately shut off.
- They noted that the machine did not run more than a couple of seconds.
- They saw the continuous mining machine tram forward and pin Brady between the ripper head and the right rib.
