Coal Mine Fatal Accident 2004-12

Operator:	Jim Walter Resources, Inc.
Mine:	No. 7 Mine
Accident Date:	June 16, 2004
Classification:	Powered Haulage
Location:	District 11, Tuscaloosa County, AL
Mine Type:	Underground
Employment:	415
Production	17,600 Tons/Day

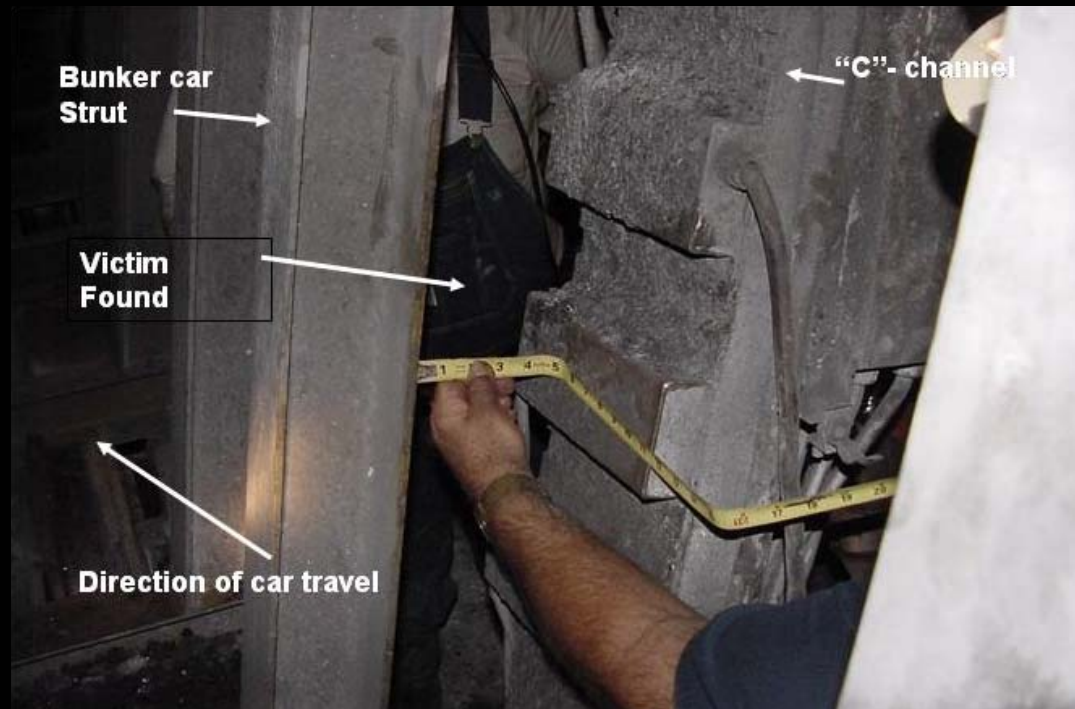
A 45-year old general inside laborer with over 23 years mining experience at the mine was fatally injured in a powered haulage accident at the underground raw coal storage bunker area. The accident occurred while the victim was washing loose raw coal material away from the discharge end of the bunker system seal belt into the production shaft pocket, which was part of his normal job duties. The victim became entrapped between a vertical support beam on the frame of the moving number 15 bunker car and a stationary upright steel "C" channel. There were no eye-witnesses to the accident .

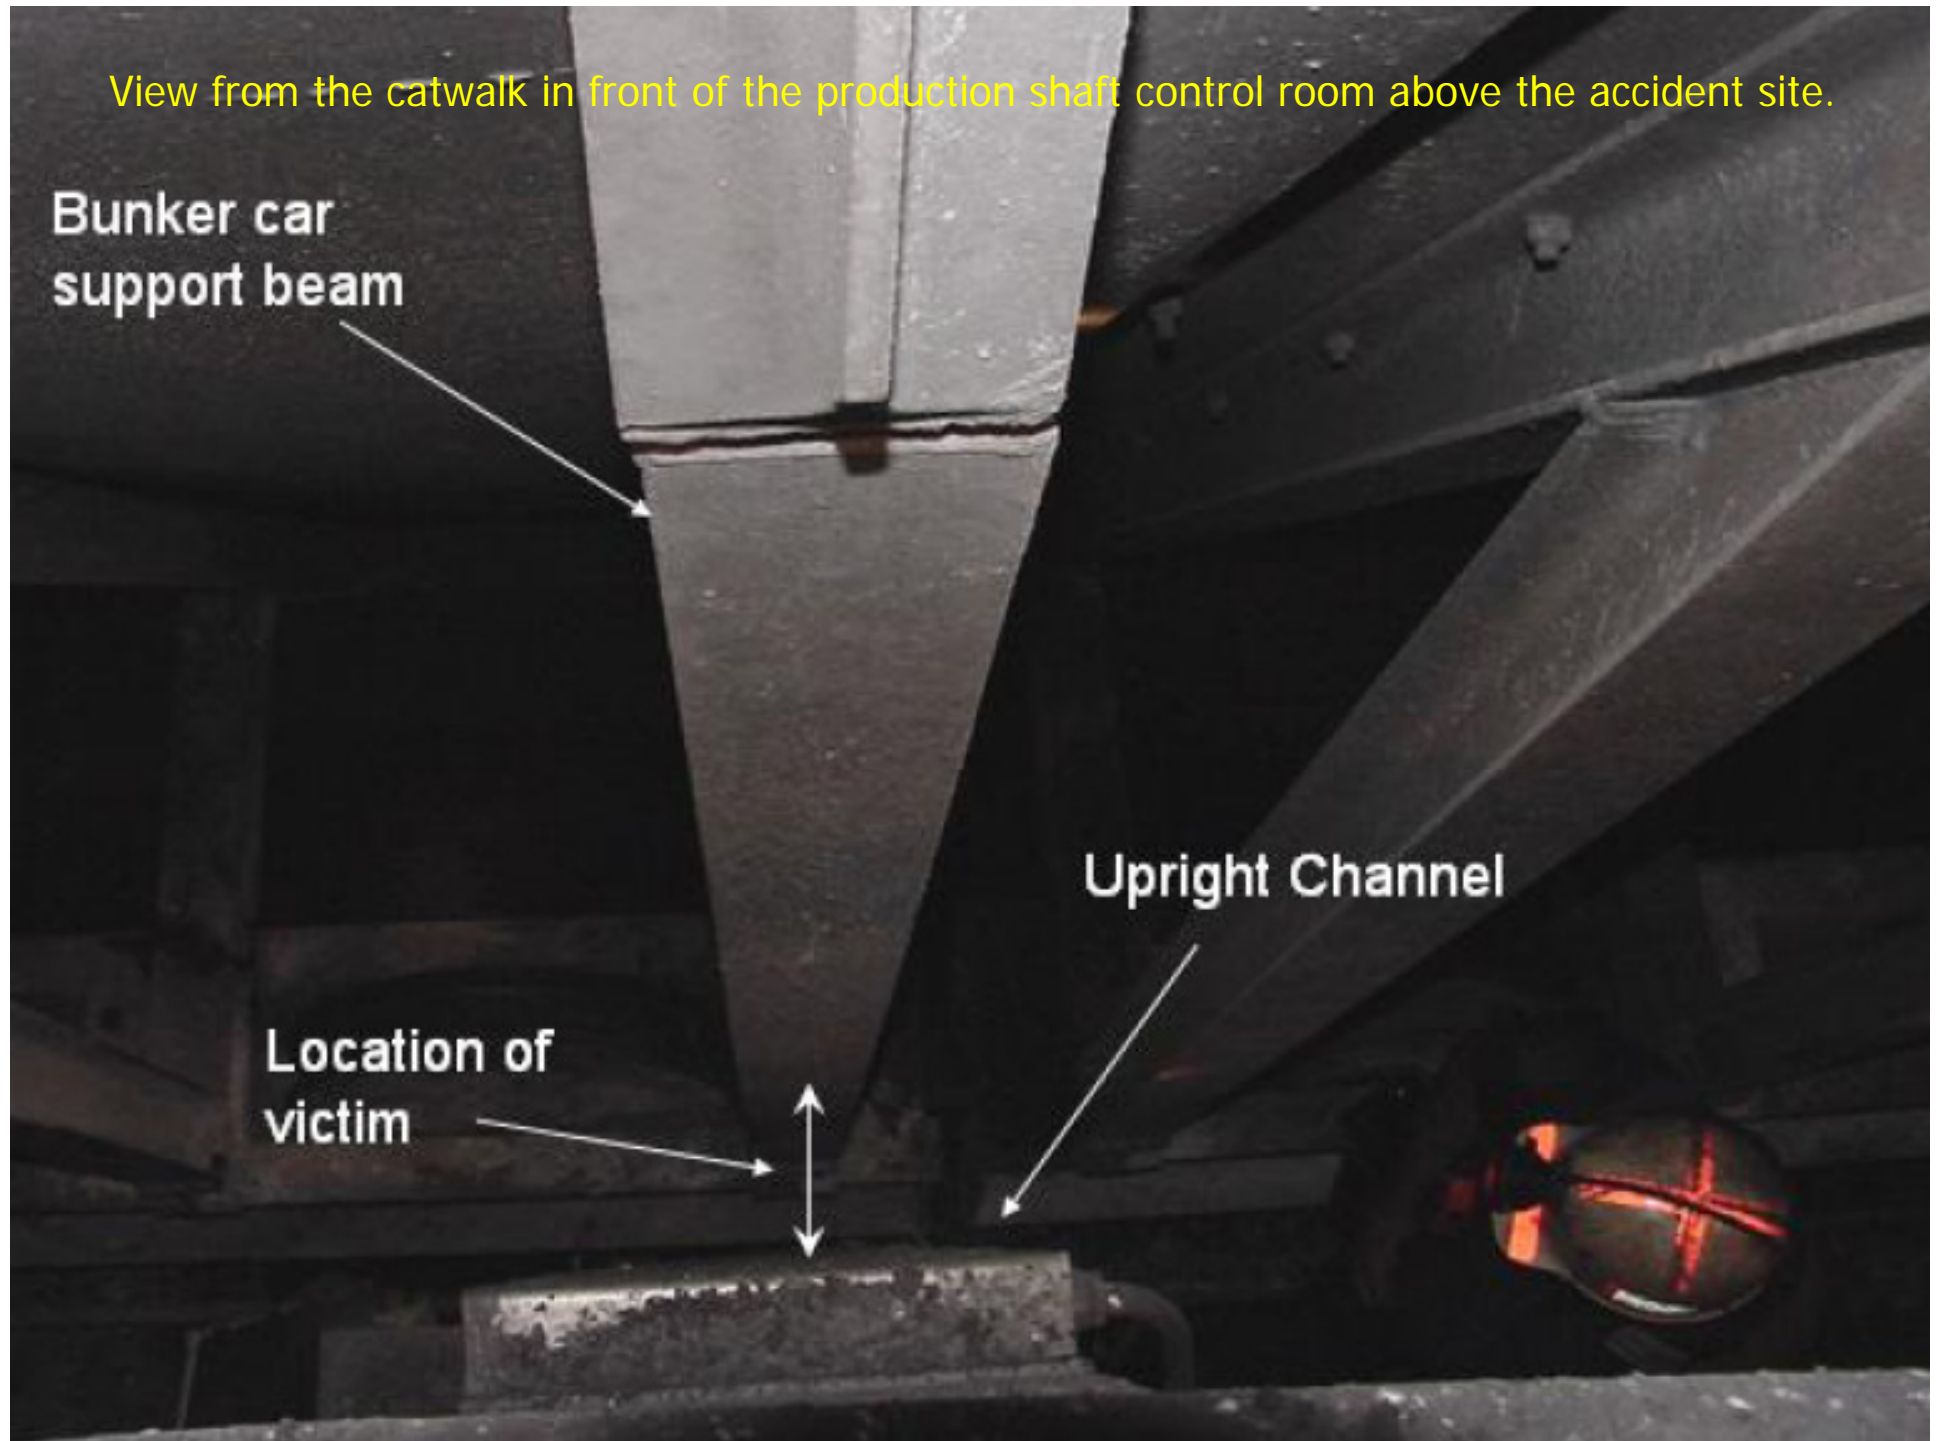
View from the catwalk in front of the production shaft control room above the accident site.

Bunker car
support beam

Upright Channel

Location of
victim

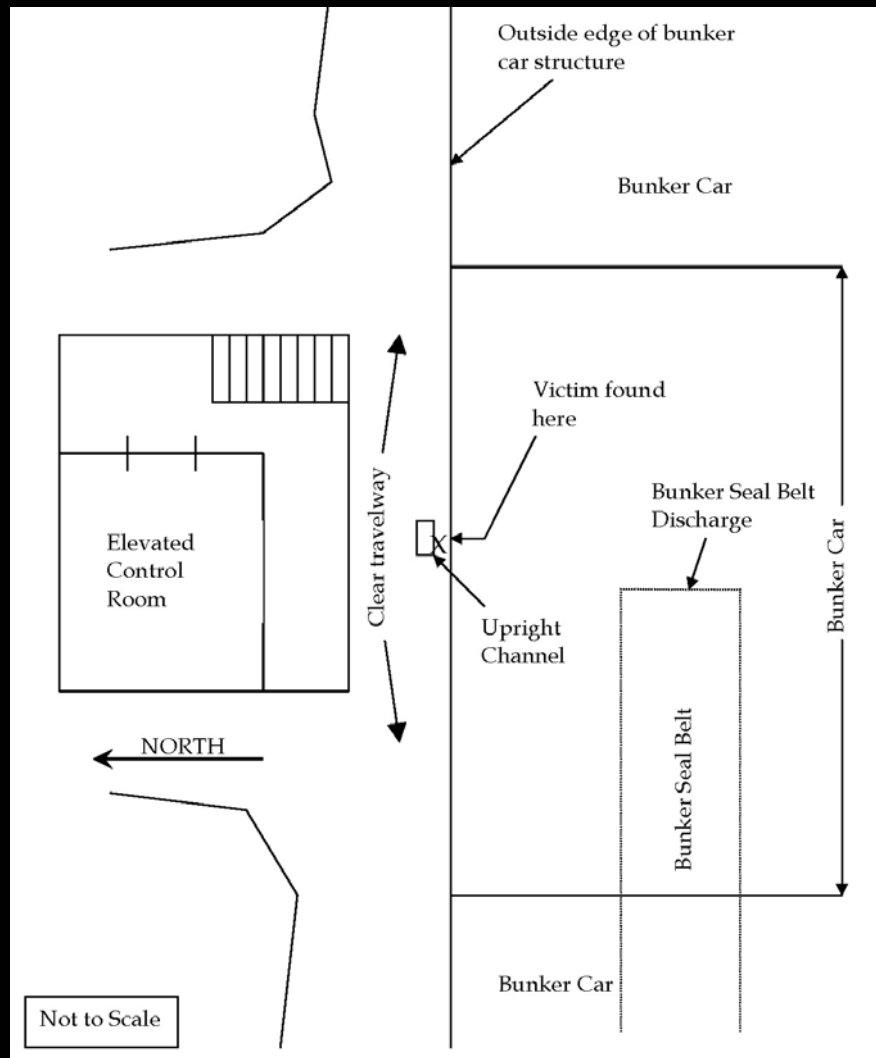
The victim sustained fatal injuries while performing his normal job duties from a position in which a pinch-point between a stationary upright steel channel and a bunker car support beam was created by movement of the bunker cars.

Contributing causes to the accident include leaving the upright sensor channel in place after removing the automatic system from service, inadequate warning devices, and lack of an emergency stop system accessible to miners working around the bunker.

Causal Factor: The upright channel on which the automatic car location/position sensors were installed was not removed from the area though the system had been inoperative since shortly after installation.

Corrective Actions: The mine operator removed the upright channel.
