Coal Mine Fatal Accident 2004-19

Operator:	Consolidation Coal Company
Mine:	Buchanan Mine #1
Accident Date:	September 26, 2004
Classification:	Powered Haulage
Location:	District 5, Buchanan County, VA
Mine Type:	Underground
Employment:	418
Production	18,000 Tons/Day

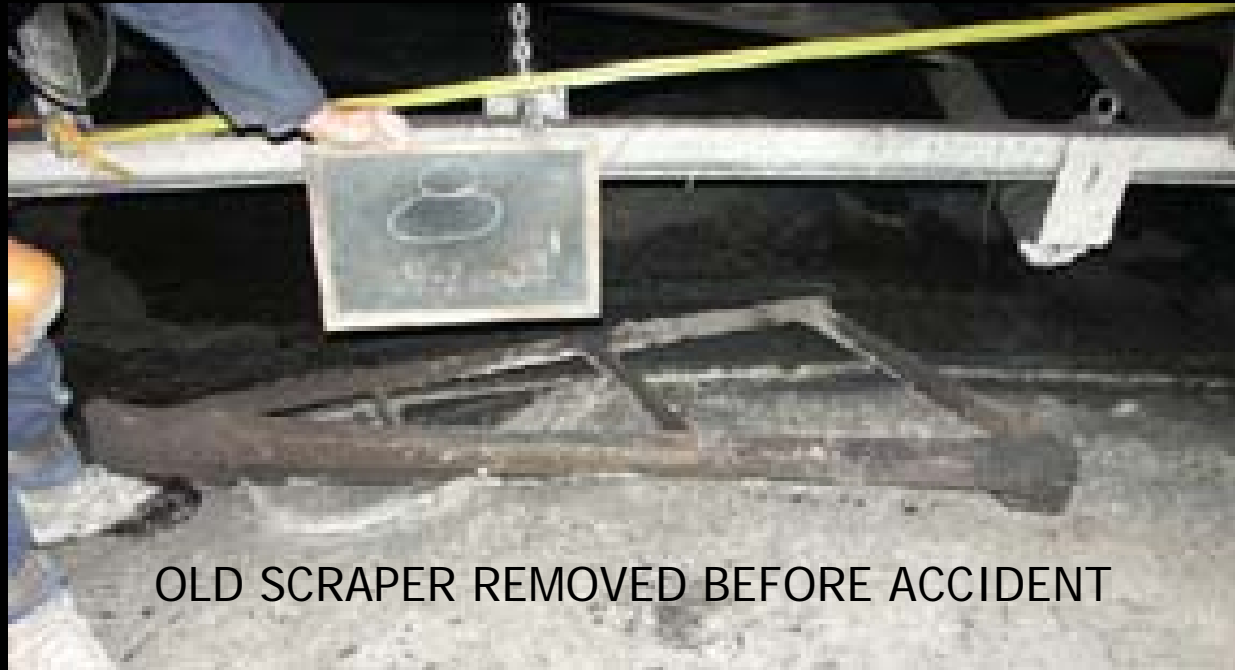
OLD SCRAPER REMOVED BEFORE ACCIDENT

The victim was attempting to install a belt scraper at the tailpiece. He attached a chain to the scraper and attempted to throw the other end of the chain between the belts. The chain became caught between the top of the bottom belt and the tail roller, which caused the chain, scraper, and victim to be pulled through the tail roller.

Corrective Actions: An Action Plan was submitted to MSHA by the coal company. The plan states that all employees will be given additional training. Mine management will also conduct weekly job observations on employees that normally have duties that require lock-out and tag procedures. These observations will be recorded on appropriate forms.
