Coal Mine Fatal Accident 2004-29

Operator:	Tennco Incorporated
Mine:	Valley Creek Mine No. 2
Accident Date:	December 21, 2004
Classification:	Machinery
Location:	District 7, Claiborne County, KY
Mine Type:	Underground
Employment:	28
Production	1100 Tons/Day

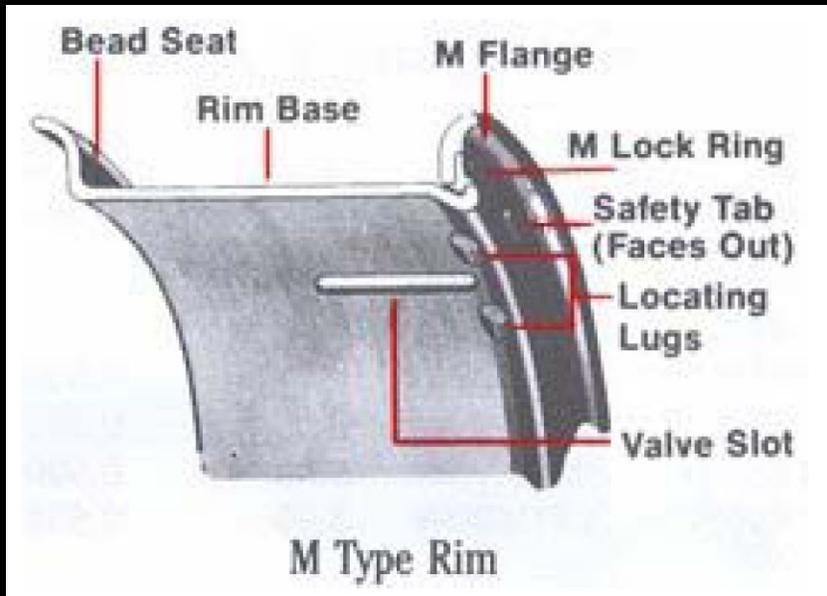
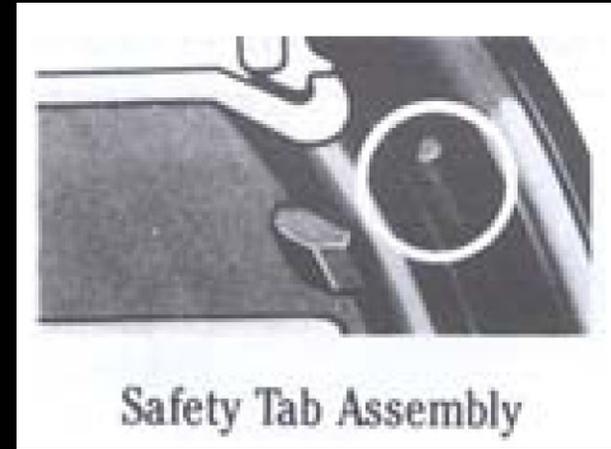
The components of the rim assembly consisted of a rim base, a split locking ring and a continuous side ring or flange. These parts are designed to allow the locking ring to fit into a gutter on the base rim, "locking" the flange in place on the rim when the tire is inflated.

Causal Factor: The accepted tire servicing procedures were not followed during the assembly of the 1200-20 tire and wheel. Interviews with Blair Tire Company Inc. personnel revealed that training issues existed.

The accident occurred when the lock ring and flange separated from the rim assembly violently during the mounting of the 1200-20 air filled tire. The exact mechanism of the lock ring and flange separation could not be determined. The accident resulted from the cumulative effect of deficiencies that occurred during the assembly, handling, and mounting of the wheel and tire unit.

Corrective Actions: The mine operator eliminated the use of split rim air filled shuttle car tires and is now using foam filled tires which do not present the same hazards as air filled tires.

When using split rim air filled tires the size and type of both the tire and the rim wheel components should be checked for compatibility prior to assembly. Multi-piece wheel components should not be interchanged except as provided in the charts or in the applicable rim manual. Rim parts should be inspected for any damage and deformity, wear, free of any dirt, surface rust, corrosion and pitting prior to mounting and inflation. The tire side of the lock ring should be a distinctive identifying color, or some other distinctive means, so as to afford immediate identification of proper placement of the lock ring. OSHA Regulations covering the Servicing Multi-Piece and Single-Piece Rim Wheels, 29 CFR 1910.177 should be followed by Blair Tire Company Inc.
