MNM Fatal 2004 - 02

- Falling Material Accident (New Mexico)
- January 30, 2004
- Sand and Gravel Operation
- Plant Manager
- 60 years old
- 40 years experience

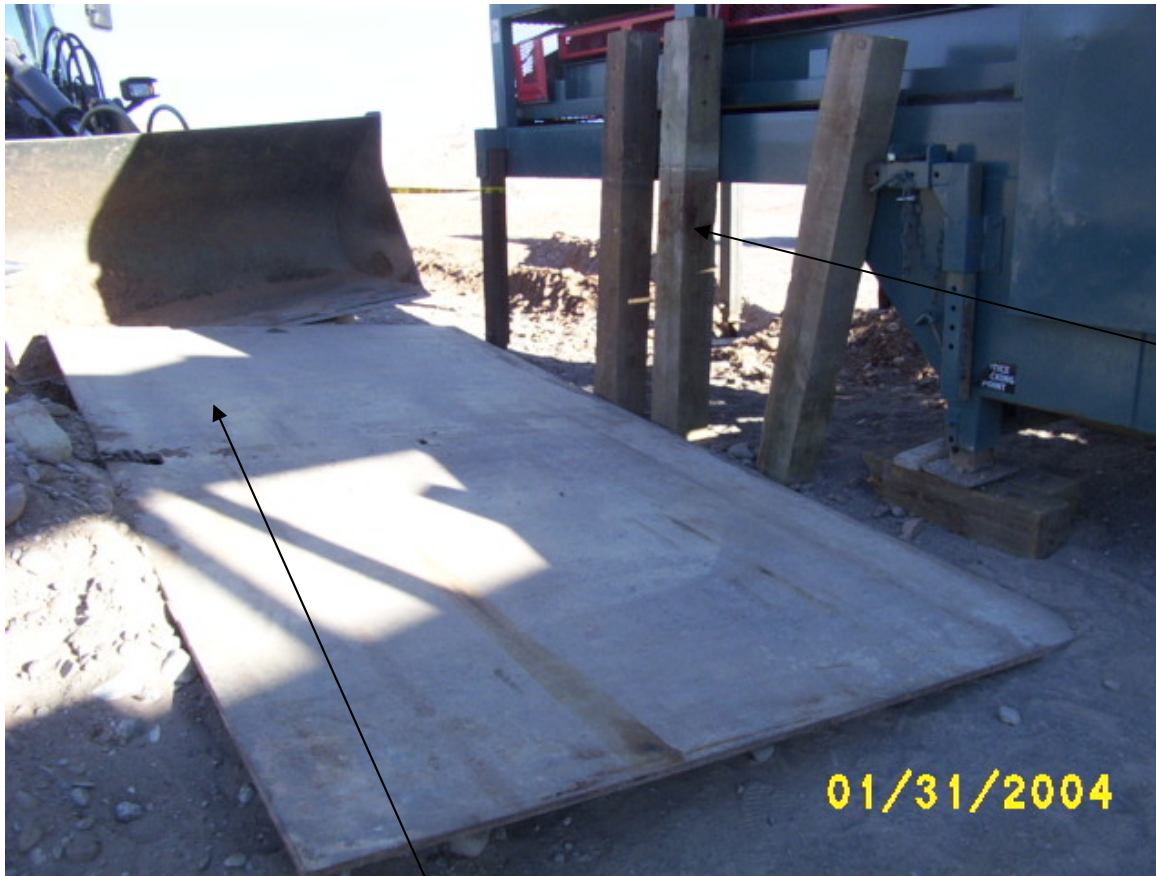
Timbers used to
support plate so it
Would not hit the plant.

15' x 8' x 1" plate

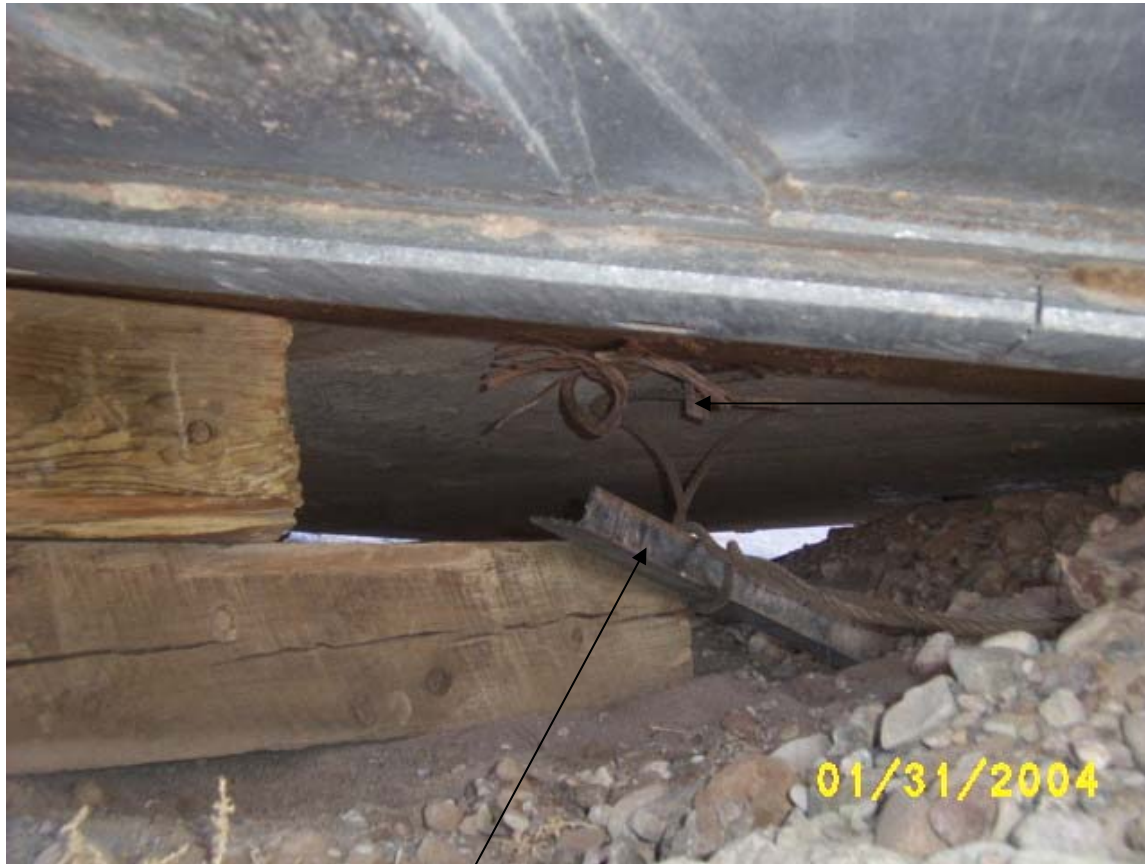
Eye plate where
the cable was
looped through
and attached to
anchor.

2" x 1 1/2" angle iron used to twist cable to bring up the slack.

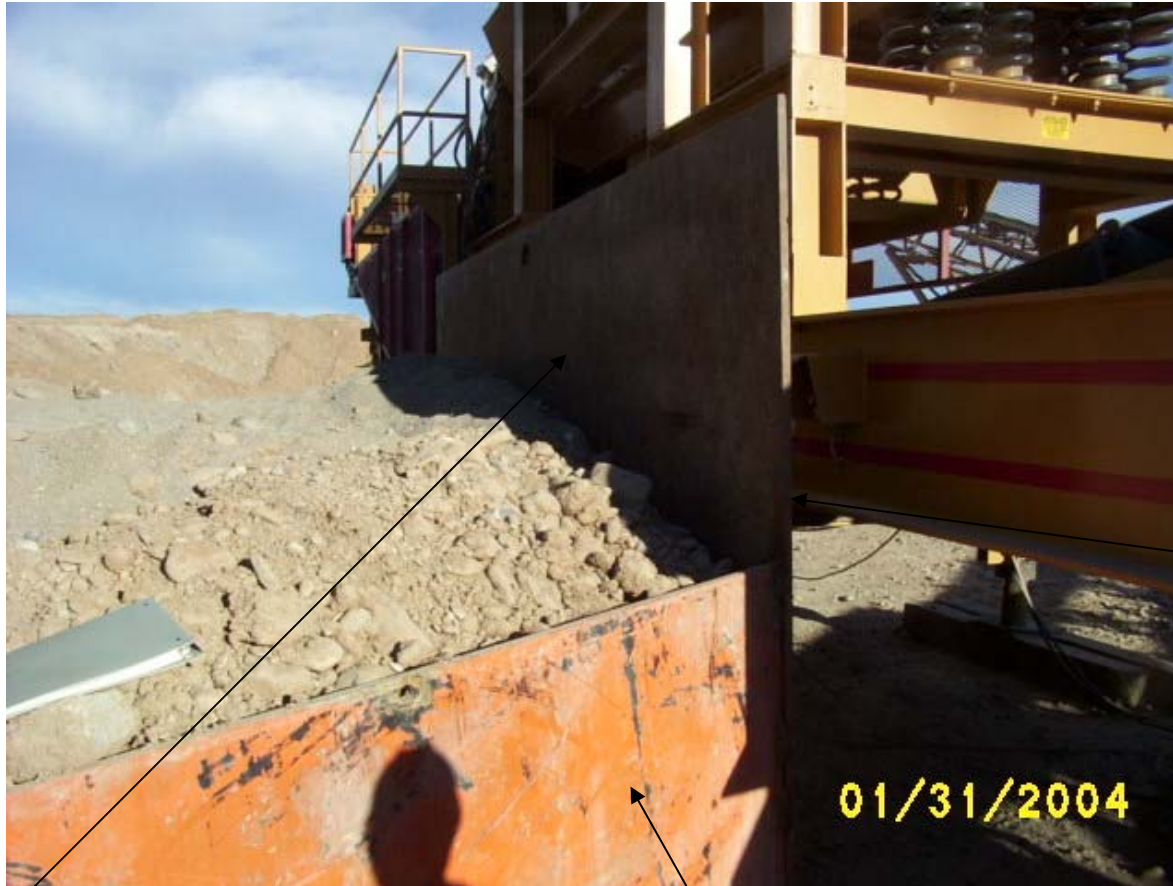
Correct setup showing back plate supported with welded side plates.

Side plate (wing)
welded to back
plate.

Back plate to keep material from going under the plant.

Side plate (wing) to help support back plate and material
