REPORT OF INVESTIGATION

Fatal Machinery Accident
Occurred: January 3, 2004
Date of Death: January 4, 2004

SUFCO Mine
Canyon Fuel Company, LLC
I.D. No. 42-00089
Salina, Sevier County, Utah

**FATAL MACHINERY ACCIDENT
SUFCO MINE, ID NO. 42-00089
CANYON FUEL COMPANY, LLC
SALINA, SEVIER COUNTY, UTAH
JANUARY 3, 2004**

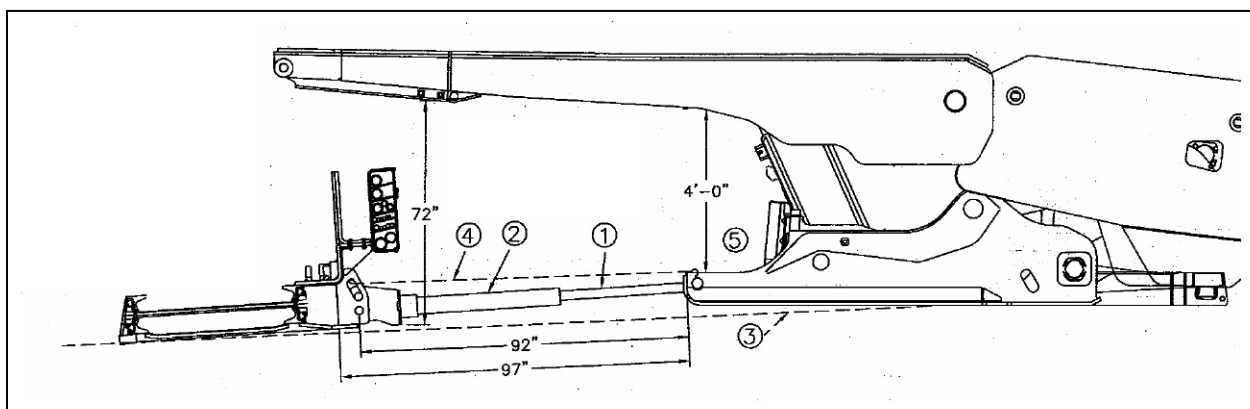
**SIDE VIEW SKETCH OF NO. 49 SHIELD
(NOT TO SCALE)**

- 1 – SHIELD RELAY BAR EXTENDED 29.5 INCHES BEYOND END OF BASE SKID
- 2 – 42-INCH ALUMINUM EXTENSION ATTACHED TO RELAY BAR
- 3 – FLOOR HORIZON – REFERENCE ONLY
- 4 – LOCATION OF CHAIN RIGGING BETWEEN SHIELD AND FACE CONVEYOR
- 5 – LOCATION OF VICTIM

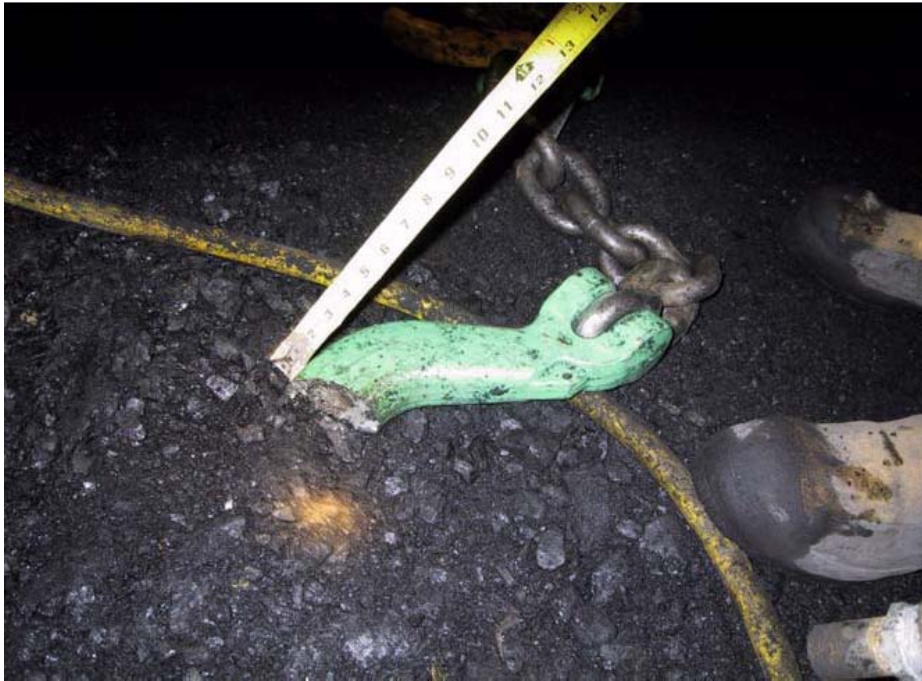
APPENDIX C

6. When proper rigging procedures are used, the centerline of the hook should be in line with the centerline of the chain. Wear marks on the inside of the hook showed that the hook contacted the edge of the slotted hole approximately $1\frac{1}{2}$ inches from the tip of the hook. Wear marks showed that the outside of the hook contacted the opposite side of the slotted hole. With the hook in this position, there was an angle of approximately 60 degrees between the centerline of the hook and the centerline of the chain. This misalignment caused the inside dimension of the hook to spread from approximately $2\frac{1}{2}$ inches to about $4\frac{1}{8}$ inches before it broke. In summary, when the slotted hole was checked for compatibility with the hook used on the rigging configuration, the hook would not properly engage due to the physical characteristics of the hook and the size and bore of the welded ear on the conveyor, thus causing tip loading of the hook. Information from the manufacturer indicated that the recommended working load of a hook when tip loaded would be reduced to 41 percent of the design working load. Thus, the tip loaded hook would have a working load of 14,473 (0.41 times 35,300) pounds and a breaking load of about 57,892 pounds.

BROKEN HOOK THAT STRUCK VICTIM

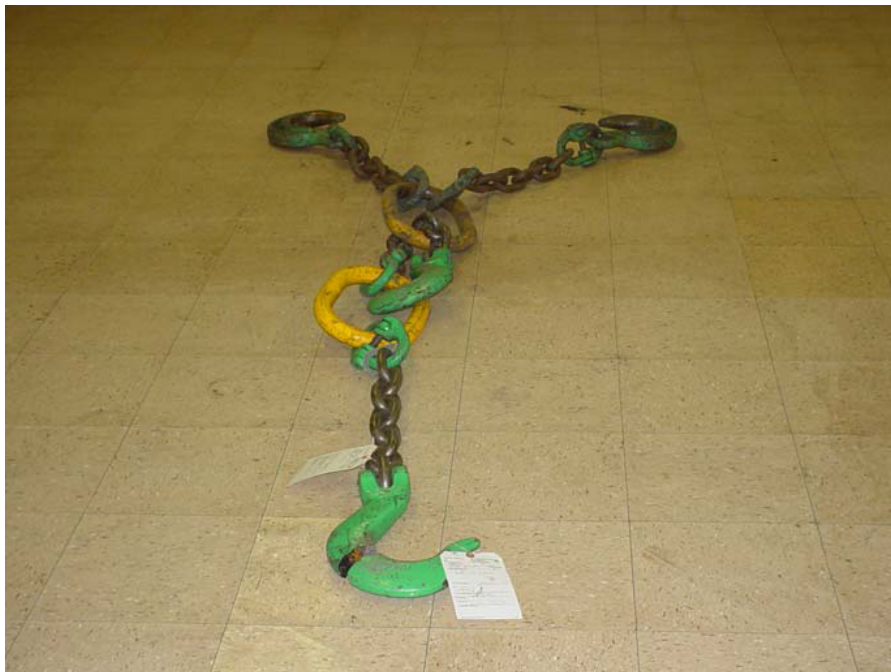
APPENDIX D

At the time of the accident, an attempt was being made to pull the "iron bound" No. 49 shield by using the ram cylinders on the adjacent shields. The toe of the "iron bound" shield was attached to the face conveyor by the use of two similar two-legged chain slings. Both of the slings were made from Grade 10 chain components and had a reach of 3.5 feet. The main difference between the two chain slings was that one had sling hooks and the other had foundry hooks. Both slings had the same maximum recommended loads. The chain sling with the foundry hooks was connected to the toes of No. 49 shield by placing the hooks into 2 holes in the top of the shield toes. These holes were approximately $49\frac{1}{4}$ inches apart. The sling with the sling hooks was used as a straight chain with the two chains extending from opposite ends of the master link. One chain was connected to the master link of the other chain by the use of a chocker hitch, which involved wrapping the chain around the master link and hooking the hook to the chain. The other end of the chain was attached to the conveyor pan by placing the hook in the slotted hole used to connect the ram for advancing the longwall. This hole was approximately $2\frac{1}{2}$ inches wide by $4\frac{3}{8}$ inches long. The slotted hole was approximately 25 degrees from vertical. The angle between the location where the hook was connected to the face conveyor and where the 2 hooks were connected to the toes of the shield was approximately 84 degrees from vertical. The combination of these angles made the angle between the centerline of the slotted hole and the direction that the chain slings were pulling approximately 109 degrees. At this angle, the effective width of the slotted hole for the hook, which was attached to the face conveyor, was approximately $2\frac{5}{8}$ inches.

THE TWO 2-LEGGED CHAIN SLINGS AS RIGGED DURING ACCIDENT
THE BROKEN HOOK IS IN FOREGROUND WITH WHITE TAG ATTACHED

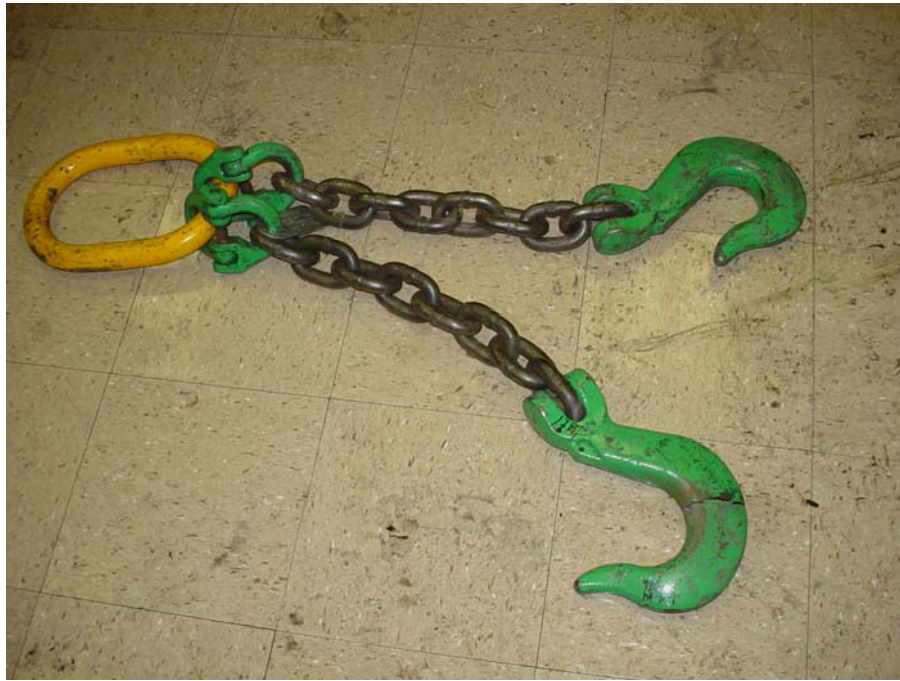
APPENDIX E

5. The two-legged chain sling, which broke during the accident, was assembled and distributed by D&M Wire Rope of Grand Junction, Colorado. The D&M serial number on the chain sling was 392339. The chain sling consisted of a master link with two chains attached by the use of quick-alloy coupling links. Each of the chains had eight $\frac{3}{4}$ -inch, Grade 10 welded chain links with a Grade 10 sling type chain hook attached to the end. The chain hooks had clevis type ends, which were used to attach the hooks to the chains. Each of the components of the chain sling had a recommended maximum working strength of 35,300 lbs, when loaded by a straight pull. All of the components in the chain sling had a factor of safety of 4:1, giving these components an average breaking strength of approximately 141,200 lbs during a straight pull. The maximum reach on the chain sling from the inside of the master link to the inside of one of the chain hooks was 3

2-LEGGED CHAIN SLING WITH BROKEN HOOK

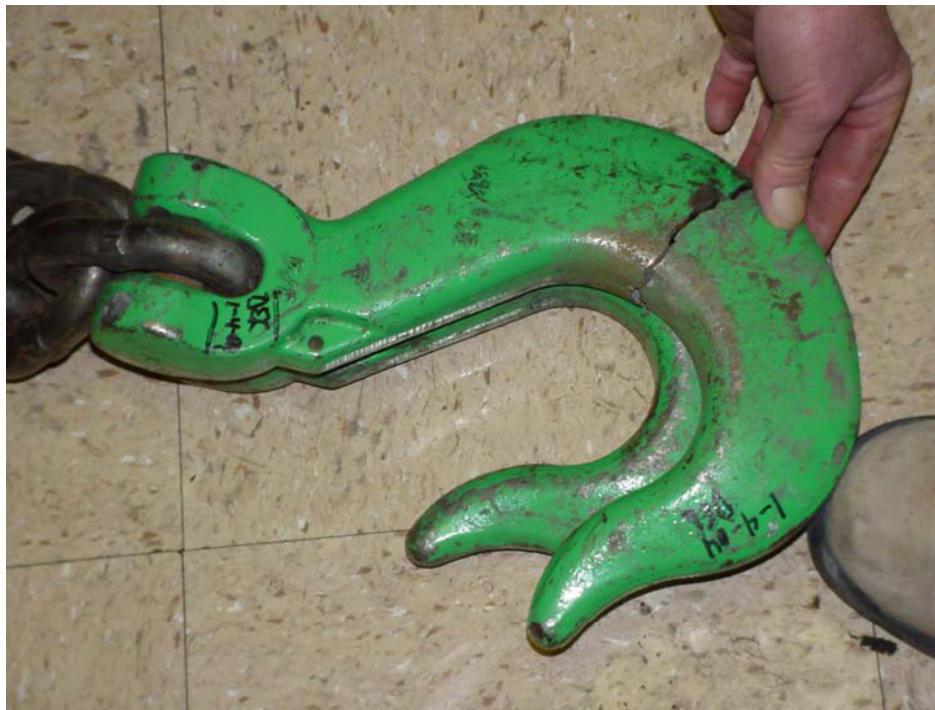
APPENDIX F

BROKEN HOOK LAYING ON TOP OF OTHER HOOK FROM 2-LEGGED CHAIN SLING

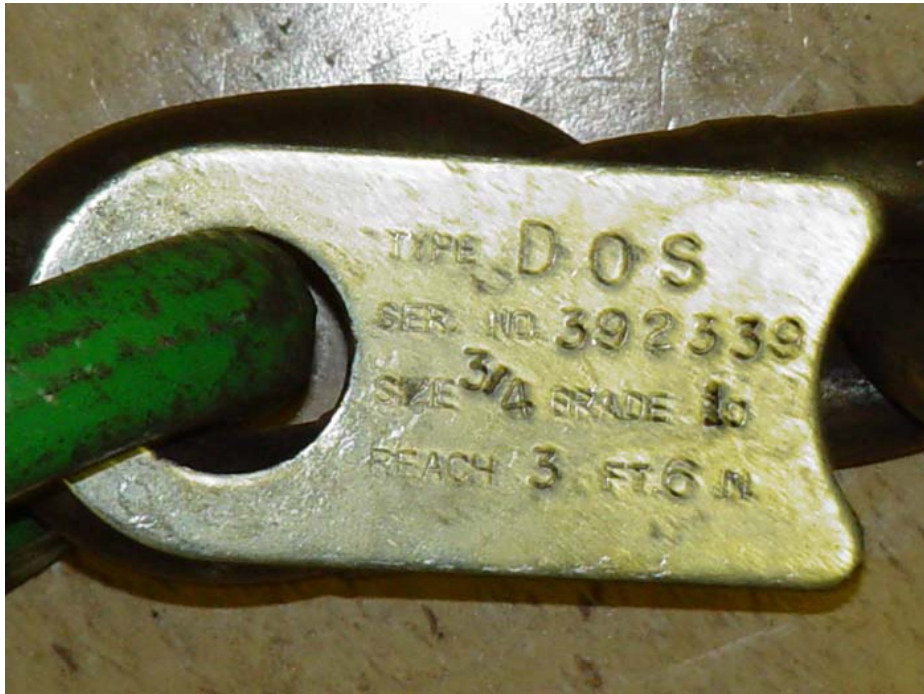
APPENDIX G

SLING IDENTIFICATION TAG

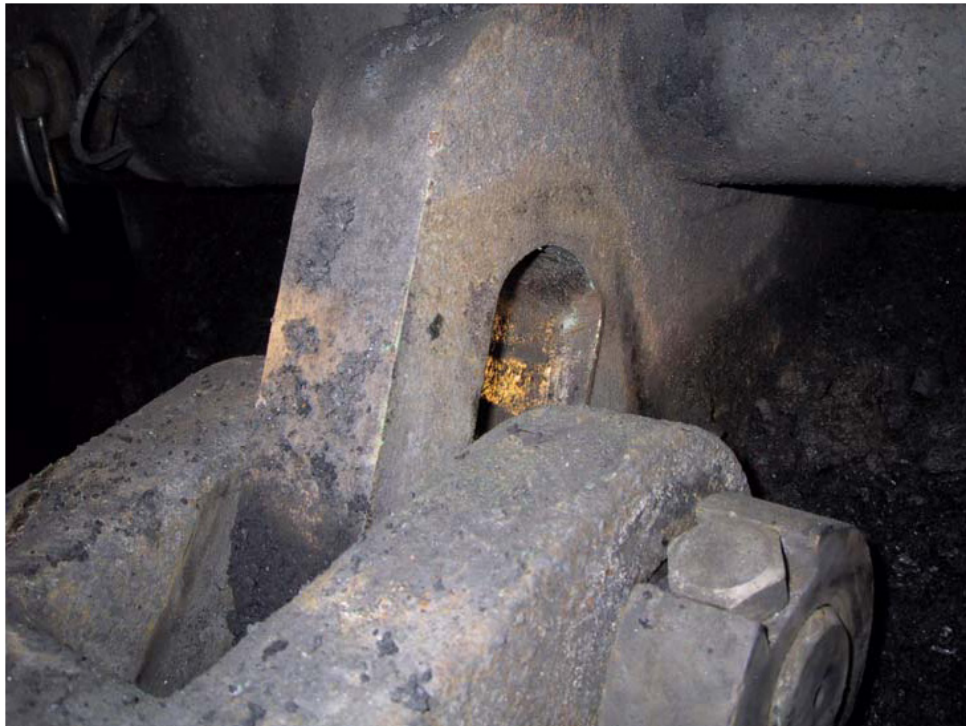
APPENDIX H

SLOTTED HOLE ON FACE CONVEYOR WHERE HOOK WAS INSERTED

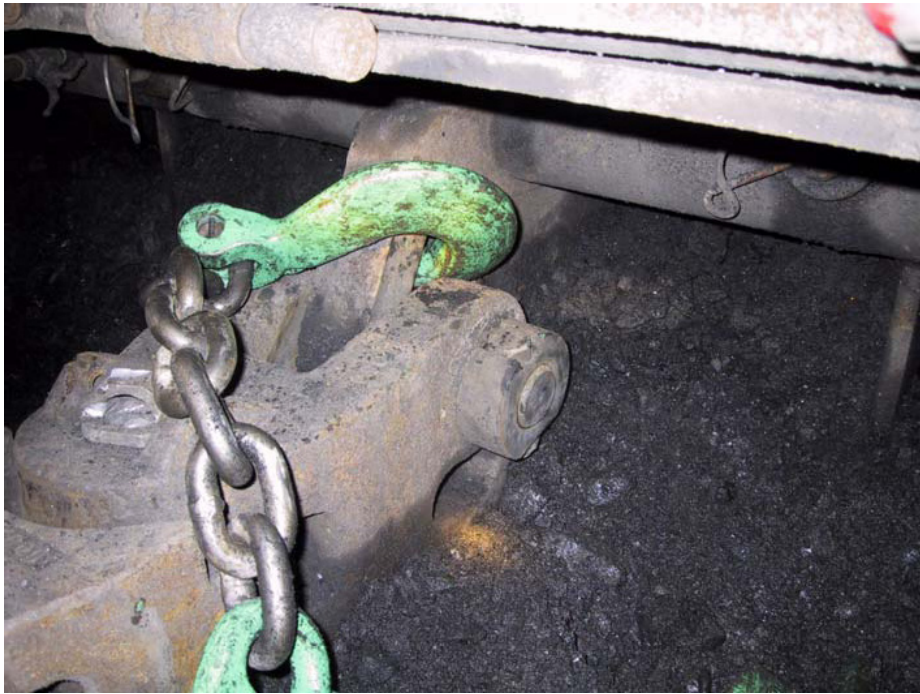
APPENDIX I

RE-ENACTMENT OF HOOK INSERTED INTO SLOTTED HOLE ON FACE CONVEYOR

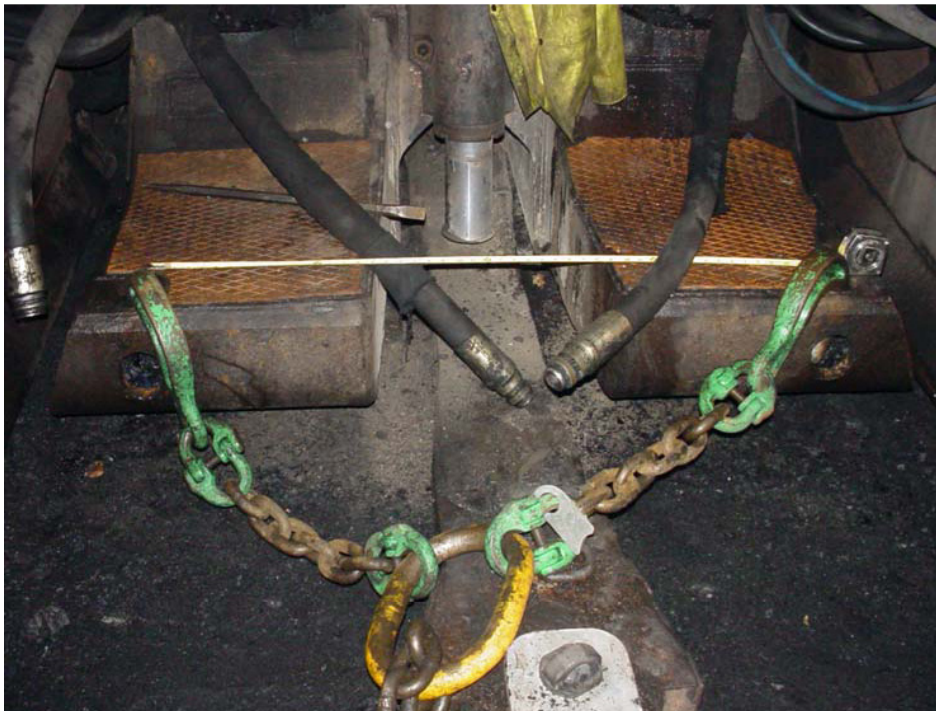
APPENDIX J

RE-ENACTMENT OF SLING ATTACHED TO TOES OF NO. 49 SHIELD
VICTIM WAS LOCATED ON THE RIGHT SIDE SHIELD TOE

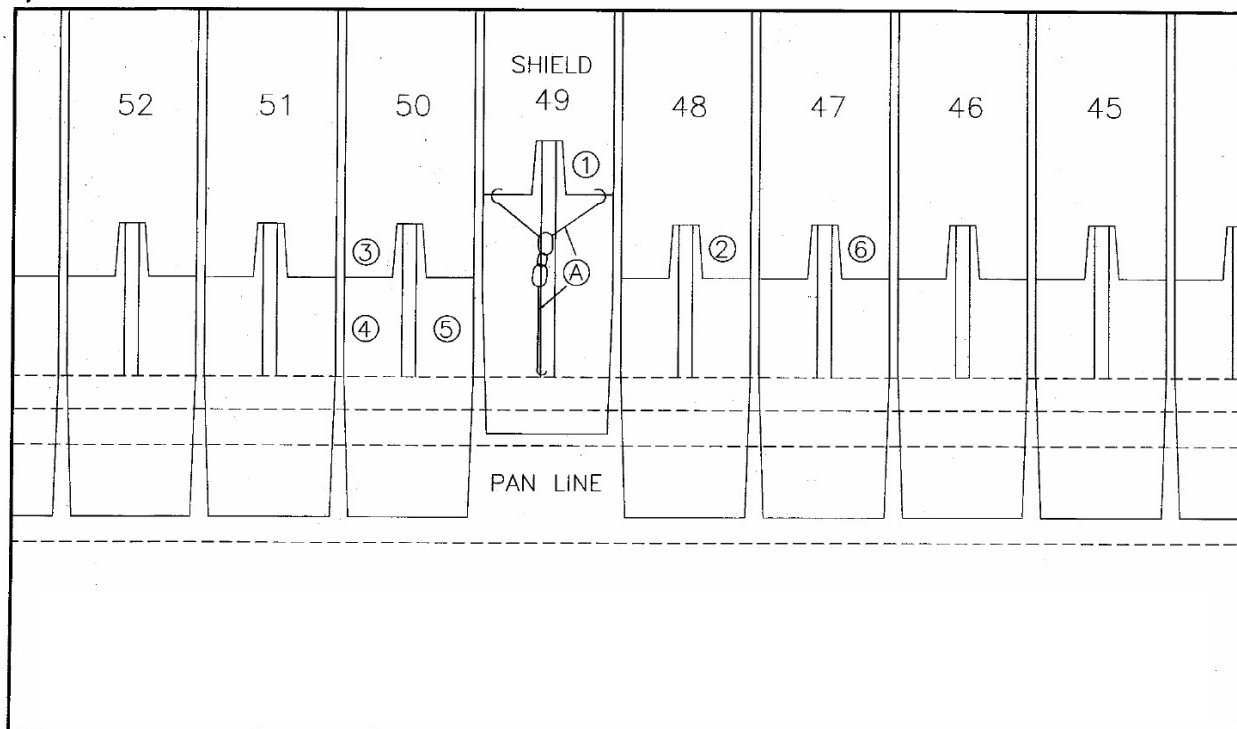
APPENDIX K

9. At the time of the accident, Willden, Beach, Crane, Joe Hewko, mechanic, Kirk Jensen, diesel mechanic, and Rick Parkins, longwall coordinator for Canyon Fuel's three Utah mines, were in the area. See Appendix K for locations. Willden and Jensen both stated during the investigation that they were very uncomfortable with the chain rigging arrangement. Parkins, who had just traveled past No. 49 shield, cautioned the miners not to trust the chains. He did not give any directions or instructions on using the chain slings or on the work that was being done at No. 49 shield. Parkins claimed that he did not have authority to direct the workforce or assign duties and that he only acted in an advisory capacity to mine management on longwall operations. Statements indicated that Crane was comfortable with the chain sling rigging and that he chose to operate the controls of No. 49 shield.

- 1 – RUSSELL CRANE (Victim)
- 2 – RUSSELL WILLDEN, Supervisor
- 3 – KIRK JENSEN, Diesel Mechanic
- 4 – JOE HEWKO, Mechanic
- 5 – PHILLIP BEACH, Laborer
- 6 – RICK PARKINS, Longwall Coordinator
- A – CHAIN RIGGING BETWEEN SHIELD
AND FACE CONVEYOR

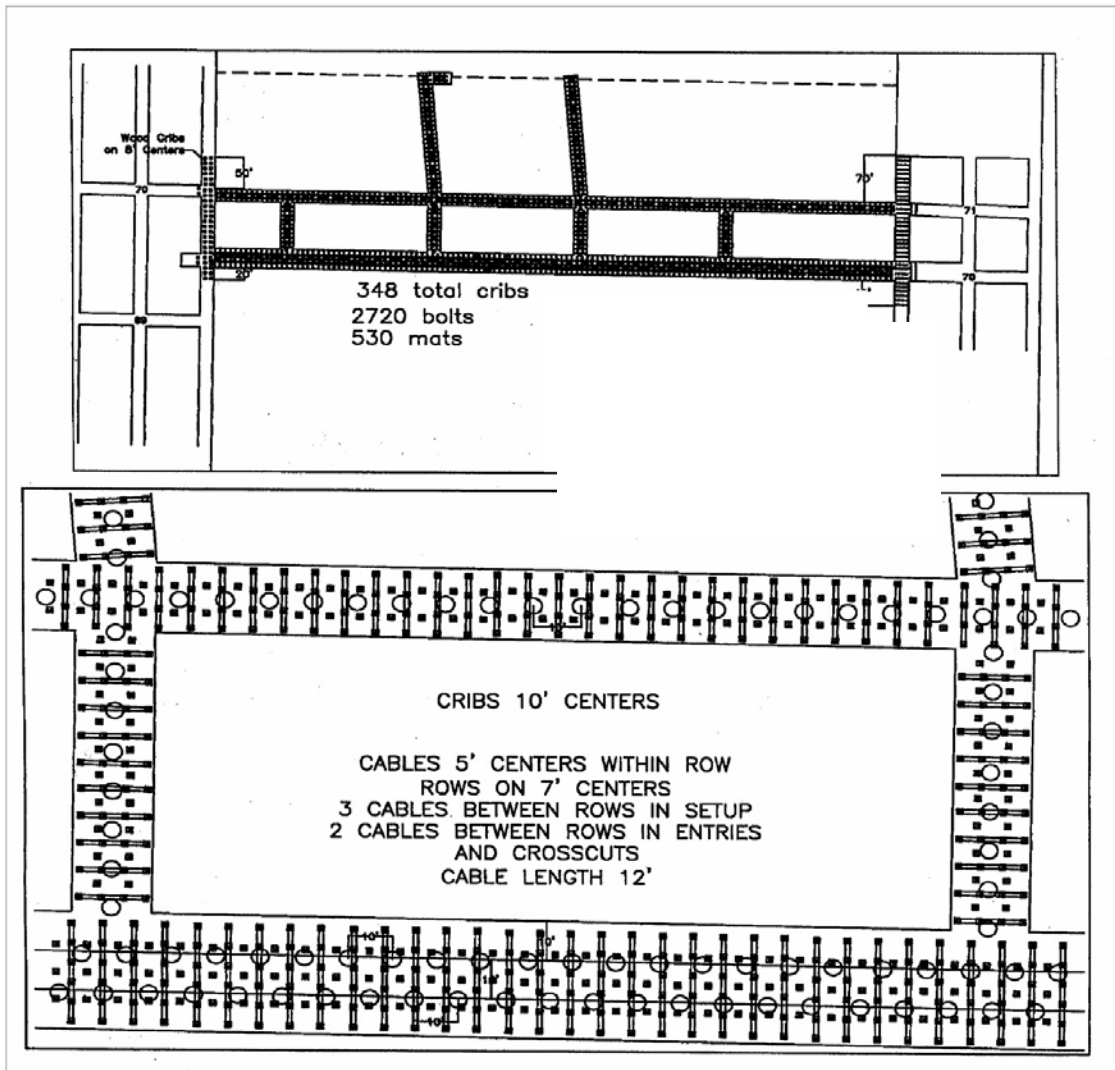
3LPE SETUP ROOM SUPPORT PLAN

2. The setup rooms were initially supported with 5-foot long resin bolts on 5-foot centers with wire mesh throughout. To mine through the setup rooms, additional support was installed including 12-foot cable bolts on 5-foot centers in rows spaced 7 feet apart. "Monster mats" were installed with the bolts in these rows. Additional 12-foot cable bolts (3 in the setup entry and 2 in other entries) were installed between the rows. Four-foot diameter Minova TEKGR0UT 1800 ton capacity cuttable cribs made of cementitious material were installed in all entries. A TEKSET bag with 800-ton strength was set on top of each crib to cushion the crib to the roof. The 30-foot wide setup room had two rows of cribs on 10-foot centers with cribs staggered on 5-foot centers between the rows. All other entries had a single row of cribs installed on 10-foot centers down the middle of the entry. Approval for use of these additional supports was granted by MSHA on November 13, 2003. The additional support materials were installed in all the entries prior to the longwall section retreating through the area (see Appendix L for a drawing showing the additional support).
