REPORT OF INVESTIGATION

Fatal Powered Haulage Accident  
April 22, 2004

No. 7 Mine  
Jim Walter Resources, Inc.  
Brookwood, Tuscaloosa County, Alabama  
ID No. 01-01401

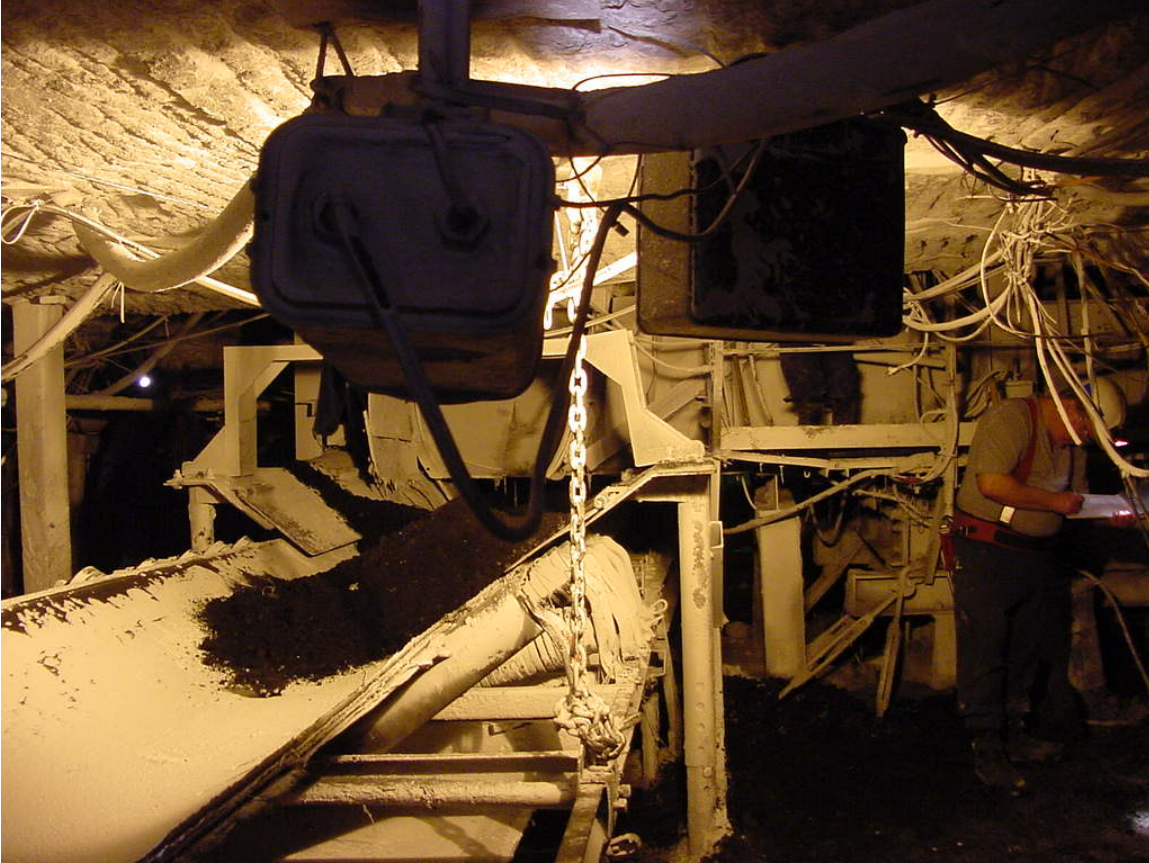
### **Victim's Work Area, North Main Belt Discharges to West "A" Belt**

It is likely the accident occurred at the North Main belt discharge to the West "A" belt. (See appendix C, North Main Head Roller). This had been the normal work area for the victim during the past two years. The victim's duties were to clean the belts and keep the head roller discharge chutes free of obstructions.

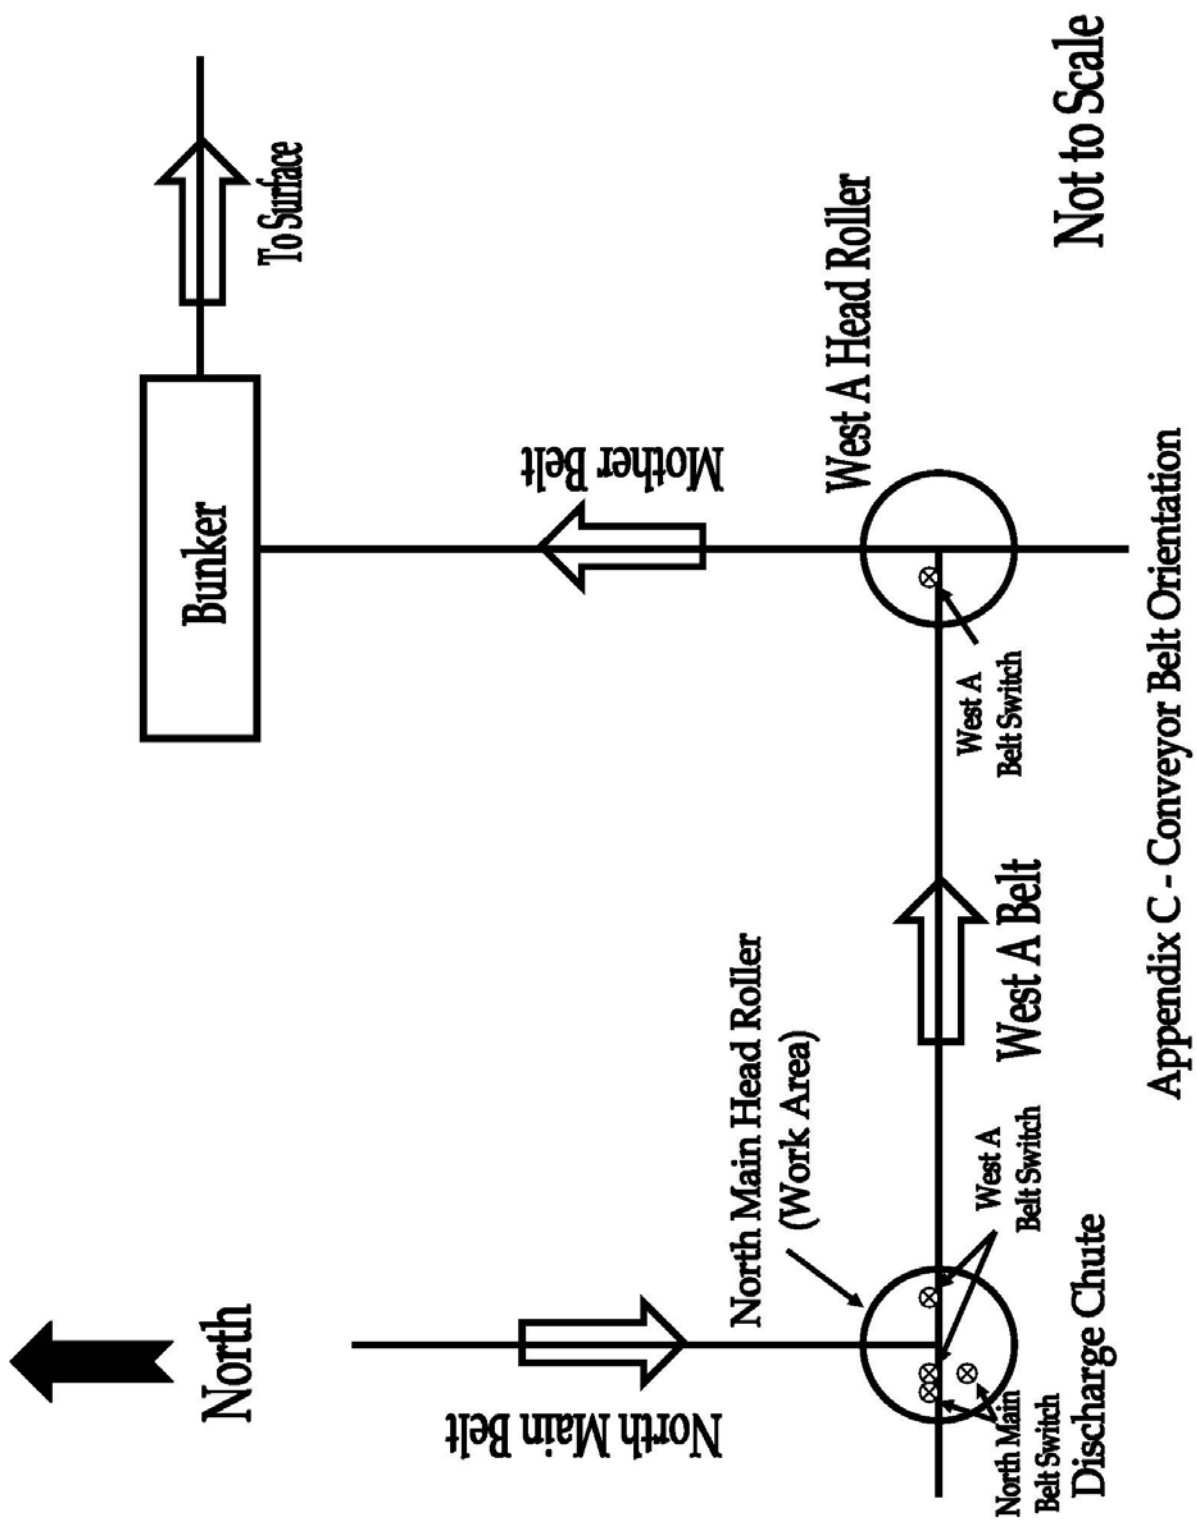
A line diagram of the conveyor belt system in the accident area is provided in Appendix C. The 60 inch North Main belt has one belt drive pulling a 9000-foot flight at a velocity of 630 feet per minute. The belt drive consists of four 300 horsepower, 480 volt alternating current motors manufactured by FMC. The belt is controlled by a solid state, Benshaw starter. The head roller is manufactured by Precision Pulley, Inc. The North Main belt discharges onto the West "A" belt. The North Main belt head roller has an elevated catwalk system located on both sides of the head roller support structure. The elevated catwalk does not provide access into the discharge chute. The North Main belt head roller and West "A" belt head roller, with associated structures, are the oldest conveyor system installations in use at this mine.

The configuration of the North Main Belt head roller discharge chute lends itself to plugging by large rocks being conveyed from active mining areas. The discharge chute has a replaced interior liner with seams protruding approximately ¼-inch into the chute. Rocks can hang up against these protrusions, blocking the chute. Witness statements indicate North Main Belt head roller discharge chute blockages have occurred on a relatively frequent basis.

*Corrective Action:* Safe access into the North Main Belt Head roller discharge chute has been provided above the West "A" Belt.

*Corrective Action:* This chute has been completely redesigned and replaced to prevent blockages.

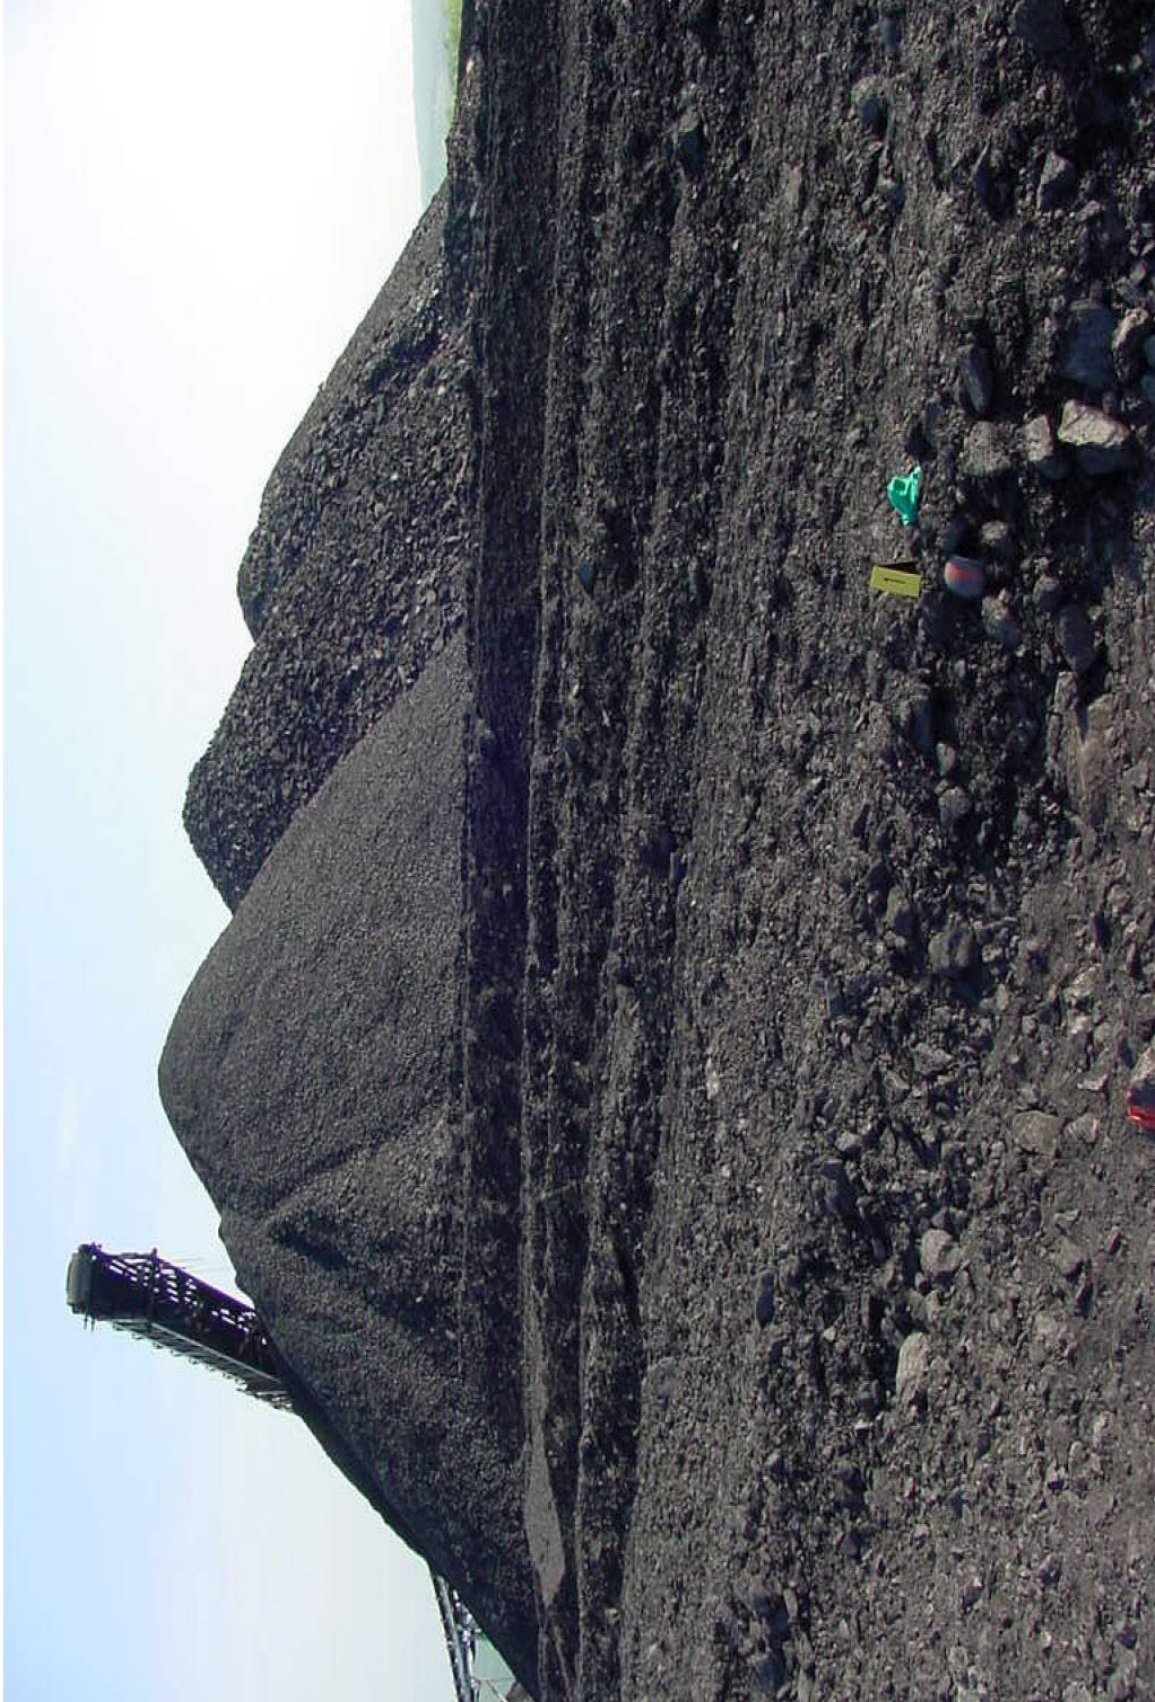
**Appendix D – Surface area where victim was recovered.**

on April 23, 2004, the coal preparation plant and rock belts were shut down to facilitate an expanded search on the surface. The lower rock bin, upper rock bin, and the rock dump at the radial stacker belt were checked. A front end loader was brought up to the rock pile and the most recently handled refuse material was uncovered in thin lifts. Between 4:20 am to 4:30 am, the victim's body was found approximately 350 feet from the radial stacker under 2 to 4 feet of rock.
