REPORT OF INVESTIGATION

Fatal Fall of Highwall
November 20, 2004

Red Cedar Surface Mine
Endurance Mining
Clothier, Boone County, West Virginia
ID No. 46-08683

Originating Office
Mine Safety and Health Administration
District 4
100 Bluestone Road
Mount Hope, West Virginia, 25880
Jesse P. Cole, District Manager

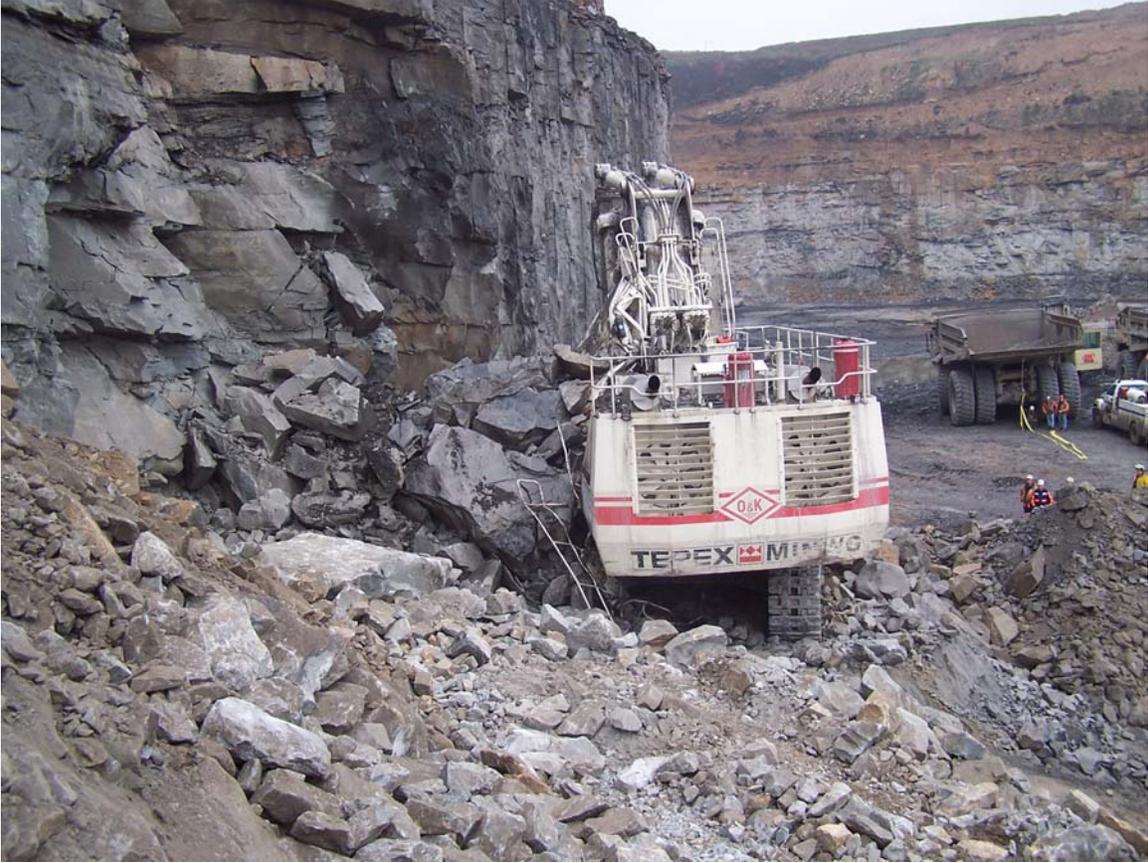
Previous surface mining in the active mining areas at the Upper Clarion level intersected old works in Pits 44 and 43. In Pit 43, the highwall broke out and fell into the pit at several locations. Brown and the equipment operators observed roof bolts being loaded out with the overburden. As mining continued toward the accident site, the location and orientation of the highwall became parallel to an old underground mine entry. The highwall contained fractured strata and cracks resulting from the collapse of three abandoned underground crosscuts and an entry near the accident site.

West of the accident site, the highwall was generally in good condition. Remains of pre-split drill holes were visible along most of the highwall west of the fall in Pit 42. East and west of the accident site, arch-shaped cracks were observed on the highwall in several locations. The arch-shaped cracking and broken rock appeared to be the result of subsidence from the old underground mine workings.

Immediately east of the accident site, the highwall was rough with more broken rock, cracking and faulting or jointing. The rock was more stratified with

Failure of the rock at the accident site appeared to have been through a combination of existing cracks and discontinuities, as well as subsidence induced fractures. The existing discontinuities on the west side appeared to be from a joint which had some brownish staining and was relatively smooth. The brownish staining suggests that the joint had been open long enough to allow weathering of the rock. The rock in the center and eastern side of the failure was more broken, noticeably rougher with more undulations along the break, and more splitting along the stratification.

The cab of the excavator was approximately 15 feet from the wall before the failure. The tracks of the excavator were parallel to the highwall. The excavator body was rotated 20 degrees from parallel with the excavator boom closer to the wall. The excavator cab was positioned on the highwall side of the excavator body. The proximity of the excavator from the wall and the length of its boom indicated that the excavator was not being operated perpendicular to the highwall at the time of the accident.

shot bank towards the highwall. However, when the working pad was pulled at the base of the wall, the excavator typically rotated 180 degrees to place the operator's cab against the wall. This exposed the operator to any existing hazardous highwall conditions. The excavator was in this position loading a truck when the highwall collapsed, completely destroying the cab.

The accident occurred because the ground control plan did not provide for safe control of the highwall and safe working conditions in areas near abandoned underground mine workings. Subsidence resulting from the second mining of the abandoned underground mine workings caused the highwall to be unstable. The unstable highwall collapsed crushing the machine operators cab and resulted in the death of the machine operator. At the time of the accident, the operator's cab was positioned immediately adjacent to the highwall while the pad was being excavated. This was the normal procedure for excavator positioning.

Corrective Action: The mine operator revised the ground control plan for the mine on December 3, 2004. This change modified the mine plan to require that drilling procedures be implemented where contour mining occurred adjacent to old underground mine works. The revised plan also required a bench to be left above the pit floor located away from the outermost edge of old underground mine works. This resulted in highwall development away from the old mine workings to prevent subsidence from affecting the stability of the highwall.

Corrective Action: The mine operator revised the ground control plan for the mine on December 3, 2004, to safely control the highwalls and to provide safe working conditions for persons working near highwalls. The plan revision addressed highwall stability in the contour cuts where old works intersected and/or were located adjacent to the active surface mining areas at the mine.

Corrective Action: The mine operator revised the ground control plan for the mine on December 3, 2004, to prevent highwall material from striking the operators cab.
