Report of Investigation

Fatal Sliding Material Accident

June 19, 2004

**Northwest Aggregates
Santosh Pit
Scappoose, Columbia County, Oregon
Mine ID No. 35-00525**

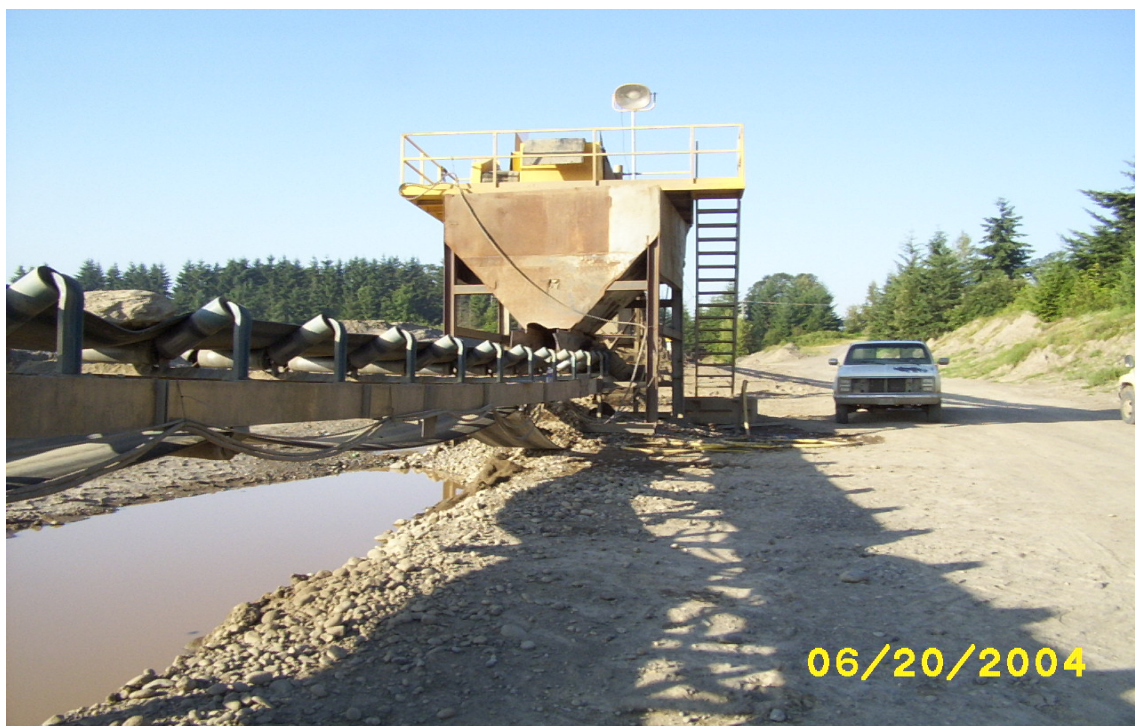
Wendell S. Alden, line maintenance man, age 33, was fatally injured on June 19, 2004, when he was engulfed by sliding material. Alden was attempting to free material which had plugged in a 30-ton transfer hopper. The victim entered the hopper from the top and was standing on the material when it broke free.

The accident occurred at the transfer hopper between field conveyor belts number 10 and number 11 on the feed conveyor pit line.

The transfer hopper, installed in early 2004, measured 14 feet, 4 inches from the ground with a 10-foot-square top. The hopper dropped 4 feet, tapering to the bottom discharge point over a 42-inch-wide conveyor. The four-legged, 30-ton hopper was free standing and was fed by another 42-inch-wide conveyor in the pit line that dumped material into the top.

Corrective Action: Management should develop a written procedure that requires miners to use safety harnesses and lanyards securely anchored when working in the transfer hopper. The procedures should ensure that miners are protected from hazards when working in hoppers or bins where there is a danger of becoming engulfed in sliding material.
