**Report of Investigation**

**Fatal Powered Haulage Accident**

**June 29, 2004**

**Golden Phoenix Minerals, Inc.  
Golden Phoenix Mineral Ridge  
Silver Peak, Esmeralda County, Nevada  
Mine ID No. 26-02302**

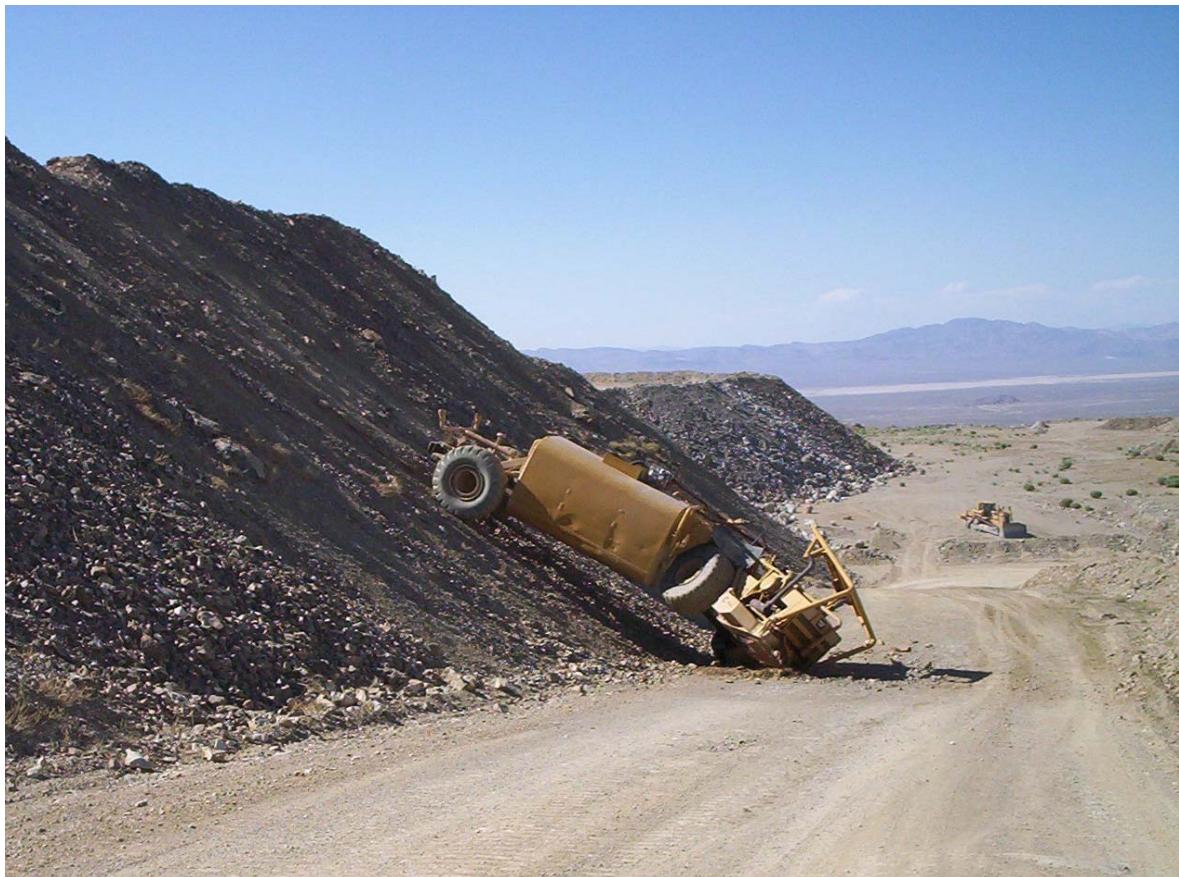
On June 29, 2004, David M. Miller, maintenance supervisor, age 43, was fatally injured when the truck he was operating over traveled a berm and plunged to a haul road 72 feet below.

The accident was caused by the failure to maintain all braking systems on the truck in functional condition. Equipment safety checks had not been routinely performed and the equipment had not been repaired or removed from operation.
