REPORT OF INVESTIGATION

**Surface Metal Mine
(Copper Ore)**

**Fatal Machinery Accident
December 5, 2004**

**Robinson Nevada Mining Company
Robinson Operation
Ruth, White Pine County, Nevada
Mine I.D. No. 26-01916**

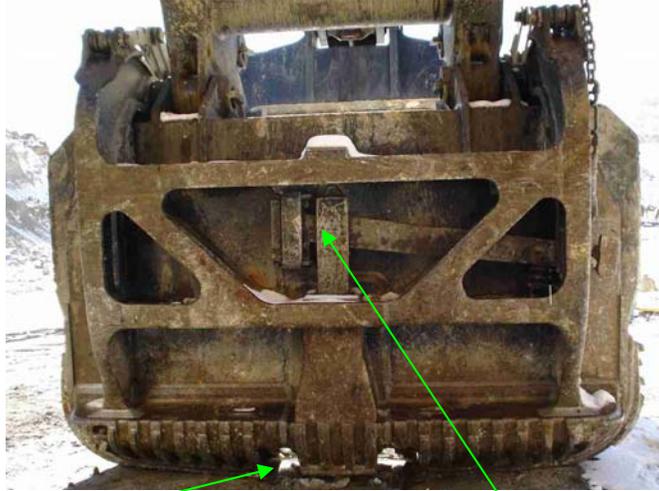
Dutchman **Picture #1** **Latch Bar**

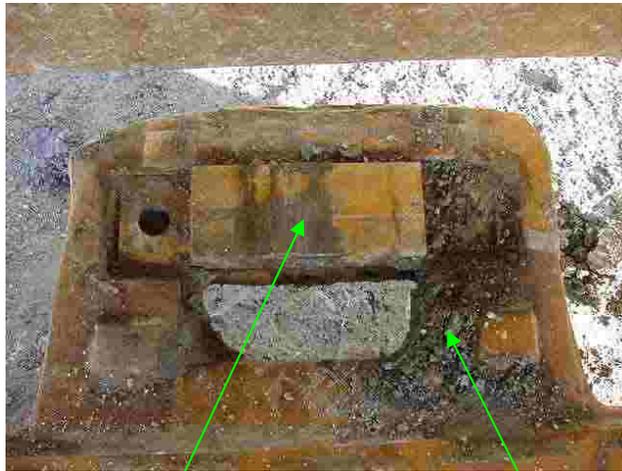
Dutchman Insert **Picture #2** **Dutchman**
