## Coal Mine Fatal Accident 2005-14 & 15

Operator:	Bell County Coal Corporation
Mine:	Preparation Plant
Accident Date:	August 19, 2005
Classification:	Powered Haulage
Location:	Dist. 7, Bell County, Kentucky
Mine Type:	Preparation Plant
Production:	5,000 tons raw coal processed/day

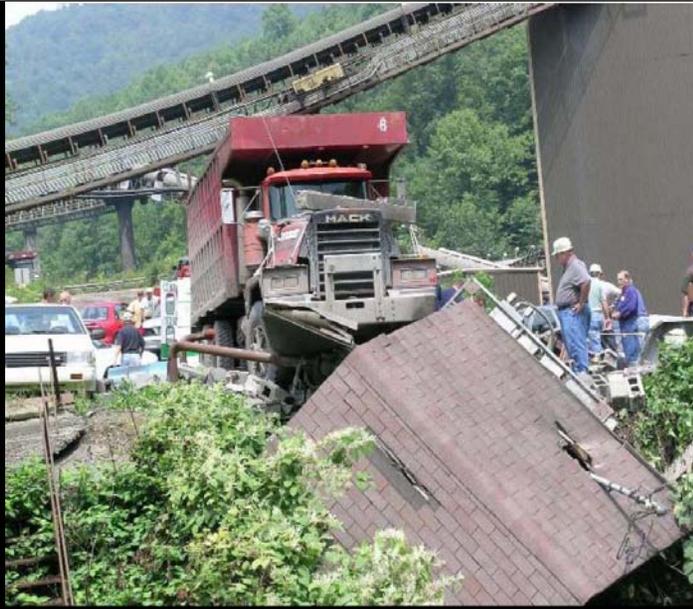
Victim B, another truck driver, parked his truck along side the bin. A third truck driver parked in a level area to the west of the pump house. A few minutes later, a fourth truck driver parked on the hill above the pump house and walked down and joined the three others. The fourth driver stated he set both the park brake and the hand brake before exiting the truck, leaving it running and with the transmission in neutral. After a period of time, estimated between five and 15 minutes, his truck rolled down the hill and struck the center of the pump house. The roof was knocked up and off the back of the building and the concrete block walls were destroyed. Victims A and B were fatally crushed in the fallen pump house. A fifth truck driver, while sitting in his truck, heard a sound like a service brake being released, and saw the truck roll down the hill and strike the pump house.

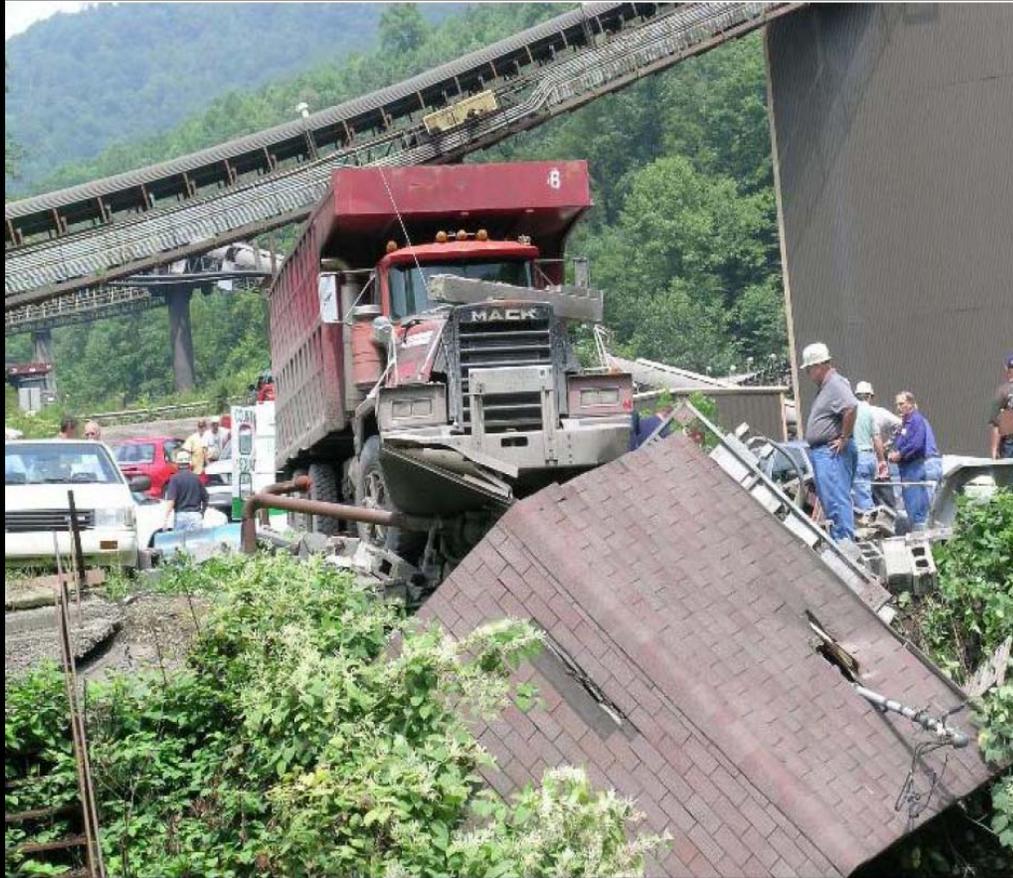
## The Truck

The 1988 Mack haul truck was provided with a Jacobs Engine Brake (Jake Brake) that could not have been applied at the time of the accident because the truck transmission was in neutral. The empty weight of the truck is approximately 39,500 lbs. The truck suffered only cosmetic damage in the accident and was fully operational for testing.

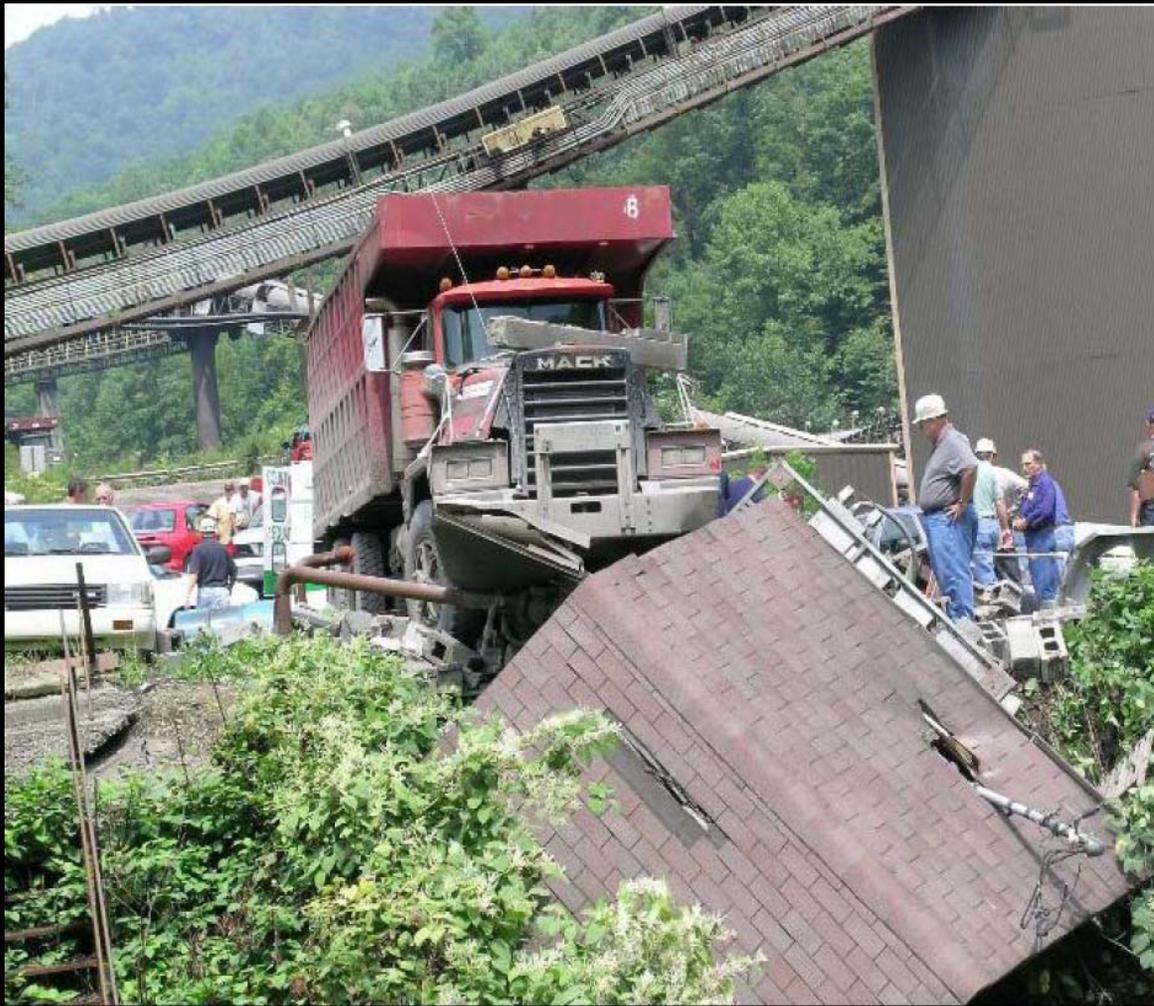
**Hand-Control Brake System Description:** The truck's steering column is equipped with a Bendix TC-2 hand-control valve that is called a "dump brake" or "hand-control brake lever". The control lever is stamped with the label: "Not For Parking."

**Hand-control brake**: The hand-control brake lever was moved to the fully applied position and the driver removed his hand from the control. All other brakes were released. The brake lever slowly moved from the fully applied position toward the released position. Throughout this time the truck remained stationary. After 8 minutes, the brake lever rapidly moved the last several inches to the released position and the truck started rolling down the grade. The slow movement, followed by fast movement of the control lever was characteristic of several tests. Only the setting of this brake could produce the events described by the various witnesses. Overall, the time lapse ranged from 7 ½ to 12 ½ minutes. This is consistent with the witness' accounts, allowing the driver ample time to walk to the pump house and join the other drivers.

- Set truck parking brakes and block the wheels or turn them into a bank or berm when parking any truck on a grade.
- NEVER use a steering column-mounted "dump brake" for parking.
- Maintain equipment braking systems in good repair and adjustment.
- Stop, Look, Analyze, and Manage (SLAM) work areas to ensure that safe work procedures are being followed.
- Conduct pre-operational checks to identify any defects that may affect the safe operation of equipment before being placed into service.
