Coal Mine Fatal Accident 2005-18

Operator:	Reading Anthracite Company
Mine:	Wadesville - P33
Accident Date:	December 6, 2005
Classification:	Powered Haulage
Location:	Dist. 1, Schuylkill County, PA
Mine Type:	Surface Mine
Production:	1,130 tons coal/day

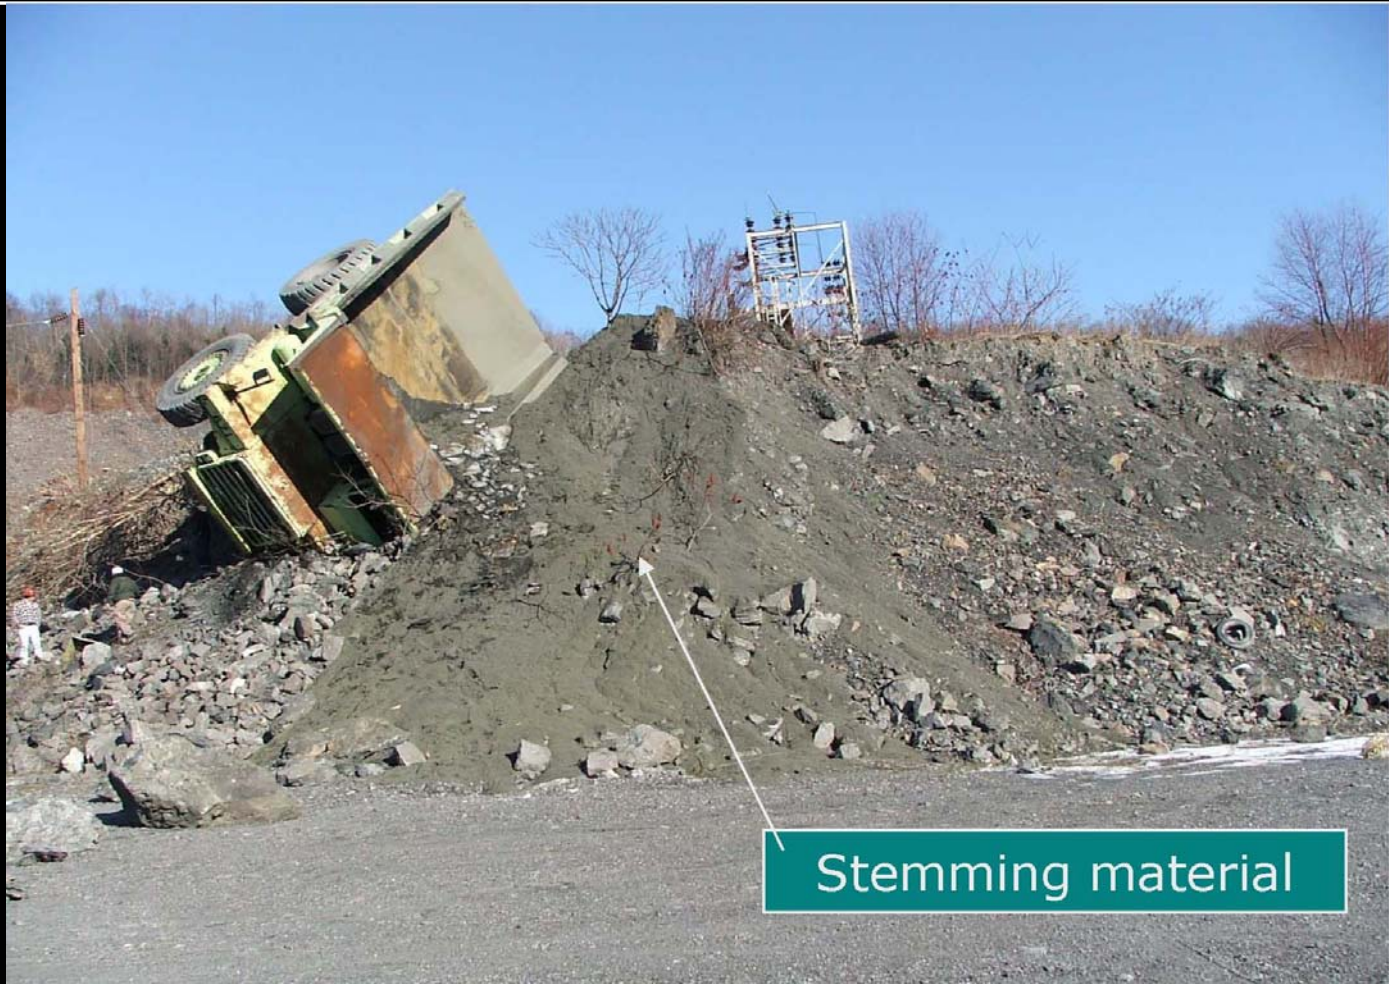
A Caterpillar haul truck driver, arrived at the rock refuse dump and saw the Euclid R-85 haul truck on its side. The victim, who received fatal injuries, was inside the operator's cab. The truck's engine was still running and the rear tires were spinning. As rescue operators were attempting to enter the truck, the engine stopped.

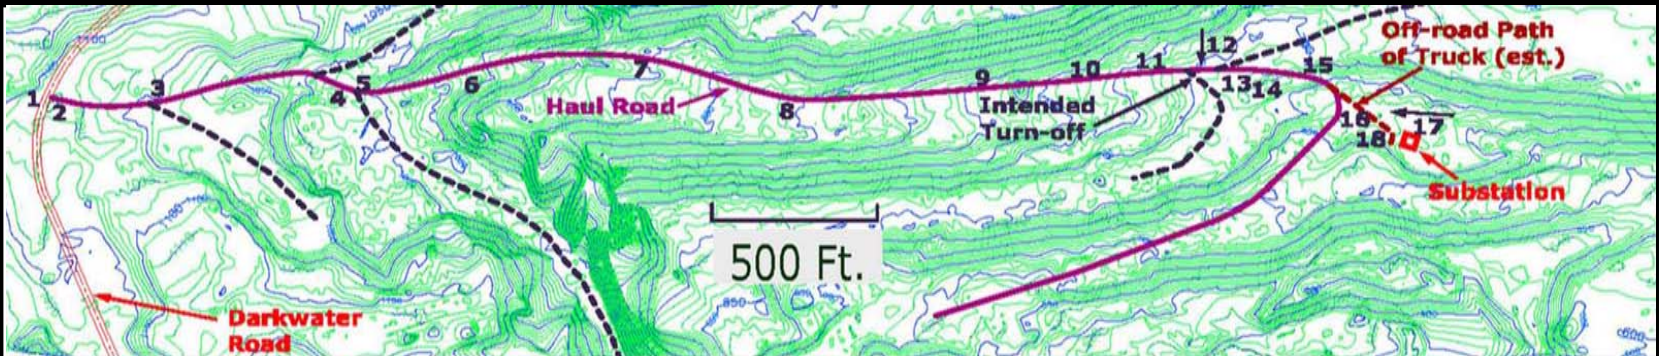
The pit was accessed via an unpaved haul road. This haul road was approximately 4,000 feet long and ranged in width from 50 to 75 feet. The haul road surface was reasonably smooth and clear of snow. Although portions of the haul road were frozen, they were not icy. Left side tire marks were visible on a rock refuse bank approximately 600 feet from the accident scene. This area of the haul road had a variable grade of 9.6 to 14 percent.

Corrective Action: The operator should develop a program to require mine haul roads, grades and turns are designed within the manufacturer's recommendations to insure the mine's equipment is capable of safely traveling on the haul roads. Runaway truck ramps should be at critical locations along the haul roads. Signs should be posted directing equipment into the escape ramps. Mine personnel should be trained in the location, proper procedures and use of these ramps.

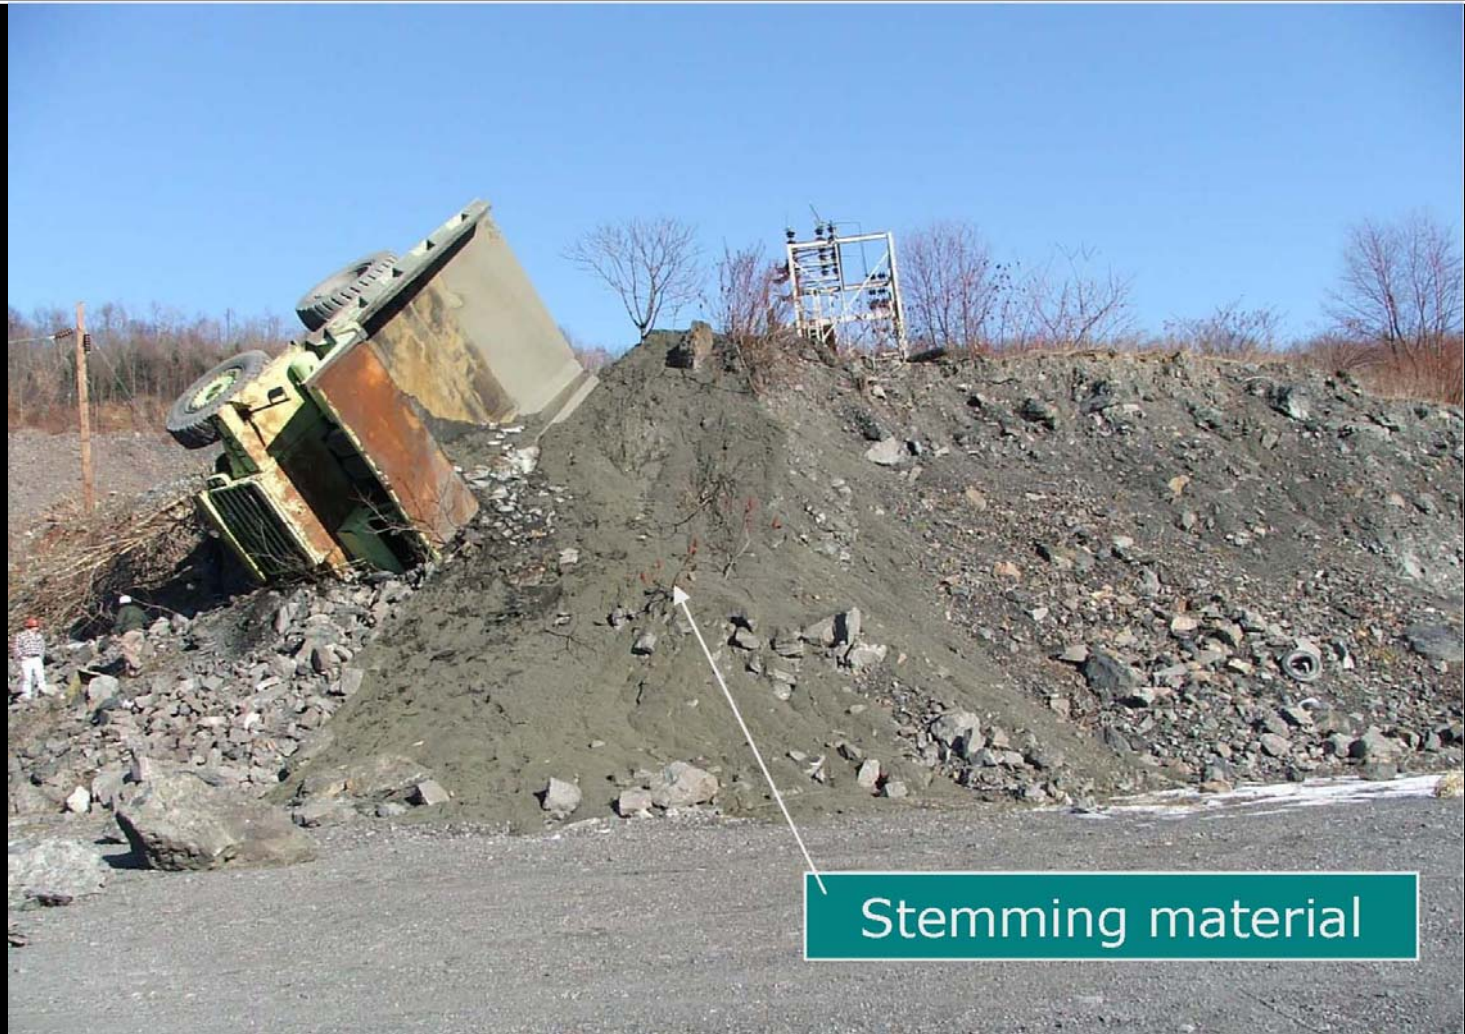
The truck involved in the accident was a 1975 Euclid R-85 haul truck. The net vehicle weight (light weight) of the truck was 117,100 pounds. The estimated weight of the load at the time of the accident was 170,000 pounds (85 tons). The gross vehicle weight of the truck was 287,100 pounds.

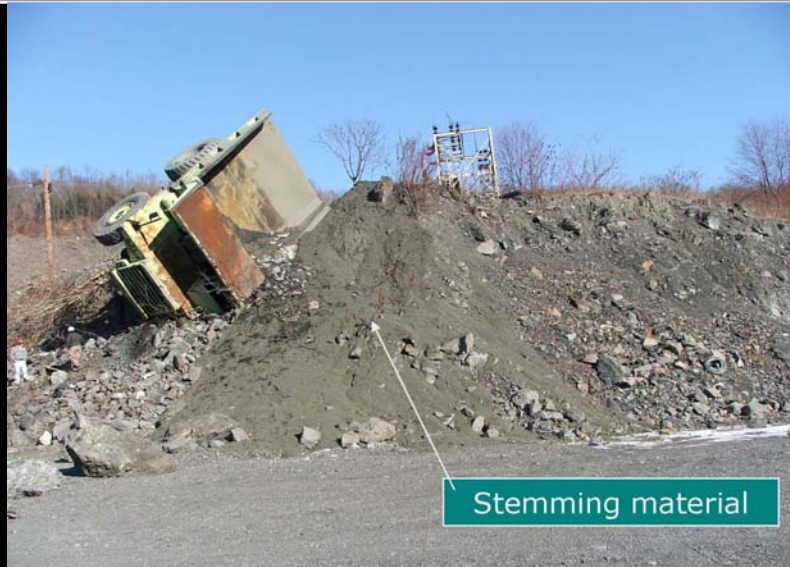
The truck was equipped with drum brakes on all four wheels, none of which were properly maintained. The brake system was air over hydraulic. The check valve in the air system to prevent air going from the dry air tank to the wet air tank was defective. The brake shoe lining, brake drum, and all related brake parts of the left front wheel were contaminated with brake fluid and grease. The brake fluid and grease compromised the braking ability of the left front brake shoe lining and the brake drum. The main hydraulic line fitting on the right front brake was completely blocked with a piece of rubber from the inner lining of the brake hose. This blockage rendered the right front brake inoperable. Measurements on both rear brake drums were beyond the wear limits recommended by the manufacturer's specifications. The maximum allowable wear of the brake drums was 30.250 inches. Measurements taken on the rear brake drums ranged from 30.403 to 30.525 inches.

Corrective Action: The operator should establish and implement a comprehensive haulage equipment maintenance program, in strict compliance with the manufacturer's recommended maintenance procedures, to ensure that all mechanical/electrical components are routinely checked and maintained.

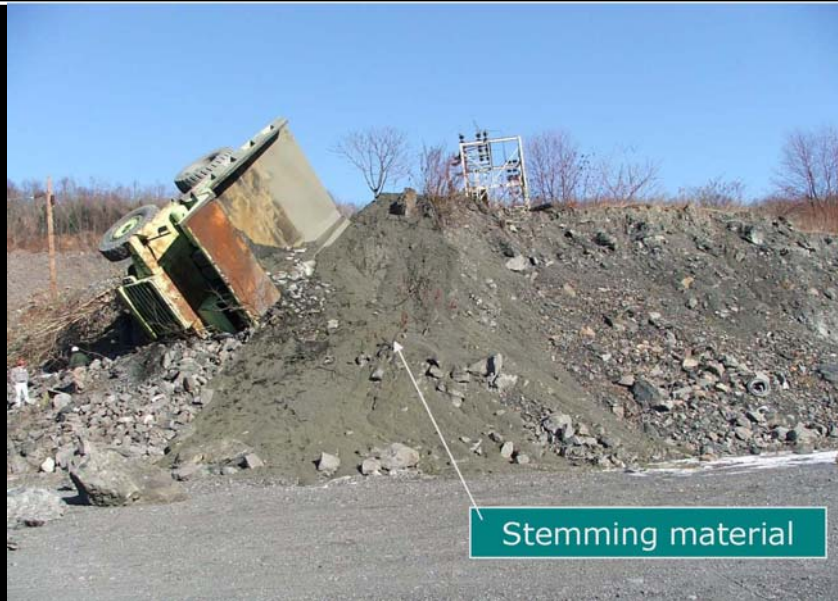
Based on tests and the amount of oil found in the transmission, the truck's transmission would not have been engaged at the time of the accident. Most of the oil drained from the transmission through the damage hose while the truck was operating on the day of the accident, which rendered the transmission and retarder inoperable.

The truck specifications showed that it should be capable of operating on a grade of 10.5 percent. The retarder chart indicated the fully loaded truck could operate at 12 mph on a 17% grade with the transmission in second gear. The retarder control was checked with the truck engine running and the air system fully charged. Movement of the control and linkage indicates the control for the retarder was working properly.
