REPORT OF INVESTIGATION

Powered Haulage Accident

April 21, 2005

Point Rock Plant
Central Appalachia Mining, LLC
Phelps, Pike County, Kentucky
ID No. 15-07010

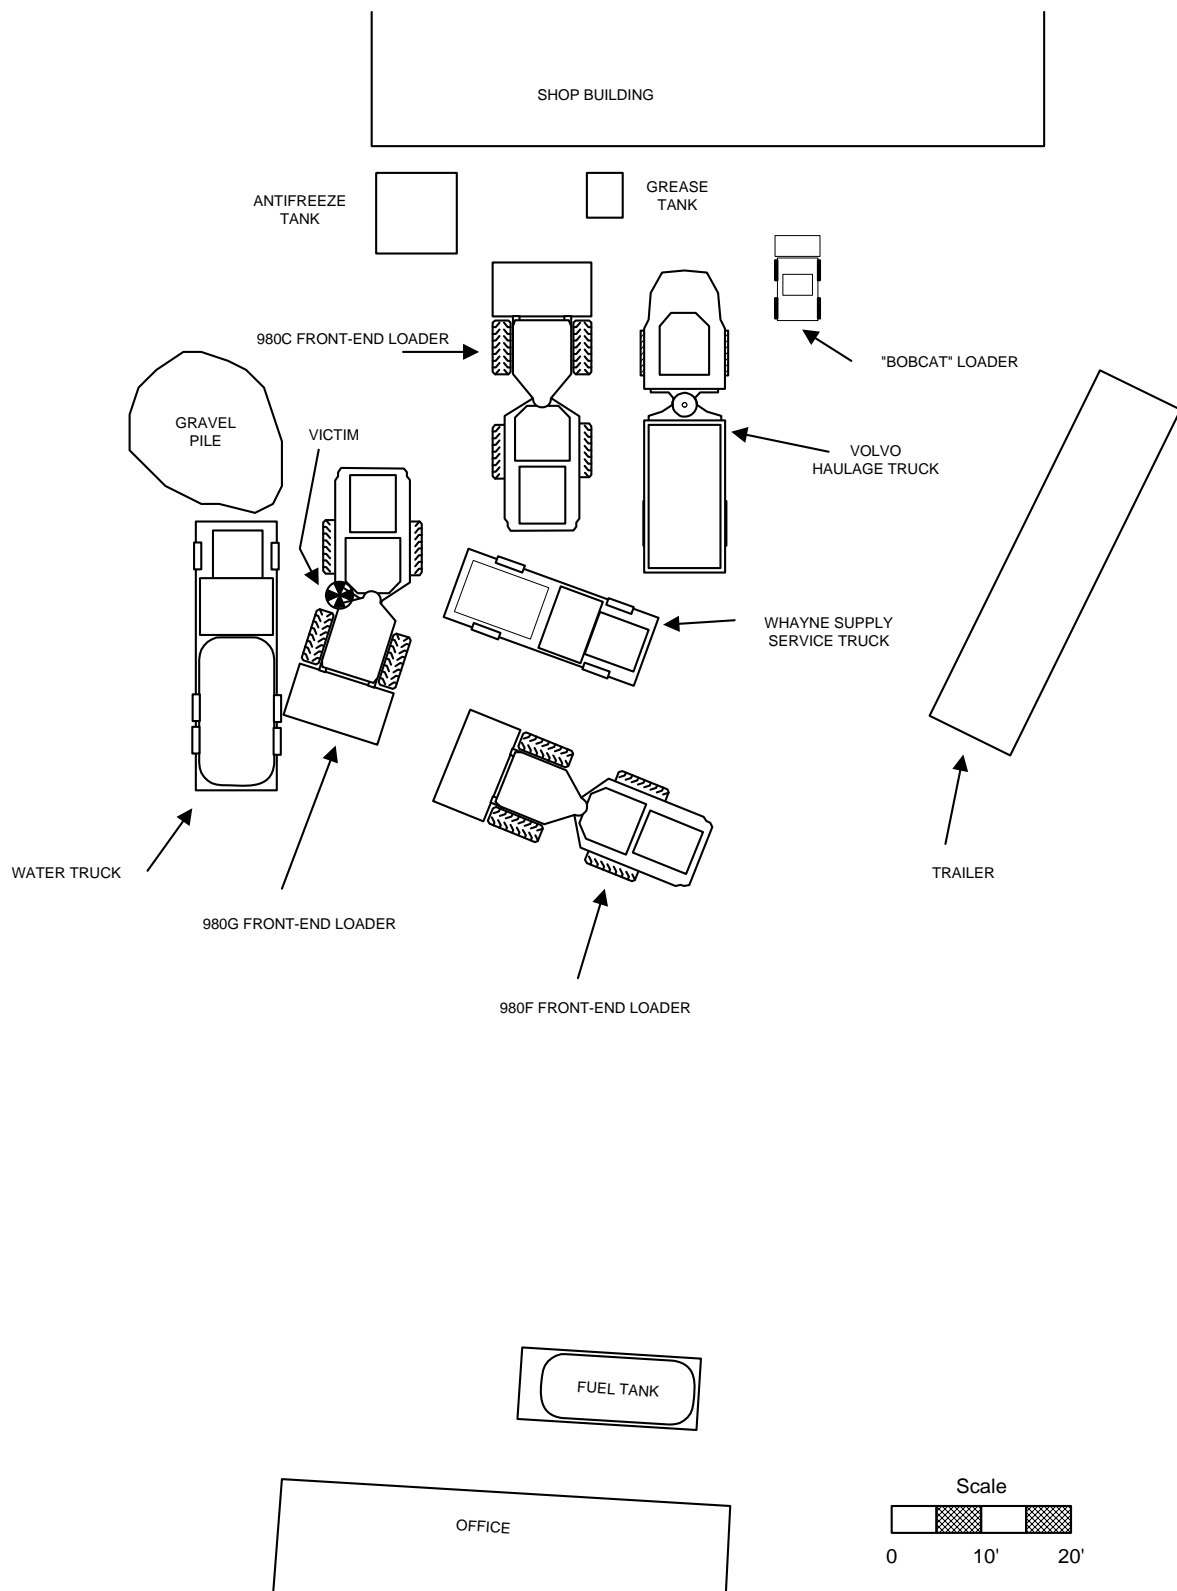
Sketch of Accident Scene
 Fatal Powered Haulage Accident
 Central Appalachia Mining, LLC
 Point Rock Plant (15-07010)
 April 21, 2005

Jamey Damron, equipment operator, and Gideon Williamson, foreman for Central Appalachia Mining, LLC, were standing outside the plant office door at approximately 2:00 p.m., when Damron observed the 980G loader bucket move to the right against the outside tire of the front tandem of the water truck which was parked parallel to the 980G loader. The engine was running and the bucket was raised. He commented to Williamson that the tire on the water truck could be damaged by the end loader bucket. Williamson observed that no one was in the cab of the 980G loader operating the controls and immediately became alarmed. He ran to the right side of the 980G loader where he observed Reynolds trapped in the articulation pivot area between the front and rear sections.

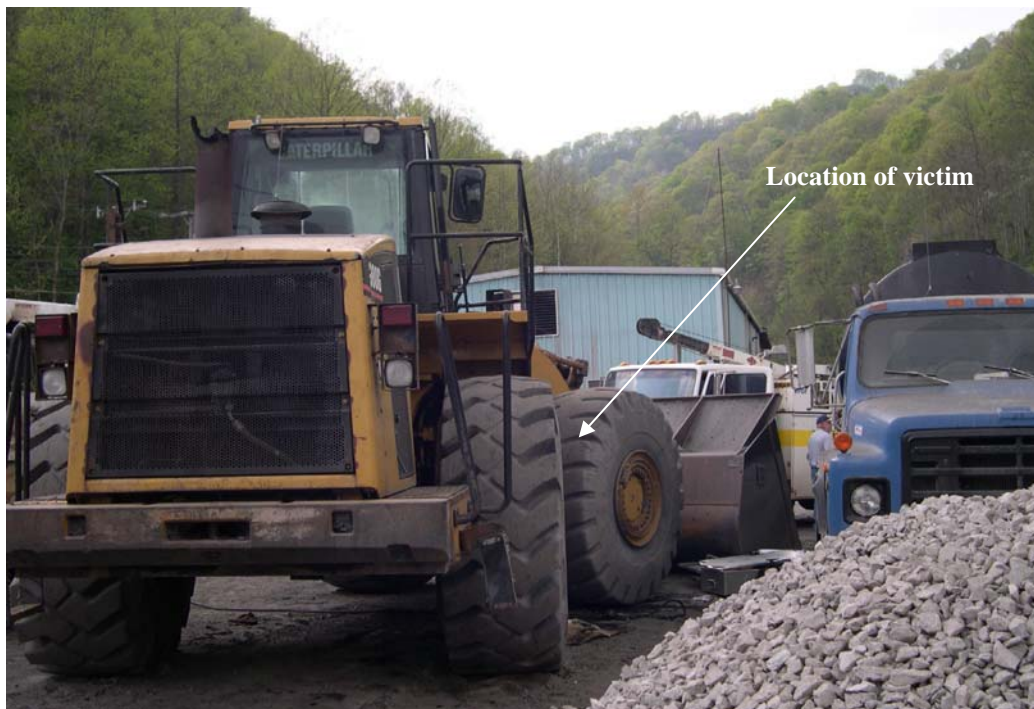
Photograph of Accident Scene

The technical evaluation revealed that the victim was attempting to troubleshoot and repair a problem with the steering system. He entered the articulation joint with the machine running. The steering frame lock was not used and no alternate method of preventing the machine from articulating was used. The exact reason the machine articulated could not be determined. However it was most likely caused by one of the following or some combination of them:

Corrective Actions: The contractor developed a written procedure to prevent a recurrence of the accident. Alternative procedures to prevent motion of the machine are to be implemented prior to performing repair work which requires an employee to enter the articulation area.

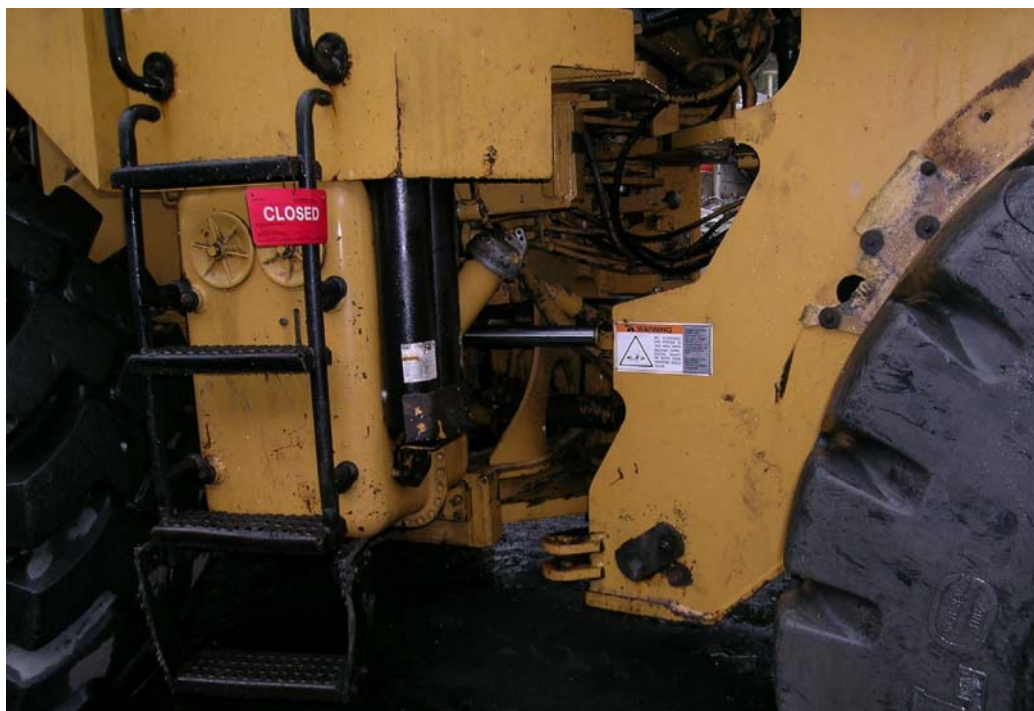
Close up of Articulation Point

4) STEERING FRAME LOCK: The 980G includes a steering frame lock located near the articulation joint on the right side of the machine. The steering frame lock is intended to prevent unintended articulation either during shipment or maintenance operations. According to the Caterpillar 980G Operation and Maintenance Manual, the lock should be used when performing service work near the articulation joint. This Manual also states the machine must be in the straight ahead position to connect the steering frame lock. The Manual contains no alternate method of locking the articulation joint in the event the machine cannot be steered to a position to install the steering frame lock pins. At the time of the accident, Whayne Supply also had no written procedure to follow in the event the steering frame lock could not be used.

During the investigation, it was found that installing the pins to lock the frame required the machine to be maneuvered back and forth in order to get the pin holes of the bar to line up with the pin holes on the frame. Although this operation may be possible with a single person (operator), it would be very difficult. It was easily accomplished with a second person on the ground directing the operator to turn the machine in the direction needed to line up the pin holes.

1. The pilot control valve was manually moved. This could have occurred as the victim was attempting to remove the steering shaft from the pilot valve.
2. The operation of the steering system was erratic and unpredictable as a result of some debris blocking the purge orifices in the steering control valve. Pressure may have built up and/or released sufficiently to allow the machine to move unexpectedly.
3. Air that had been entrapped in the pilot system as a result of the replacement of a steering line "worked out" causing the machine to articulate.
