**COAL MINE SAFETY AND HEALTH
REPORT OF INVESTIGATION**

**Fatal Powered Haulage Accident
June 10, 2005**

**Tusky # 1
Tusky Coal, LLC
Dennison, Tuscarawas County, Ohio
I.D. No. 33-04509**

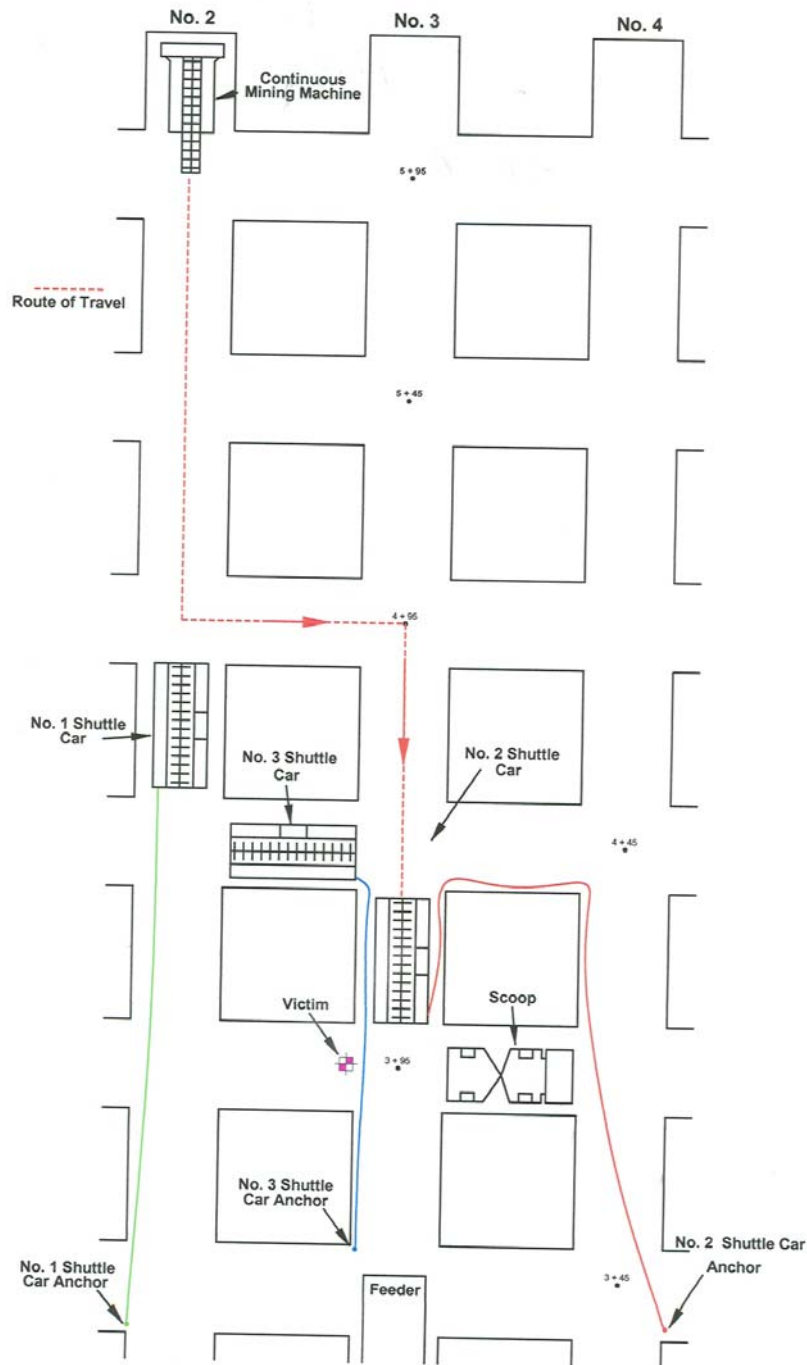
1 Left Butt off 1 Left Sub-Mains Just Prior to the Accident

As Daniels' shuttle car was being loaded, Wright crawled outby toward the section battery scoop which was located in the first crosscut inby the feeder. He stopped briefly in the No. 2 entry to talk to Joel Passage, No. 1 Shuttle Car Operator. After a brief exchange, Wright continued outby and turned into the 4th crosscut inby the feeder from the Nos. 2 to 3 entries (Appendix A shows the victims position just prior to the accident).

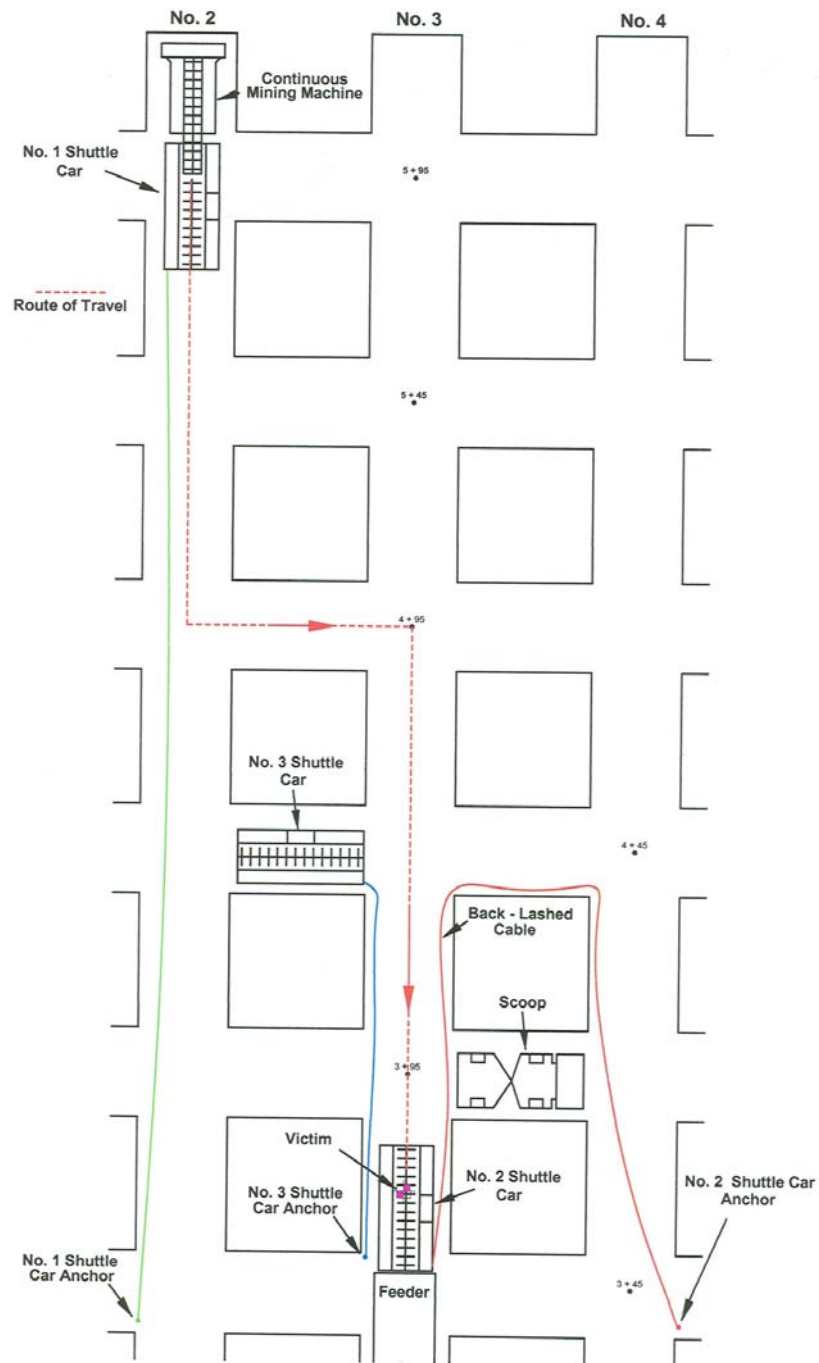
1 Left Butt off 1 Left Sub-Mains Just After the Accident

Meanwhile, Daniels was tramming through the crosscut and entered the No. 3 entry. Visibility was limited due to the mining height and the coal load in the shuttle car. Daniels could see a light to his right in the first crosscut inby the feeder and assumed it was Wright. He was also aware that the trailing cable for the No. 3 Shuttle Car, operated by Mathew Gene Burnworth, was lying along the right rib line (facing outby) and that Burnworth's shuttle car was parked in the second crosscut inby the feeder between Nos. 2 and 3 entries. As he began tramming in the No. 3 entry toward the feeder, he abruptly stopped between the first and second crosscuts inby the feeder in order to avoid Burnworth's cable which was lying along the right side rib line. When he stopped, the front bumper of his shuttle car was in close proximity to the intersection of the first crosscut inby the feeder. Daniels then directed his attention to the left rib line because he was back lashing his trailing cable (Appendix B shows the back lashed cable and the position of the victim just after the accident). He continued to the feeder, stopped and began unloading his shuttle car. During the unloading process, the conveyor chain stalled. Daniels raised the shuttle car boom and restarted the conveyor which ran sluggishly. He finished unloading, dismounted the shuttle car and crawled to the front to check the chain. He saw that Wright was under the front of the shuttle car and he called to his fellow crewmembers for help.
