REPORT OF INVESTIGATION

Surface Coal Preparation Facility

Fatal Powered Haulage Accident
August 19, 2005

Preparation Plant
Bell County Coal Corporation
Middlesboro, Bell County, Kentucky
ID No. 15-10212

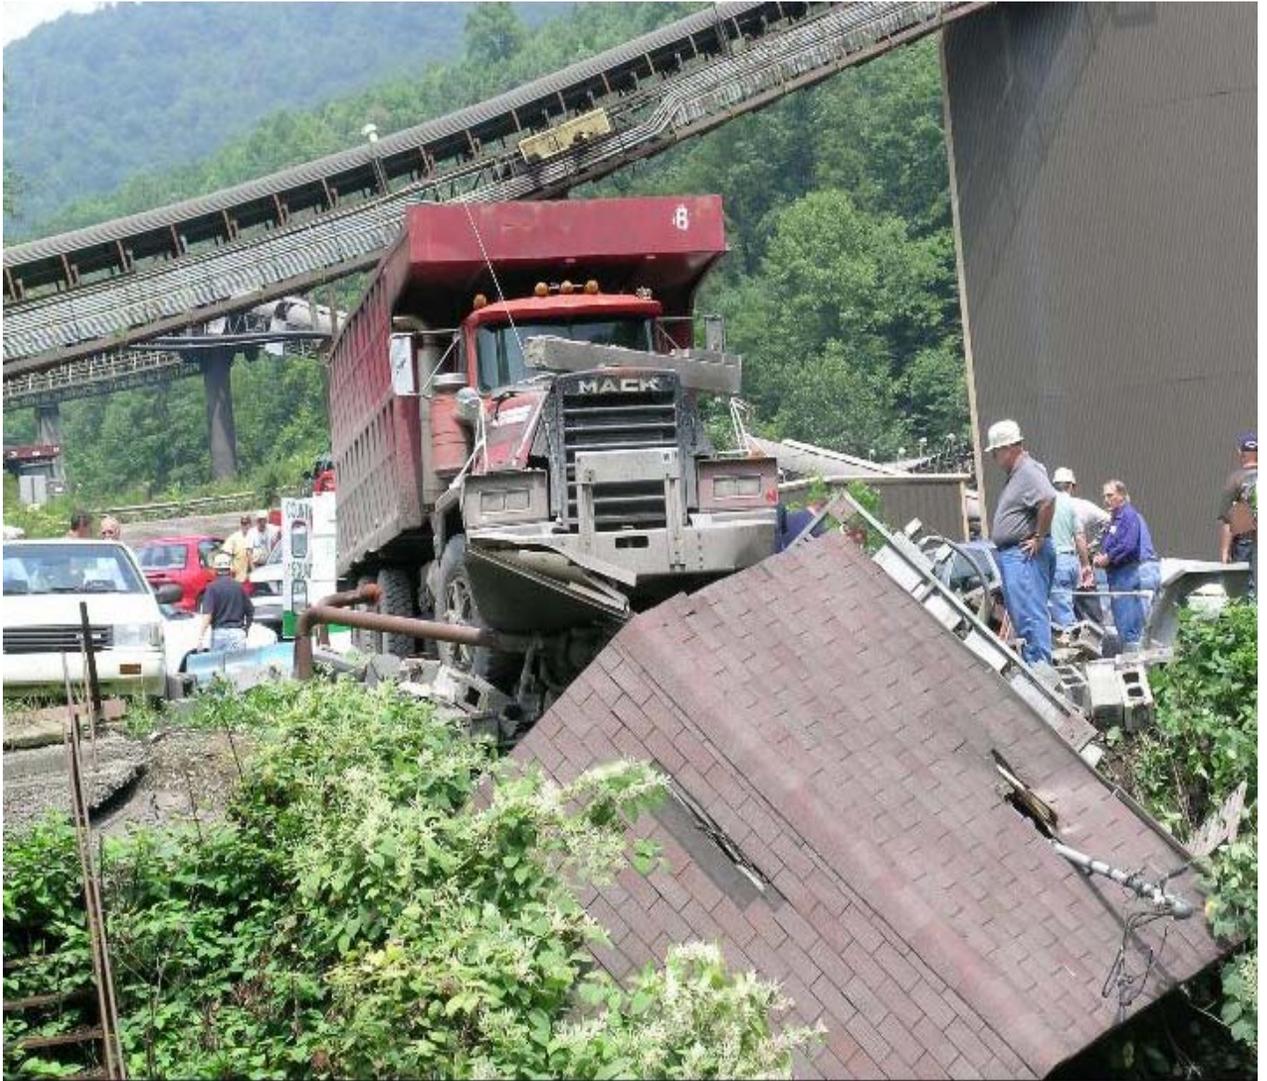
ACCIDENT SITE

At approximately 12:20 p.m. on Friday, August 19, 2005, a 51-year old truck driver with 33 years of experience and a 56-year old truck driver with 30 years of experience were fatally injured at Bell County Coal Corporation's Preparation Plant. The accident occurred when a concrete block pump house, occupied by four contract truck drivers having lunch, was struck and destroyed by a 1988 Mack haul truck which had rolled from its parked position upslope from the pump house.

The accident occurred as a result of a truck driver's use of the hand brake for parking and failure to set the parking brake and turn the wheels toward the berm when leaving the truck parked. There was no established procedure to assure that trucks were secured against motion when parked.

Corrective Action: The Company has required that all current truck drivers be trained specifically in the proper method of parking a truck and that this be made a part of the training for all newly employed truck drivers. The operator should establish a firm procedure to assure that any truck operated on mine property will be secured against motion when parked.
