REPORT OF INVESTIGATION

Fatal Fall of Roof Accident
December 12, 2005

Logansport Mine
Rosebud Mining Company

Ford City, Armstrong County, Pennsylvania
ID No. 36-08841

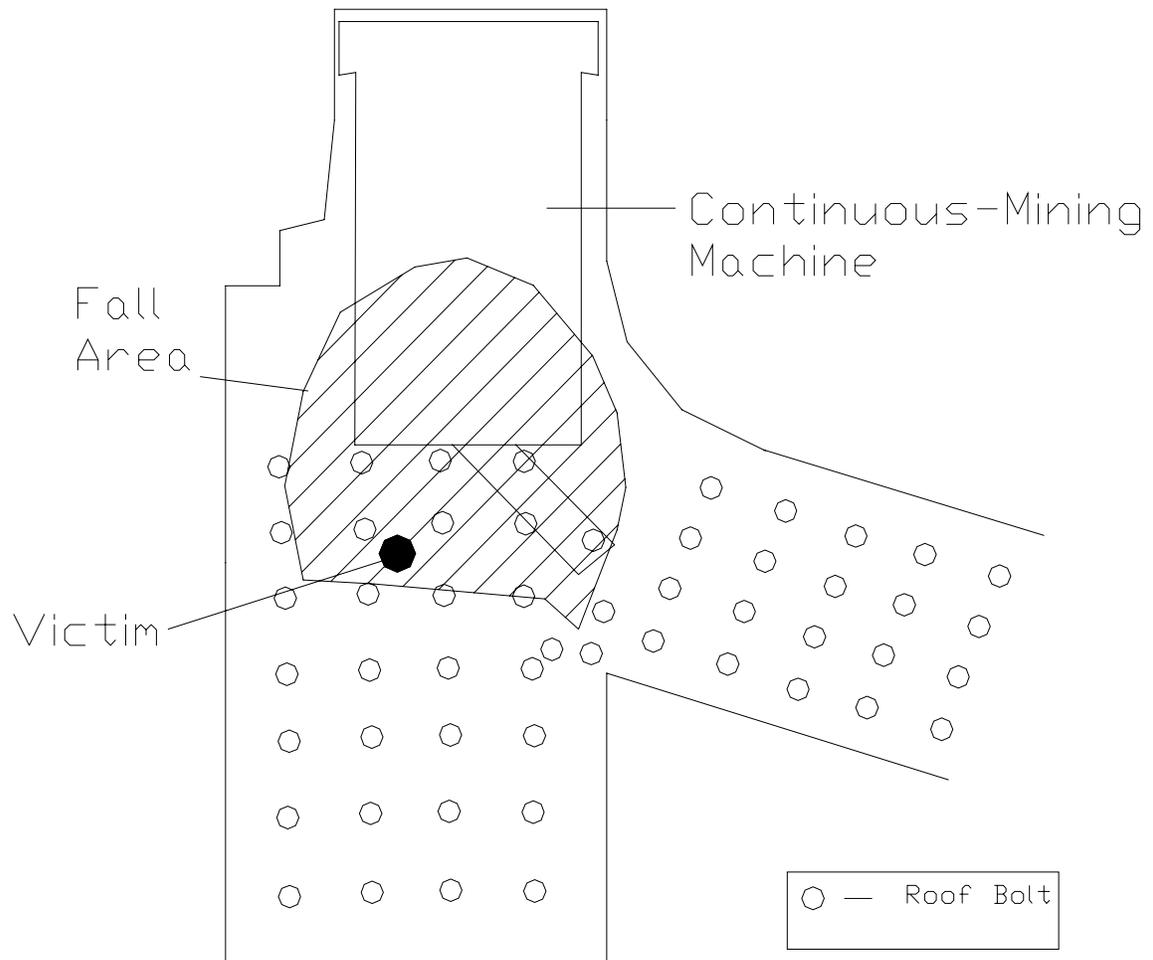
ACCIDENT SITE

At approximately 2:00 p.m. on Monday, December 12, 2005, Eric B. Hill, a 29-year old continuous miner operator, with 11 years of mining experience, was fatally injured when a roof fall occurred in the No. 21 room intersection of 6 North Butt Section. The accident occurred while the victim was mining coal in the No. 21 Return Room and was positioned on the left side of the continuous mining machine just outby the second row of roof bolts. In the intersection, the mine roof was supported with 36- and 42-inch resin grouted roof bolts.

The roof fall material fell out along a slickensided fault surface that strikes N50°W. The triangular-shaped wedge, bounded by the slickensides, was estimated to be 25 feet in length and 16 feet wide at the base (outby end). The wedge measured about 4 feet at the thickest point and tapered toward each side and the inby end. Patchy remnants of a thin calcite vein were observed on the exposed fault surface in the fall cavity. The fallen material remained largely intact and was estimated to weigh 20 tons.

Approximately 12 feet outby the edge of the intersection fall cavity, a horseback (drag fold) had been encountered in a previous cut from the No. 21 room. This feature had formed a linear wedge-shaped cavity approximately two feet wide by 1 ½ feet high, and projected into the rib where the fall-bounding N50°W-striking fault cut into the coal pillar. This drag fold zone represents the expression in the roof of the normal fault that controlled the intersection fall.

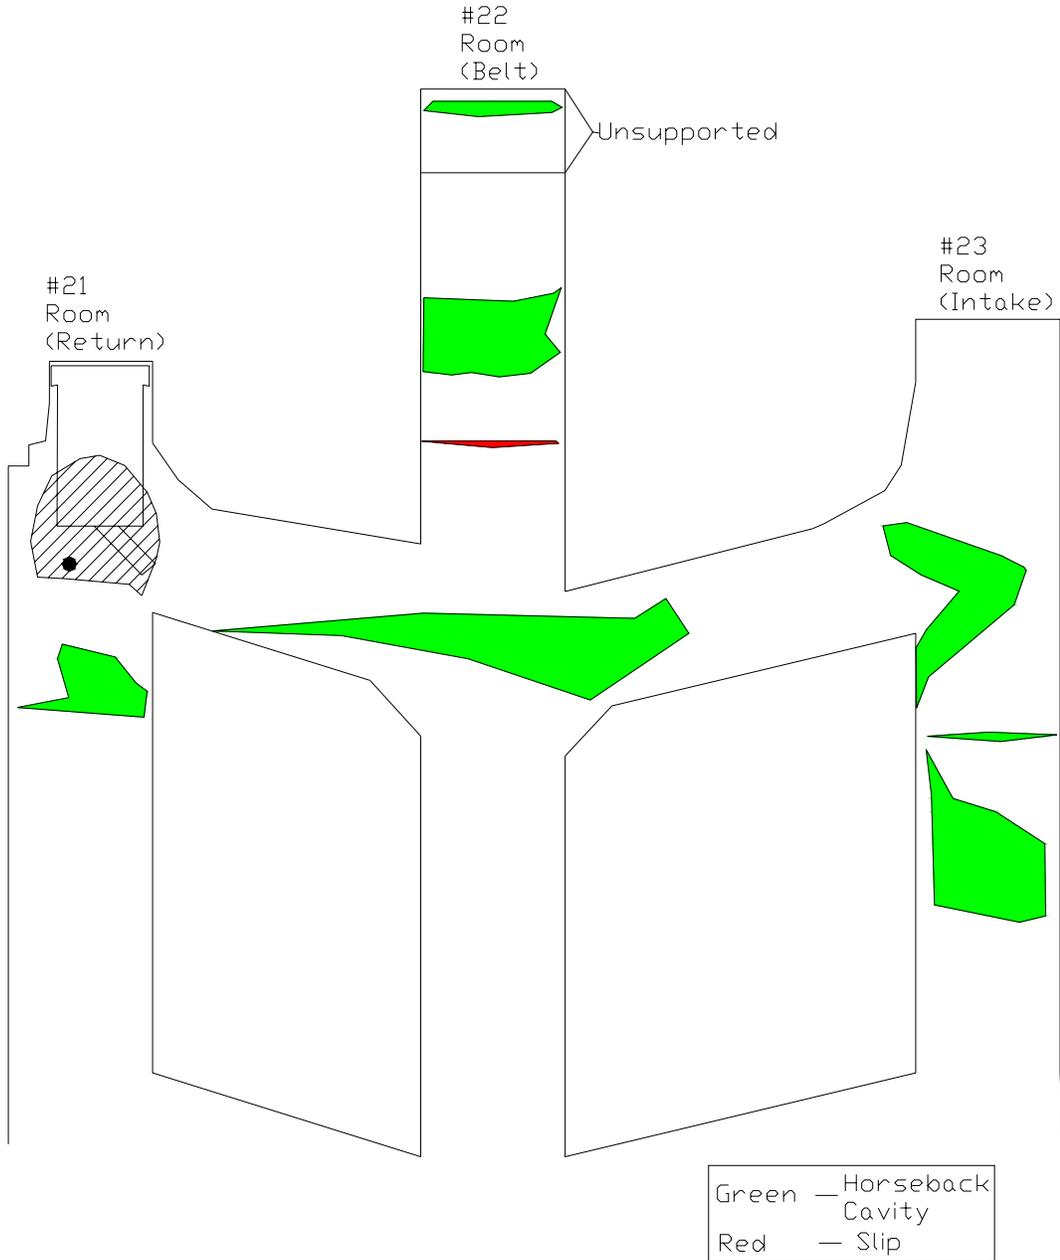
Overview of 6th North Butt Section

The majority of the slickensided faults on the section are oriented along a trend of approximately N30°E, while a second set is oriented nearly perpendicularly to the first, along a trend of approximately N50°W. The N30°E faults are arranged to define two nearly parallel zones, separated by a distance of approximately 30 feet, that trend N30°E across the 6th North Butt. The outby fault zone projects directly into the intersection where the fatal roof fall occurred.
