AMENDED  
REPORT OF INVESTIGATION

Fatal Roof Fall Accident  
December 15, 2005

Adkins Branch Mine No. 1A  
Arjay Mining, Inc.  
Panther, McDowell County, West Virginia  
ID No. 46-09106

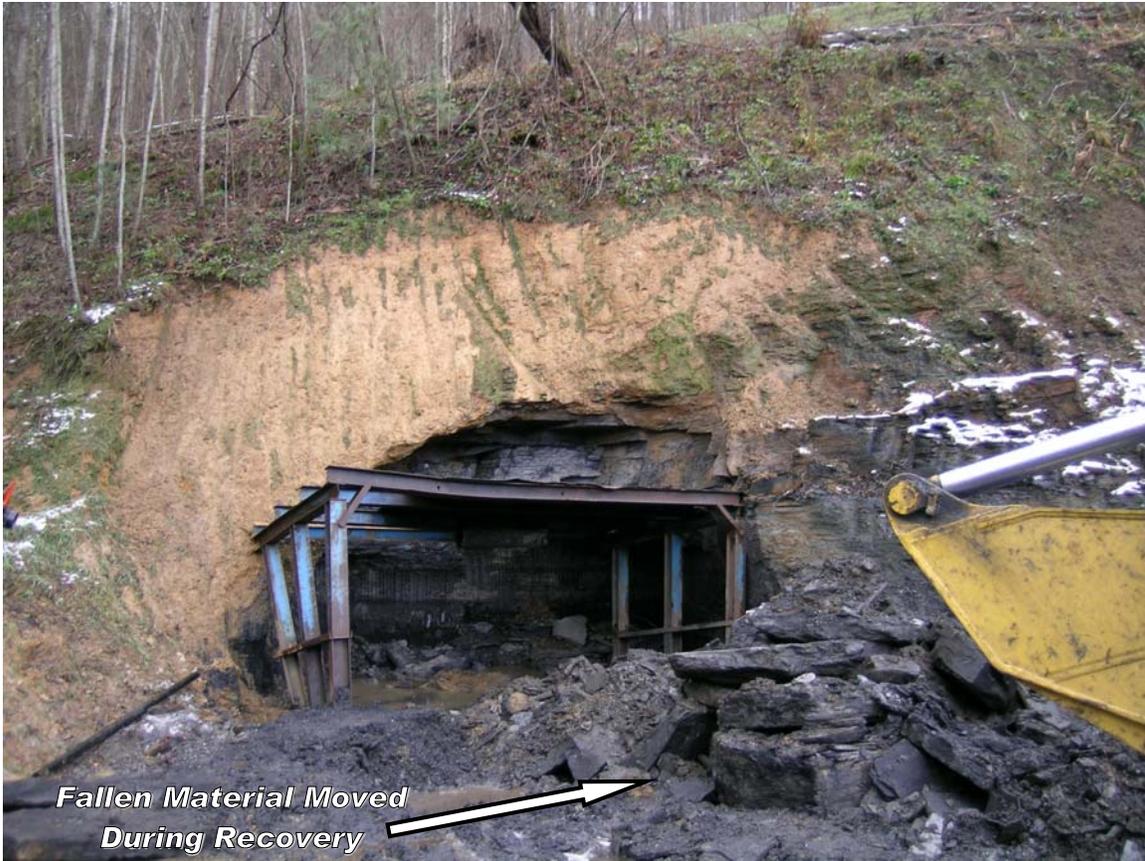
The highwall was not developed in consolidated, competent rock for a height sufficient to insure stability above the mine openings. The ground control plan did not include any methods to be used to control the hazardous highwall conditions or precautions to be taken to keep persons from being exposed to the ground hazards. Hazardous conditions were uncorrected during numerous workplace examinations. The accident resulted from failure to follow proper mining practices, procedures, and the applicable regulations. The lack of effective administrative controls contributed to the accident.
