REPORT OF INVESTIGATION

Underground Nonmetal Mine  
(Trona)

Fatal Powered Haulage Accident

Big Island Mine and Refinery  
OCI Wyoming LP  
Green River, Sweetwater County, Wyoming  
Mine I.D. No. 48-00154

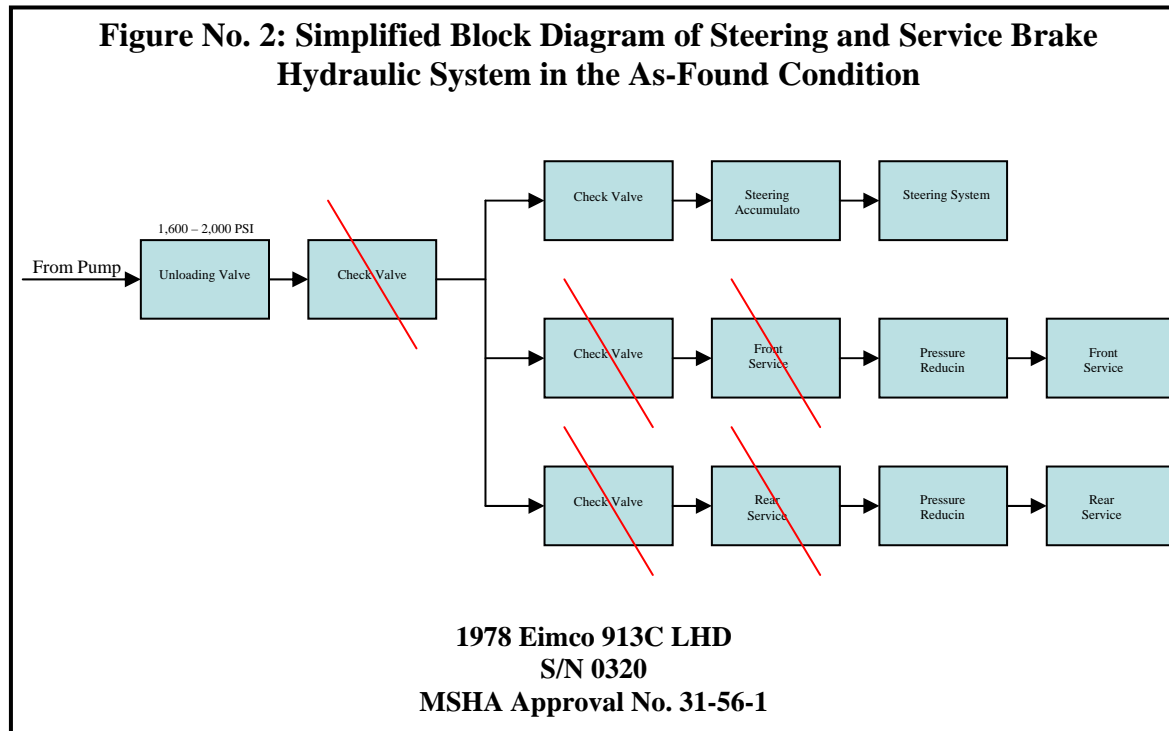
Functional tests conducted on the service brake system and a visual inspection of selected components that were removed identified that the check valve immediately downstream of the unloading valve, the check valves for each of the service brake systems, and both accumulators for each of the service brakes systems were defective. Figure No. 2 represents the simplified block diagram of

steering and service brake hydraulic system with the defects identified (illustrated with a line through the respective defective component blocks).

The effect of these defects did not allow the forklift to maintain pressure in either of the two service brake circuits once the engine was shut down.

Two significant results were found when the service brakes were tested. The operator would not be able to apply the service brakes once the engine was shut down because both service brake circuits would immediately lose pressure. Also, the operator would not be able to continue to hold the machine on the grade in the accident area with the service brakes once the engine was shut down because both circuits would immediately lose total pressure.

Visual inspection of all three check valves indicated that they would not prevent backflow due to missing and/or damaged internal components. Attempts were made to charge the two service brake accumulators after they were removed from the machine but neither of them would hold any significant pressure. Audible leaks were detected within the bladders of these two accumulators.

The defective components (the check valve immediately downstream of the unloading valve, the two service brake check valves, and the two service brake accumulators) were replaced and the system was re-tested. With the forklift maintained as recommended by the manufacturer, the operator would be able to continue to hold the machine with the service brakes applied with the engine shut down.
