REPORT OF INVESTIGATION

Surface Nonmetal Mine
(Sand and Gravel)

Fatal Powered Haulage Accident
August 1, 2005

Wash Plant #1
Commercial Rock Products
Durango, La Plata County, Colorado
Mine ID No. 05-04646

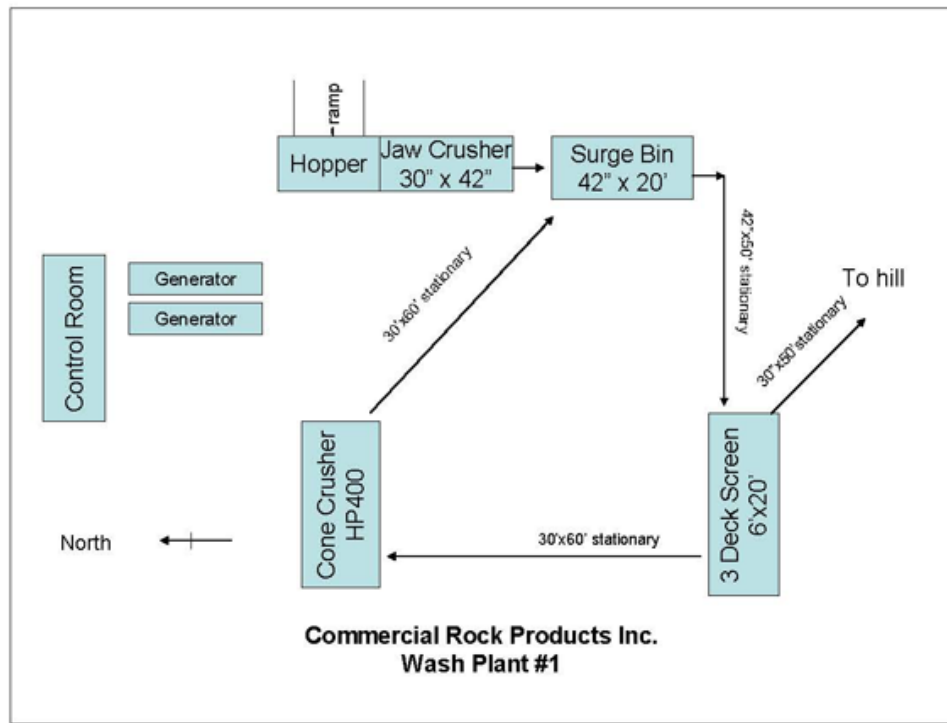
Plant Layout

The accident occurred in the plant area underneath the south side of the portable screen. The portable screen had three decks and was mounted on a rigid trailer frame with dual axels equipped with tires.
