REPORT OF INVESTIGATION

**Fatal Fall of Person Accident
October 22, 2005**

**Barrick Goldstrike Mines, Inc.
Goldstrike Mine
Carlin, Eureka County, Nevada
Mine ID No. 26-01089**

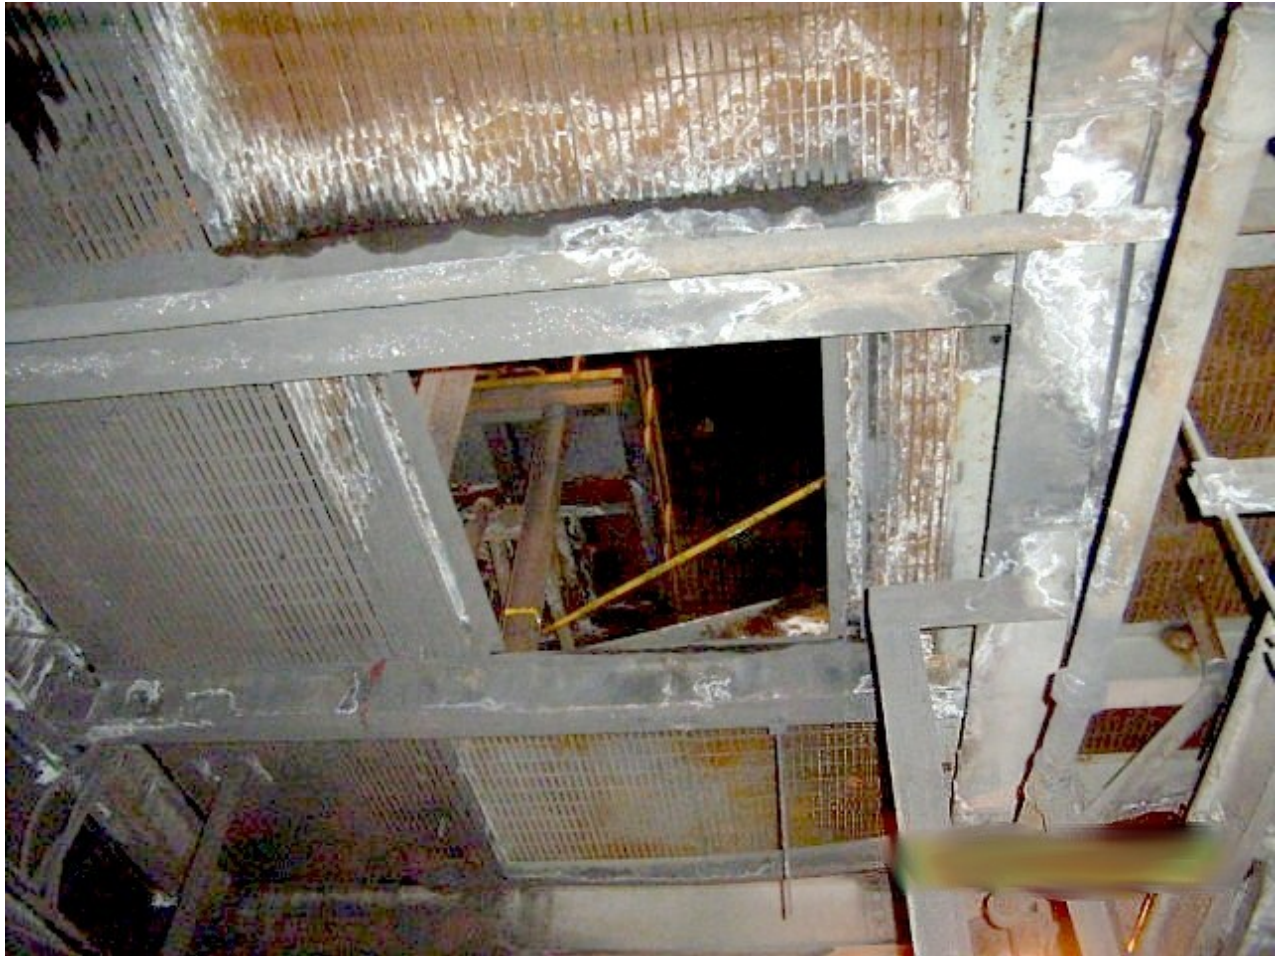
3'x 4' opening victim fell through

The second floor was constructed of expanded metal sections attached to steel support beams. A section of the floor, measuring four feet by three feet, had been removed and fitted with a steel plate cover. When the cover was removed, the opening was directly above a steel pump support located on the ground floor, 13 feet below. An electric powered, rail mounted, hoist was installed on the second floor to raise and lower the pump. A safety harness, reportedly worn by Fagg while he lifted the pump, was lying several feet from the floor opening. Several safety harnesses were located in a box about 20 feet from the accident scene.

Causal Factor: Administrative controls needed improvement because safe work procedures were not followed. The miners removed the floor cover to remove the pump, creating an opening to the sump below. The victim was working where there was a danger of falling near an unguarded floor opening and was not secured by a safety belt and line.

Causal Factor: A risk assessment was not conducted prior to beginning this task. The victim may not have recognized the hazard associated with working adjacent to the floor opening.

Corrective Action: Management should review requirements for using safety belts and lines to ensure that miners understand the established procedures when working at elevated positions where there is a danger of falling.

Corrective Action: Miners should discuss a task before beginning work to identify possible hazards and initiate actions to correct them. Management should monitor controls for effectiveness.

This citation was terminated on November 04, 2005. The hole in the floor was covered, retraining was provided to miners on fall protection, and designated anchorage points were established.
