## Coal Mine Fatal Accident 2006-39

Operator: D & R Coal, Incorporated  
Mine: Mine No. 2  
Accident Date: October 6, 2006  
Classification: Fall of Roof  
Location: Dist. 7, Knox County, KY  
Mine Type: Underground Coal Mine  
Employment: 12  
Production: 175 Tons/Day

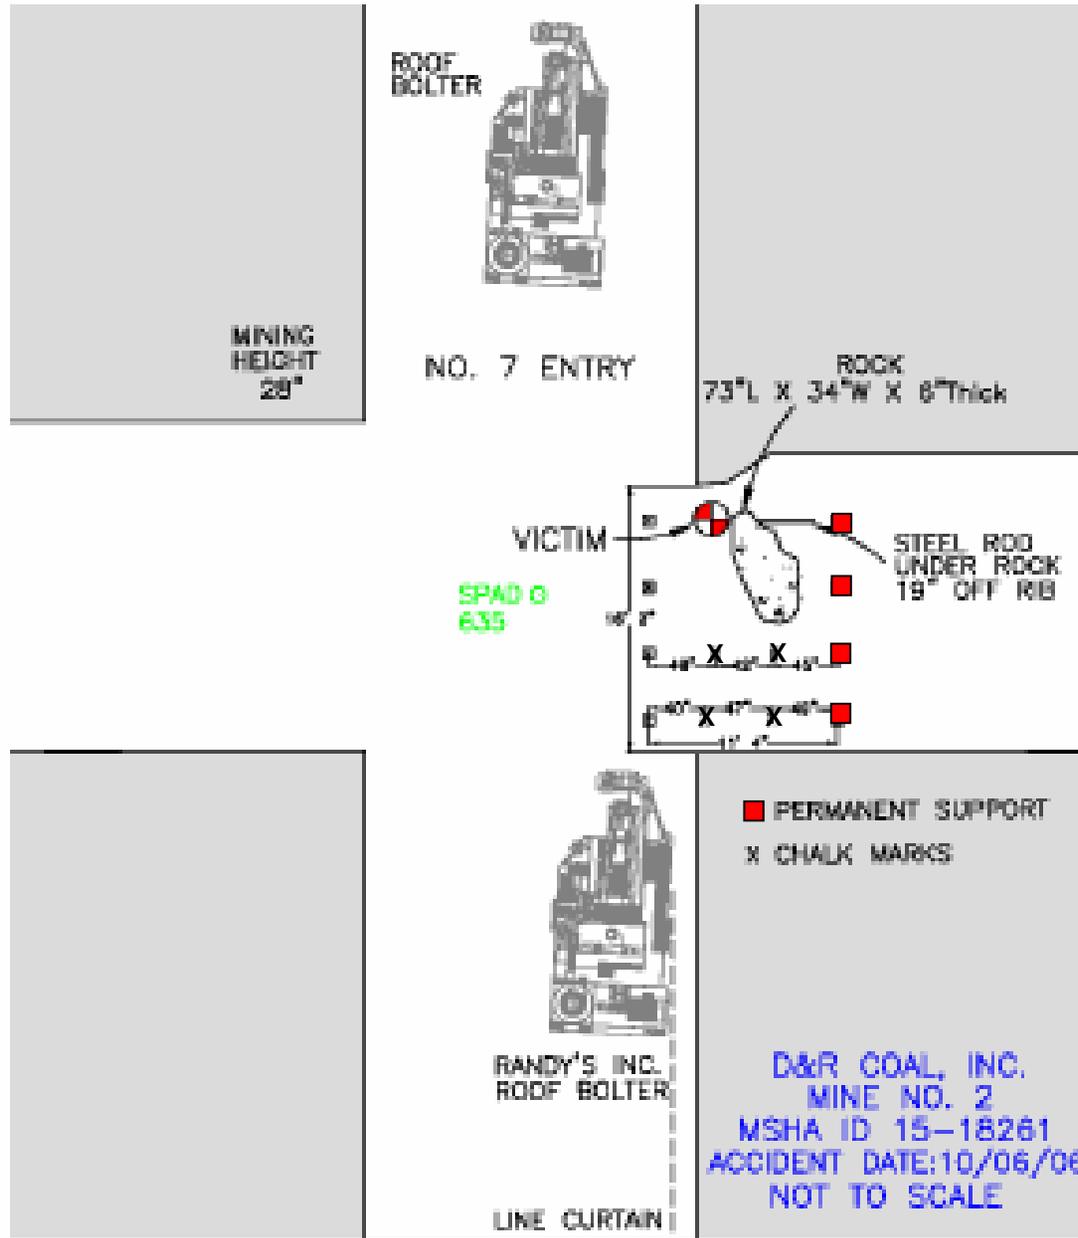
## ACCIDENT SITE

On Friday, October 6, 2006, a 56-year old roof bolter operator with 12 years of experience roof bolting and 27 years of mining experience was fatally injured. The accident occurred when the victim traveled in by the last row of permanent roof supports while marking the mine roof for locations to install roof bolts in the last open crosscut. A section of roof rock measuring approximately 34-inches wide by 73-inches long by 6 to 8-inches thick fell from the unsupported area, causing fatal crushing injuries.

Root Cause: The standards, policies, and administrative controls in use at this mine did not ensure that persons would not position themselves or travel in by the last row of permanent roof supports (roof bolts), and would not work or travel in an opening that created an intersection without additional roof support as is required by the approved roof control plan. The victim traveled in by permanent roof support to mark roof bolt locations. In addition, the unsupported crosscut had been cleaned of coal which allowed the roof bolting machine access to the unsupported area from the No. 7 entry. In order to completely clean the coal from the crosscut the scoop operators would have had to travel under unsupported roof. 30 CFR 75.202(b) requires that no person shall work or travel under unsupported roof.

Root Cause: The mine foreman routinely operated equipment and failed to exercise the duties and responsibilities which would reasonably be expected to be conducted by a certified mine foreman. Adequate observations of the work habits and mining cycle would have detected the conditions and practices which contributed to the accident.

An investigation of the fatal fall of roof accident which occurred on October 6, 2006, revealed that the operator failed to ensure that employees would not work or travel under unsupported roof. The victim, Mr. Joseph Seay, was found inby the last row of permanent roof supports, where a roof rock measuring 34-inches wide by 73-inches long by 6 to 8-inches thick fell on him causing fatal crushing head injuries. He was located inby the last row of permanent supports in the crosscut between the No. 7 and No. 8 entries. The unsupported area was 11 feet 4-inches and Seay was located 24-inches from the inby rib and his head was located 47-inches inby the crosscut from the last permanently installed roof bolt. There were four yellow chalk marks present on the mine roof indicating locations where roof bolts were to be installed. These chalk marks were located in the most outby area of the unsupported crosscut. Chalk mark measurements from permanently installed roof bolt in the No. 7 entry on the most outby rib were 40-inches, 47-inches, and 49-inches. Chalk mark measurements from the next inby permanently installed roof bolt were 49-inches, 42-inches, and 45-inches.

Corrective Action: All employees received 8 hours of Annual Refresher Training conducted by OMSL, which included emphasis on the revised Roof Control Plan.

Corrective Action: Mine management should establish and train certified mine foremen in the responsibilities of the position and their expectations for compliance. The certified mine foremen did attend the training class.
