MNMM Fatal 2006-22

- Machinery
- October 10, 2006 (Michigan)
- Sand & Gravel Operation
- Dredge Operator
- 45 years old
- 9 years experience

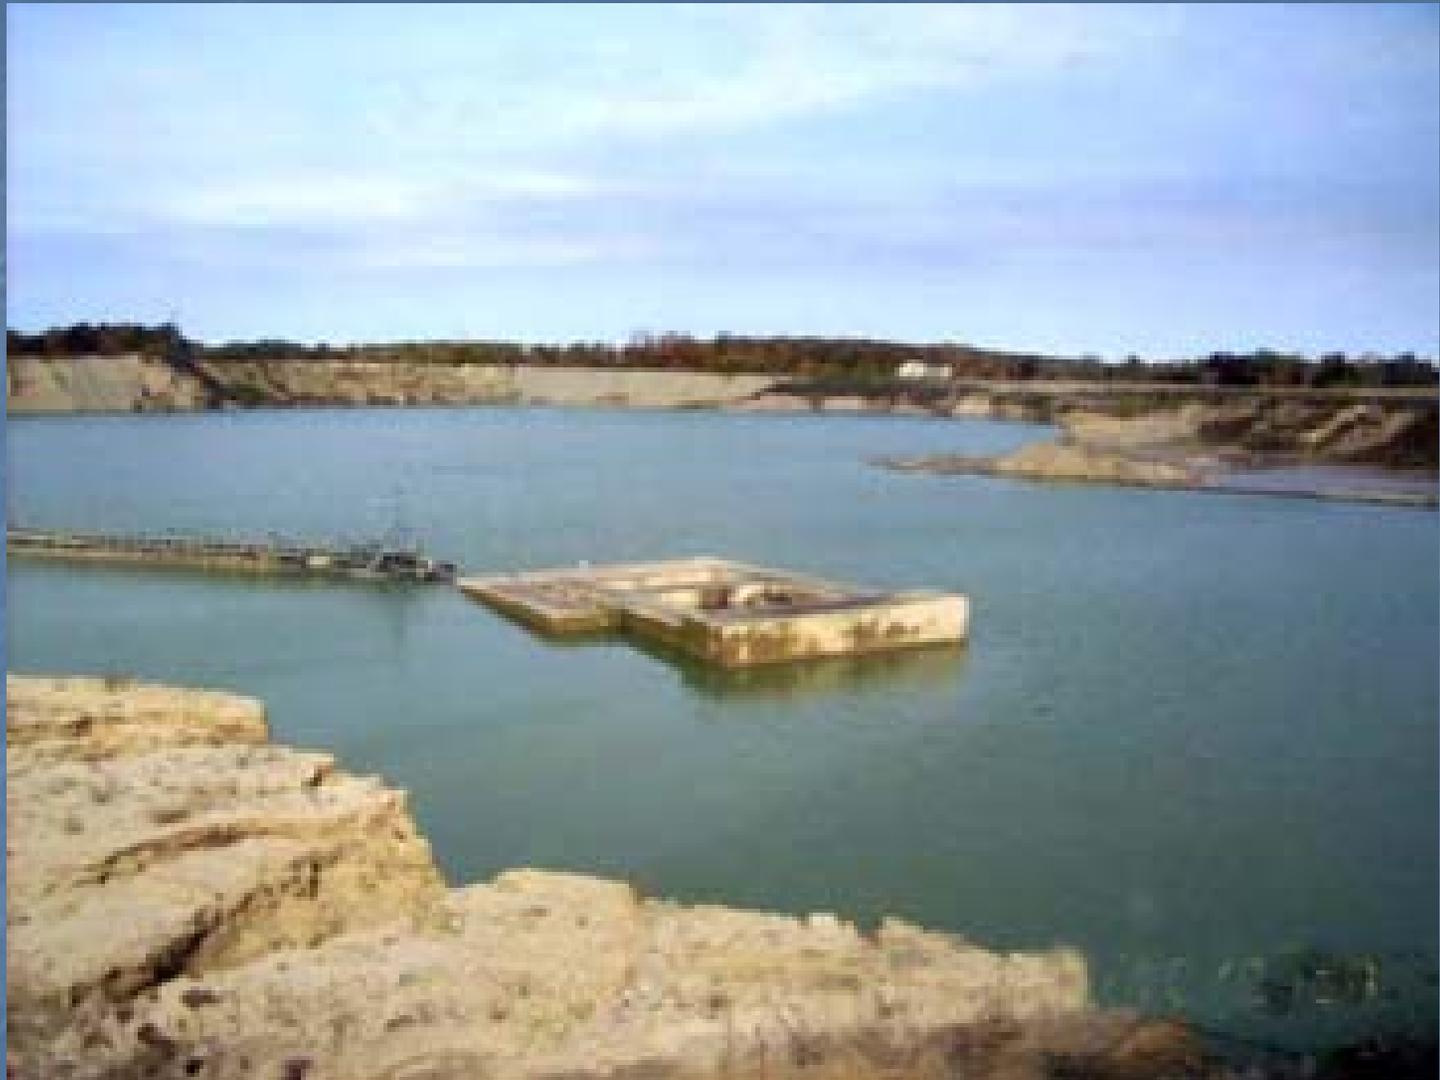
The victim drowned when the floating clamshell dredge he was operating capsized.

- Management policies and controls were inadequate. Procedures had not been established to ensure that leaks in the dredge pontoons were repaired. Sump pumps were installed in four leaking pontoon cells. The pumps were plugged into electrical ground fault circuit interrupters (gfcis) which had to be regularly monitored to ensure they were operating.

- Management policies and controls were inadequate. Procedures had not been established for modifying the original design of the dredge. Additional steel plating had been added on the front end of the dredge to support the storage of large boulders encountered while mining. Additional steel plating had also been added to the crusher feed chute.

- Management policies and controls were inadequate. Procedures had not been established to ensure the high dredge overload and full hopper alarm switches were properly positioned and functioning within the specifications set by the manufacturer. The switches were set to permit approximately 1-1/2 inches of freeboard. The dredge was designed for a minimum 12 inches of freeboard to prevent overloading the dredge.

- Always conduct a complete pre-operational check.
- Inspect all supporting structures for defects or cracks.
- On a regular basis, examine and test all safety devices and ensure that they are operating properly.
- Always wear a life jacket where there is a danger of falling into the water.
- Set up a communications schedule with persons working alone.
