**UNITED STATES  
DEPARTMENT OF LABOR  
MINE SAFETY AND HEALTH ADMINISTRATION**

**REPORT OF INVESTIGATION**

**Fatal Powered Haulage Accident  
February 17, 2006**

**Mettiki Mine  
Mettiki Coal LLC  
Oakland, Garrett County, Maryland  
ID No. 18-00621**

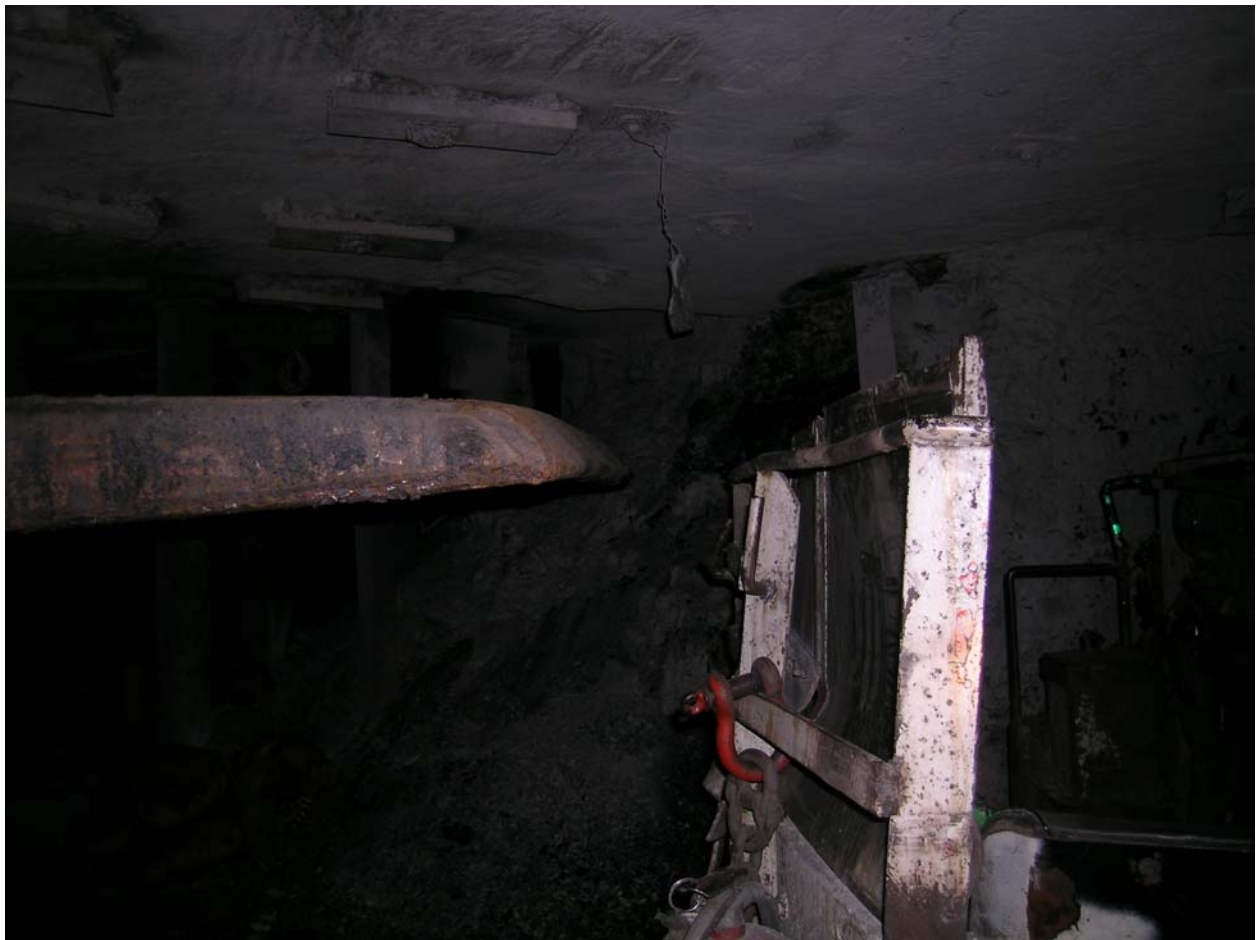
On Friday February 17, 2006, at approximately 9:30 pm, Willard J. Miller, a 35-year old roof bolting machine operator with five years mining experience, was fatally injured while operating a diesel-powered locomotive during a longwall move. The locomotive he was operating struck a parked lowboy rail car that was loaded with a longwall shield. The victim was crushed between the locomotive control panel and the tip of the longwall shield, which projected past the end of the lowboy.

The direct cause of the accident was the method in which the longwall shield was carried on the low-boy, which permitted the load to extend beyond the limits of the car and into the roadway where it could be contacted by other vehicles.

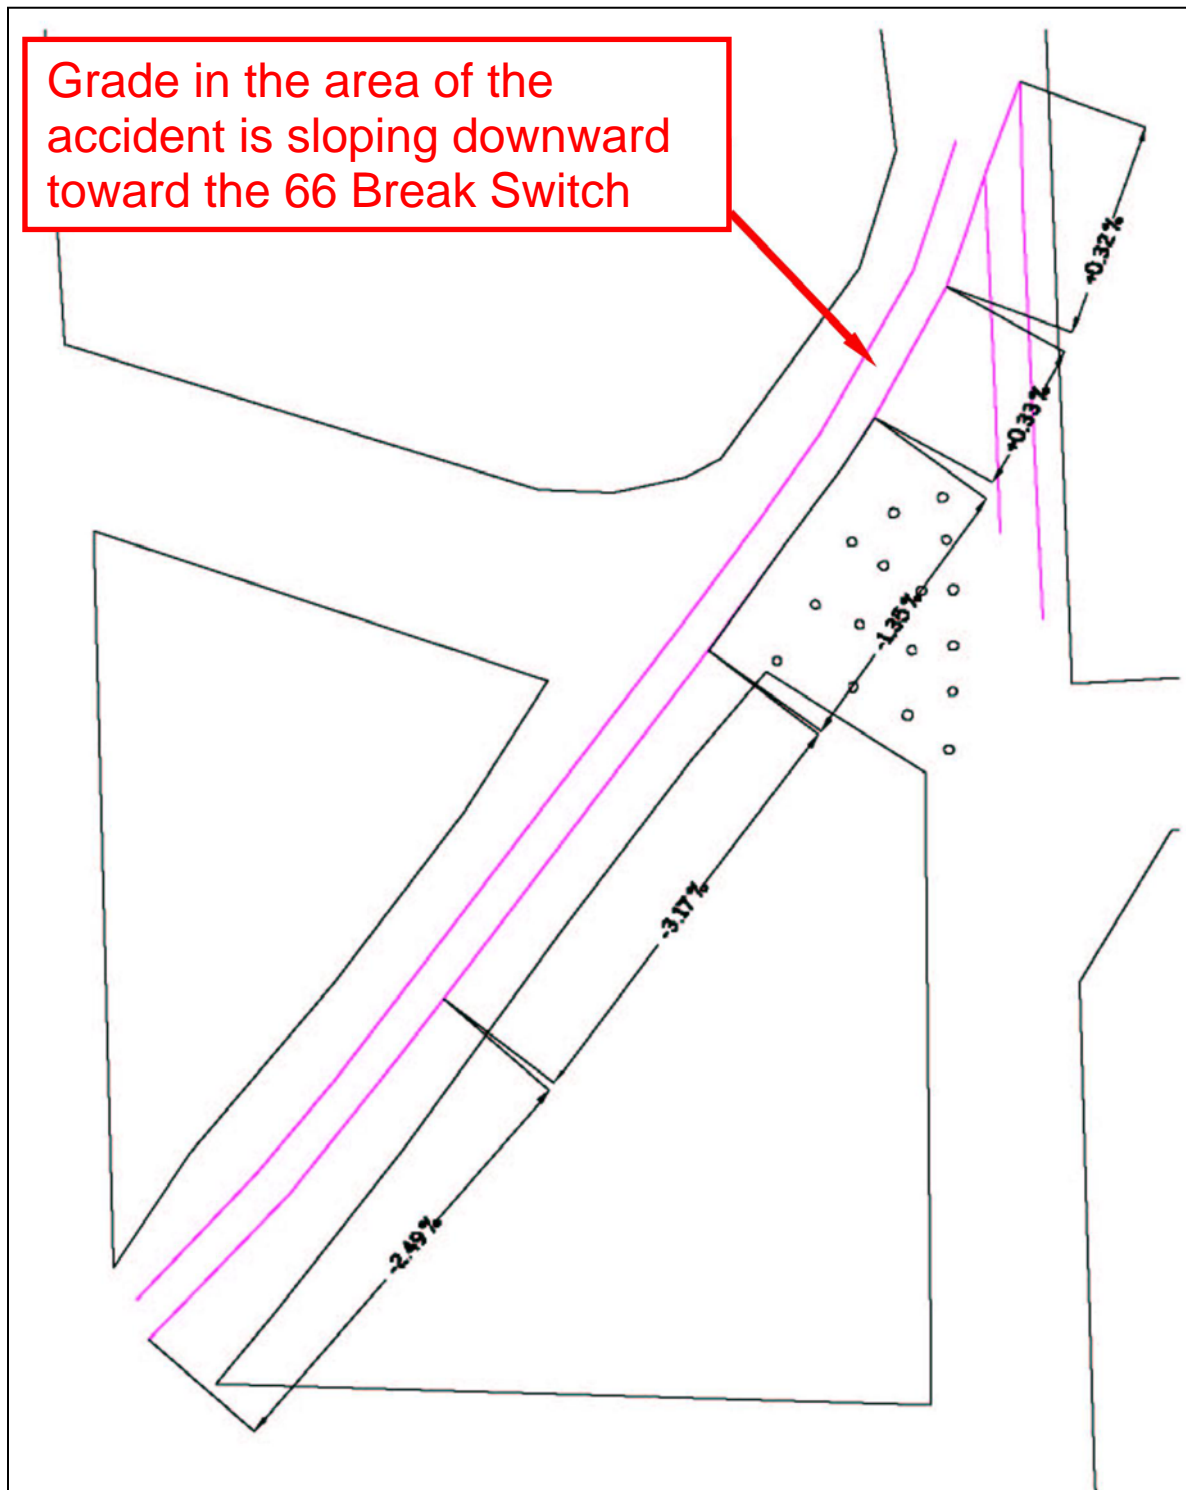
**APPENDIX F**  
Grade in the Area if the Accident

The accident scene was surveyed and the rail grade in the affected area was calculated. The slope in the entry ranged from 2.5% to 3.2% (see Appendix F). Motormen interviewed stated that they believed that this area was nearly flat, and that a locomotive pulling a longwall shield would not drift forward. However, the survey confirmed that the part of the track where the victim's trip started and eventually stopped dipped in the direction of travel. During the investigation, the victim's trip was repositioned to its parked location prior to the accident. When the air brake was released, the loaded trip accelerated forward, reaching a sufficient momentum to result in the accident without engaging the locomotive engine. A mechanical inspection of the locomotive found no mechanical defects that could have contributed to the accident.
