REPORT OF INVESTIGATION

Fatal Powered Haulage Accident
May 23, 2006

Risner Branch #1 Mine
Miller Bros Coal LLC
Rousseau, Breathitt County, Kentucky
ID No. 15-18600

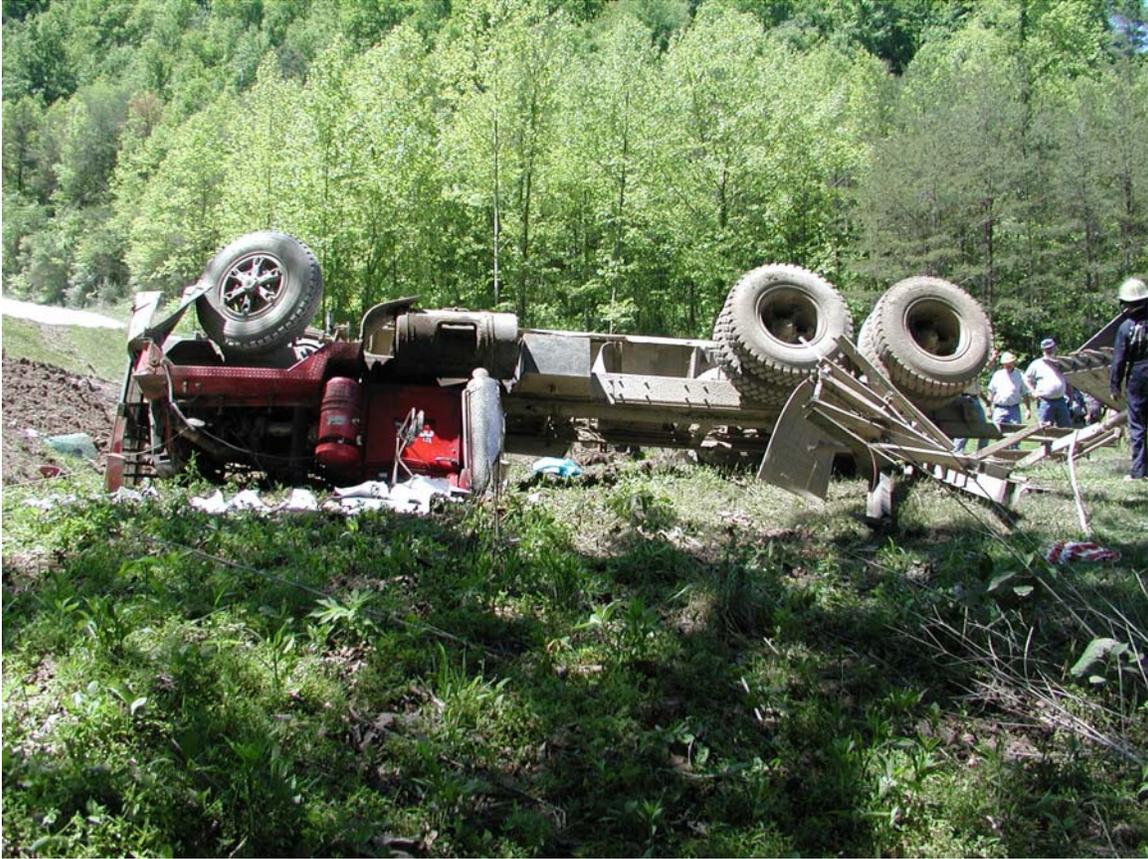
ACCIDENT SITE

At 9:50 a.m. on Tuesday, May 23, 2006, a 23-year old miner with 10 months of mining experience was fatally injured at Miller Bros Coal LLC, Risner Branch # 1 Mine. The accident occurred when Steven Bryant, driving a Mack water truck, lost control while descending a steep mine access road. The accident occurred because the service brakes were not adequate, the engine brake was inoperative, and because the victim was not task trained. The approved training plan was not followed and effective procedures were lacking to ensure adequate braking systems. The truck overturned and slid over an embankment.
