REPORT OF INVESTIGATION

Surface Coal Mine

Fatal Fall of Highwall  
July 18, 2006

Smith Branch No. 1  
Hendrickson Equipment, Inc.  
Mallie, Knott County, Kentucky  
ID No. 15-18917

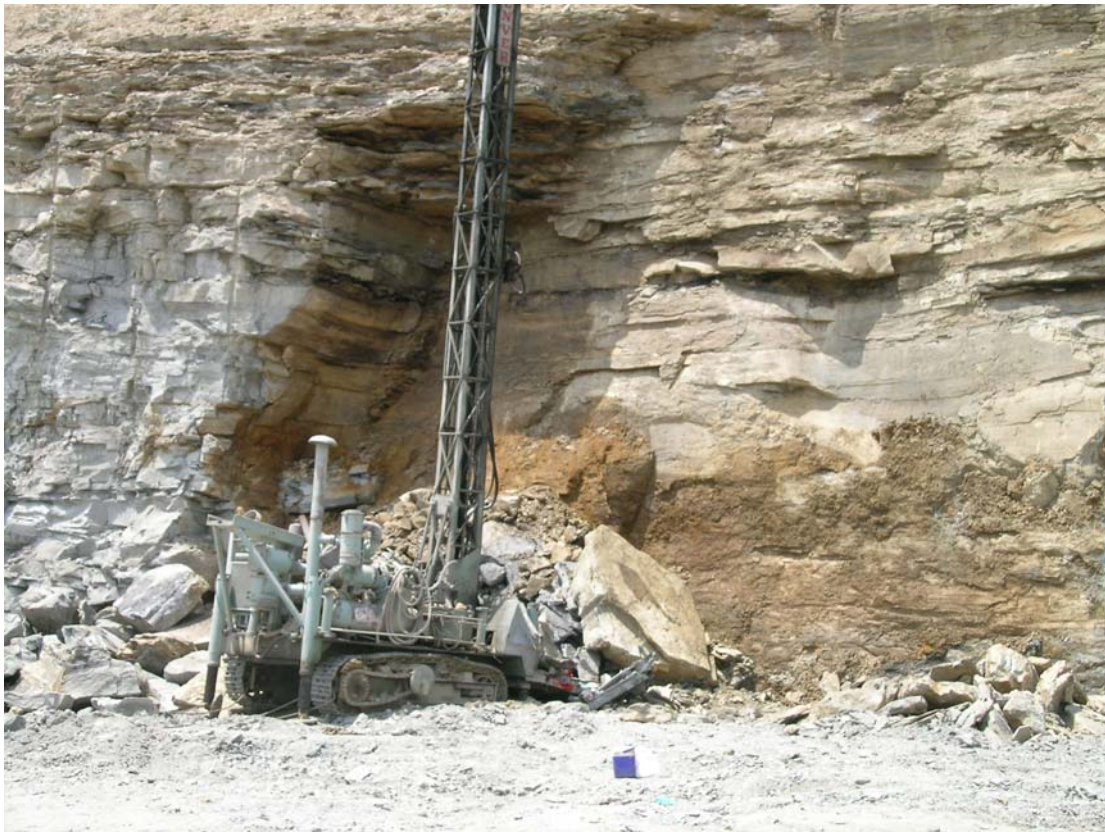
Photograph of Accident Scene

The accident occurred as Mosley was operating a highwall drill adjacent to a 43-foot highwall. As he was drilling the eighth hole of the day, rock fell onto the cab of the drill, resulting in fatal injuries to Mosley. The rock fall measured 32 feet high by 19 feet wide by 7 feet thick.

The highwall failure occurred mid-way along the working face, 220 feet from the left end and 170 feet from the right end of the wall. The failure area extended from the toe to approximately 32 feet in height, was 19 feet wide at the top, 10 feet wide at the bottom, and 7 feet thick.

The fallen rock debris created a pile approximately 20 feet wide by 20 feet long by 6 feet high on the left side and front end of the highwall drill.

The rock fall severely damaged the highwall drill on the left side and on the front end. It also struck the mast and crushed the operator's cab, fatally injuring the victim inside. The rock debris covered approximately 4 feet of the front half of the drill.

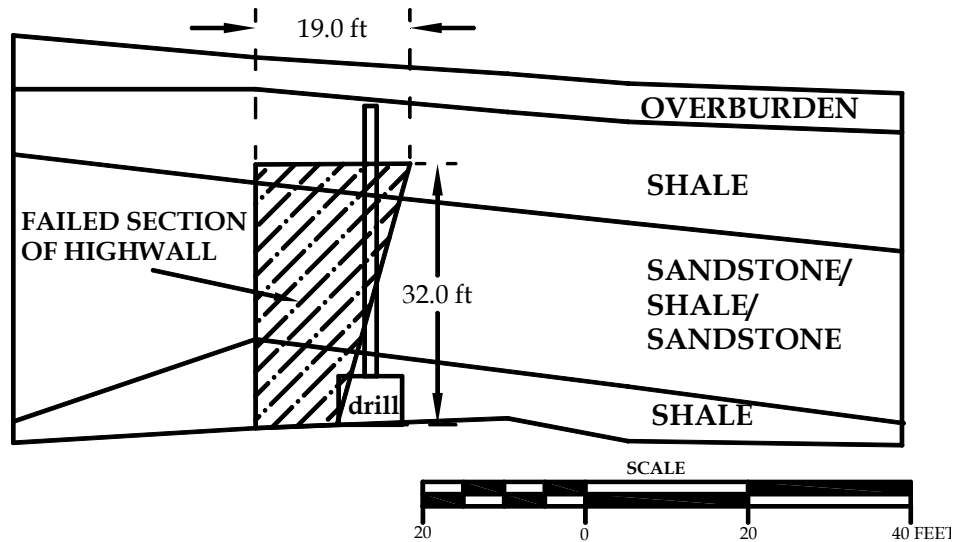
FRONT VIEW OF FAILURE AREA

Several discontinuities were present in the strata. The failed mass appears to have been bounded by a combination of discontinuities which resulted in a wedge failure. The wedge failure was the result of 2 intersecting joint sets. The left side joint strike was near perpendicular to the wall and dipped vertical. The intersecting joint was parallel to the face of the wall, and dipped slightly towards the toe. Clay infill material was observed on the face of this joint. There was no water evident on the face of the highwall on the day of the investigation. The highwall had several joint sets existing on both sides of the failure area.

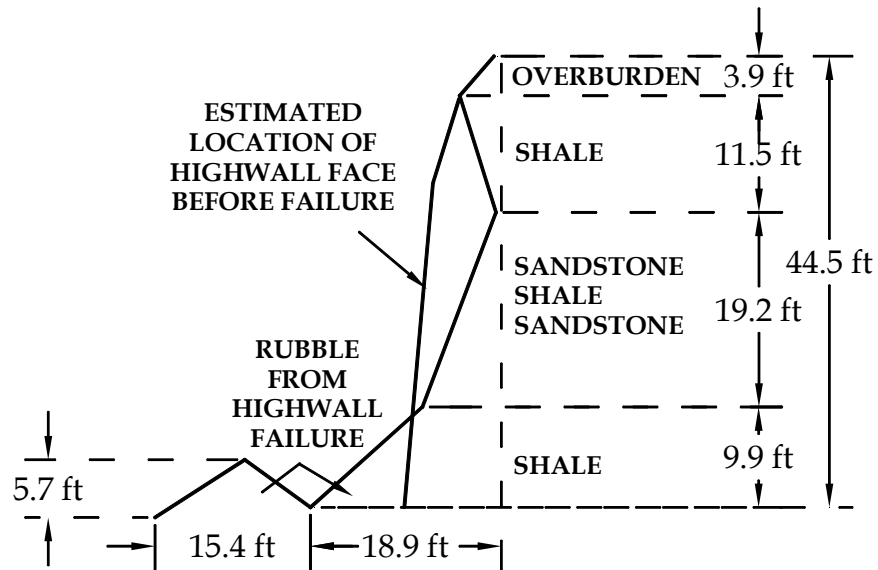
## SECTION D

When the accident occurred, the highwall drill was located less than 5 feet away from the toe of the highwall. The orientation of the drill was almost perpendicular to the wall, and it was situated on the right end of the failed highwall section. The operator's cab was located in front and to the right of the drill mast.
