REPORT OF INVESTIGATION

Fatal Fall of Roof Accident
October 6, 2006

Mine No. 2
D & R Coal, Incorporated
Barbourville, Knox County, Kentucky
ID No. 15-18261

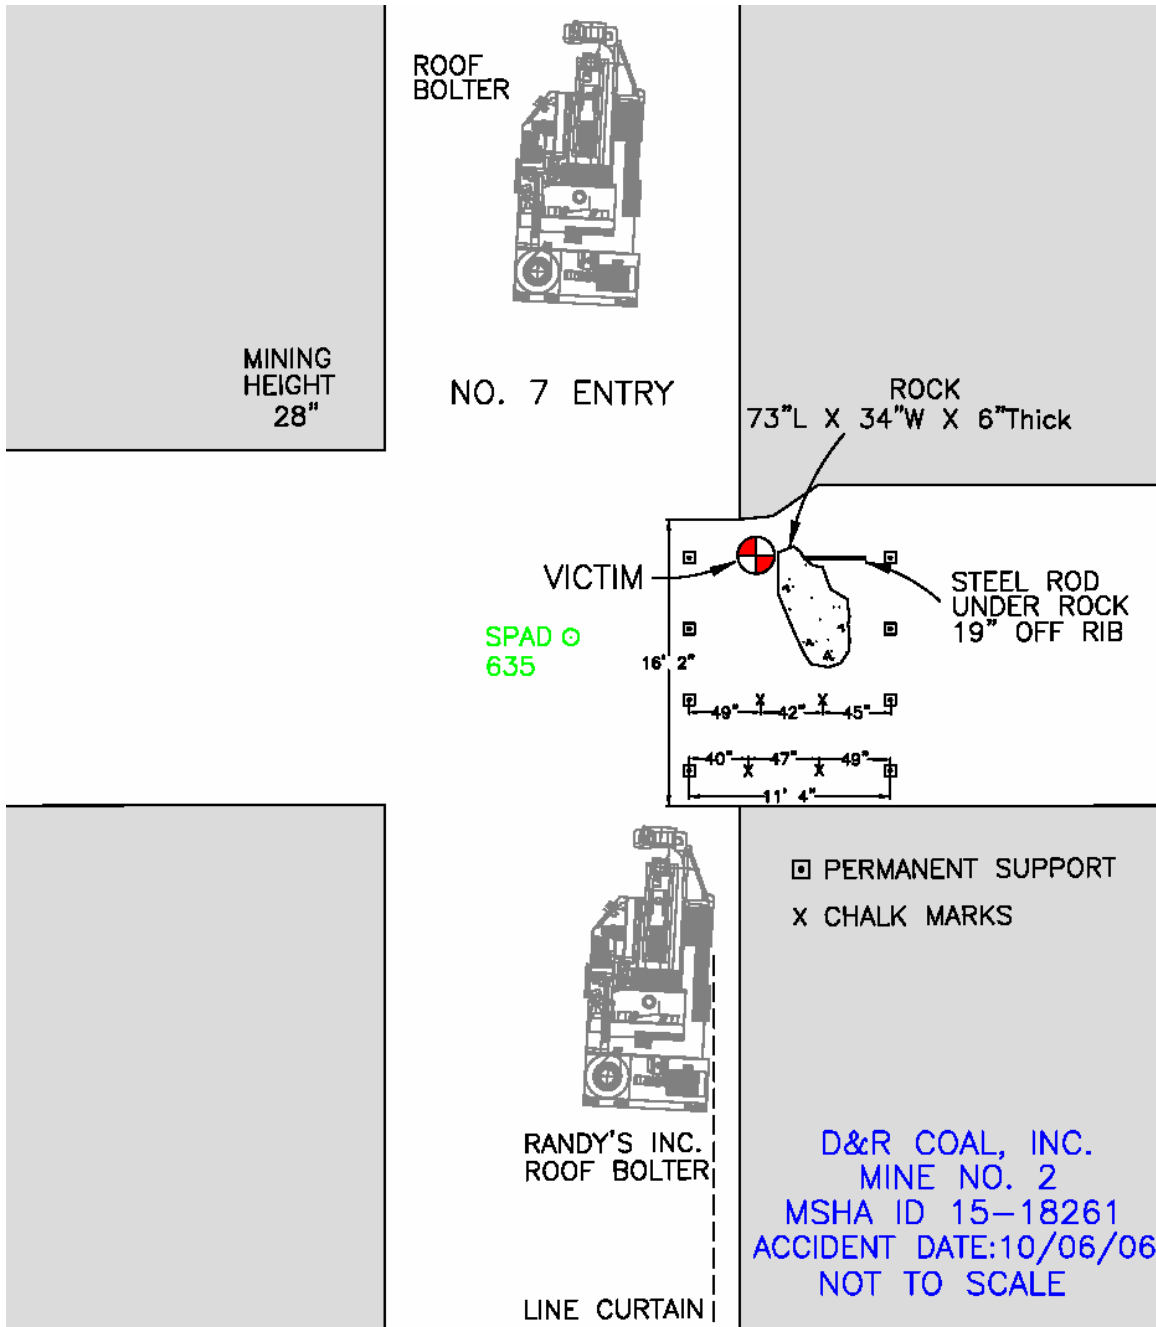
ACCIDENT SITE

Seay was found by Harris inby permanent roof support at approximately 12:30 p.m. There were no eyewitnesses to the accident, and the exact time could not be determined. Seay was located 24-inches from the inby rib, and his head was located 47-inches inby the crosscut from the last permanently installed roof bolt. Two leather gloves and a piece of yellow mine marking chalk was found 23-inches from the inby rib underneath the victim. Both gloves had yellow chalk marks on the palm sides. A 3/4 inch by 47-inch long thin metal pipe, used as a marking device, was found 19-inches from the inby rib and was lying under the broken-up roof rock. Black electrical tape was wrapped around the most inby end of the metal pipe. There was no evidence of chalk being under this taped area and the tape was flush with the end of the metal pipe.

There were four yellow chalk marks present on the mine roof in the unsupported crosscut, indicating locations where roof bolts were to be installed (See Sketch).
