REPORT OF INVESTIGATION

Surface Nonmetal Mine
(Sand & Gravel)

Fatal Falling or Rolling Material Accident
January 5, 2006

Rinker Materials
Rinker Materials 19th Ave.
Phoenix, Maricopa County, Arizona
Mine I.D. No. 02-00988

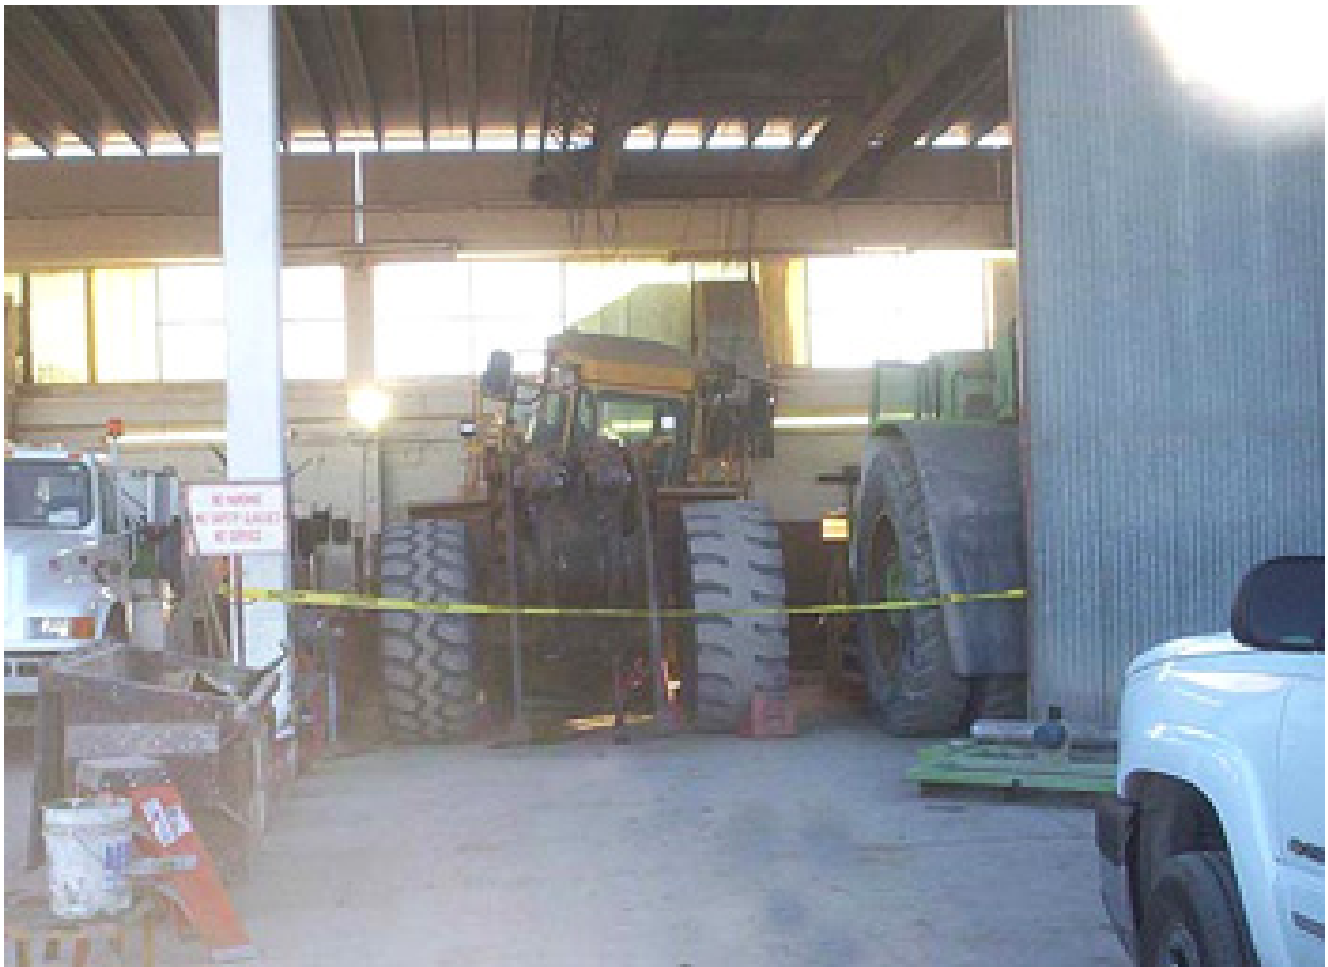
After the accident, the rear half of the machine was found with the wheels on the ground. The unit was tilted fully forward with the articulation joint area resting on the shop floor. The machine frame had rotated to the left on the oscillation trunnion. The space between the rear-left tire and fuel tank closed when the frame rotated to the left on the trunnion. The victim was pinned in this area.

The front-left screw type jack was found standing against the front-left tire on the engine unit. This jack had been removed to provide space for a three feet by four feet oil waste container under the steering cylinder to prevent spillage on the floor.

The loader was not properly blocked against hazardous motion in that, one of the two jacks supporting the front of the loader's rear main frame had been removed. Also blocks had not been placed between the rear main frame and the axle housing on both sides of the machine to prevent side-to-side (oscillation) movement of the machine.

Corrective Actions: Follow the manufacturer's procedures to block the front-end loader to ensure that persons performing the work are adequately protected.
