**REPORT OF INVESTIGATION**

Surface Nonmetal Mine  
(Phosphate)

Fatal Machinery Accident  
May 26, 2006

McDonald Construction Co.  
Contractor I.D. No. BA3  
at  
Mosaic Fertilizer, LLC  
Hookers Prairie Mine  
Polk, Bradley County, Florida  
Mine I.D. No. 08-00835

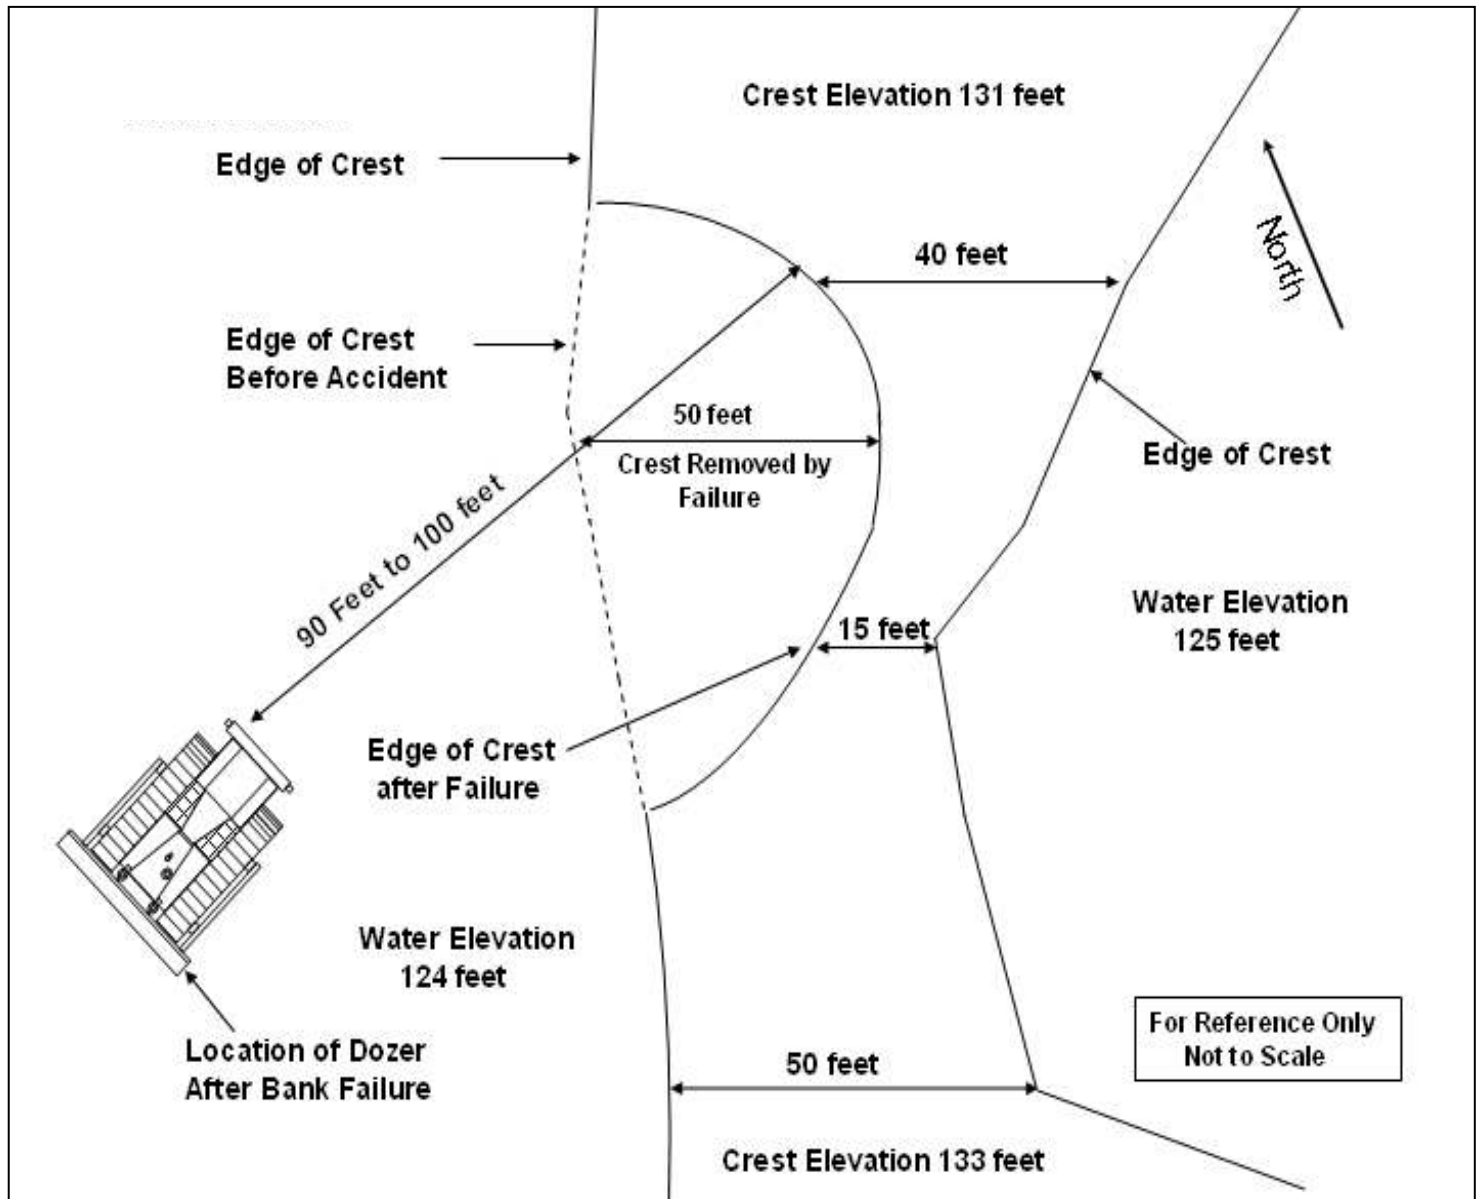
### Plan View of the Bank After the Accident

Approximately 130 feet (arc length or perimeter) of material along the west side of the bank slid/moved when the failure occurred. The scarp that remained following the failure varied in height between approximately three feet to six feet.

Based upon the height of water pumped out of the pond and measurements taken after the accident, the water surface was between five and eight feet below the crest of the bank. The sloughed overburden and sediments had filled the pit to 10 feet below the crest of the bank. Water had collected on the east and west side of the bank to form ponds.

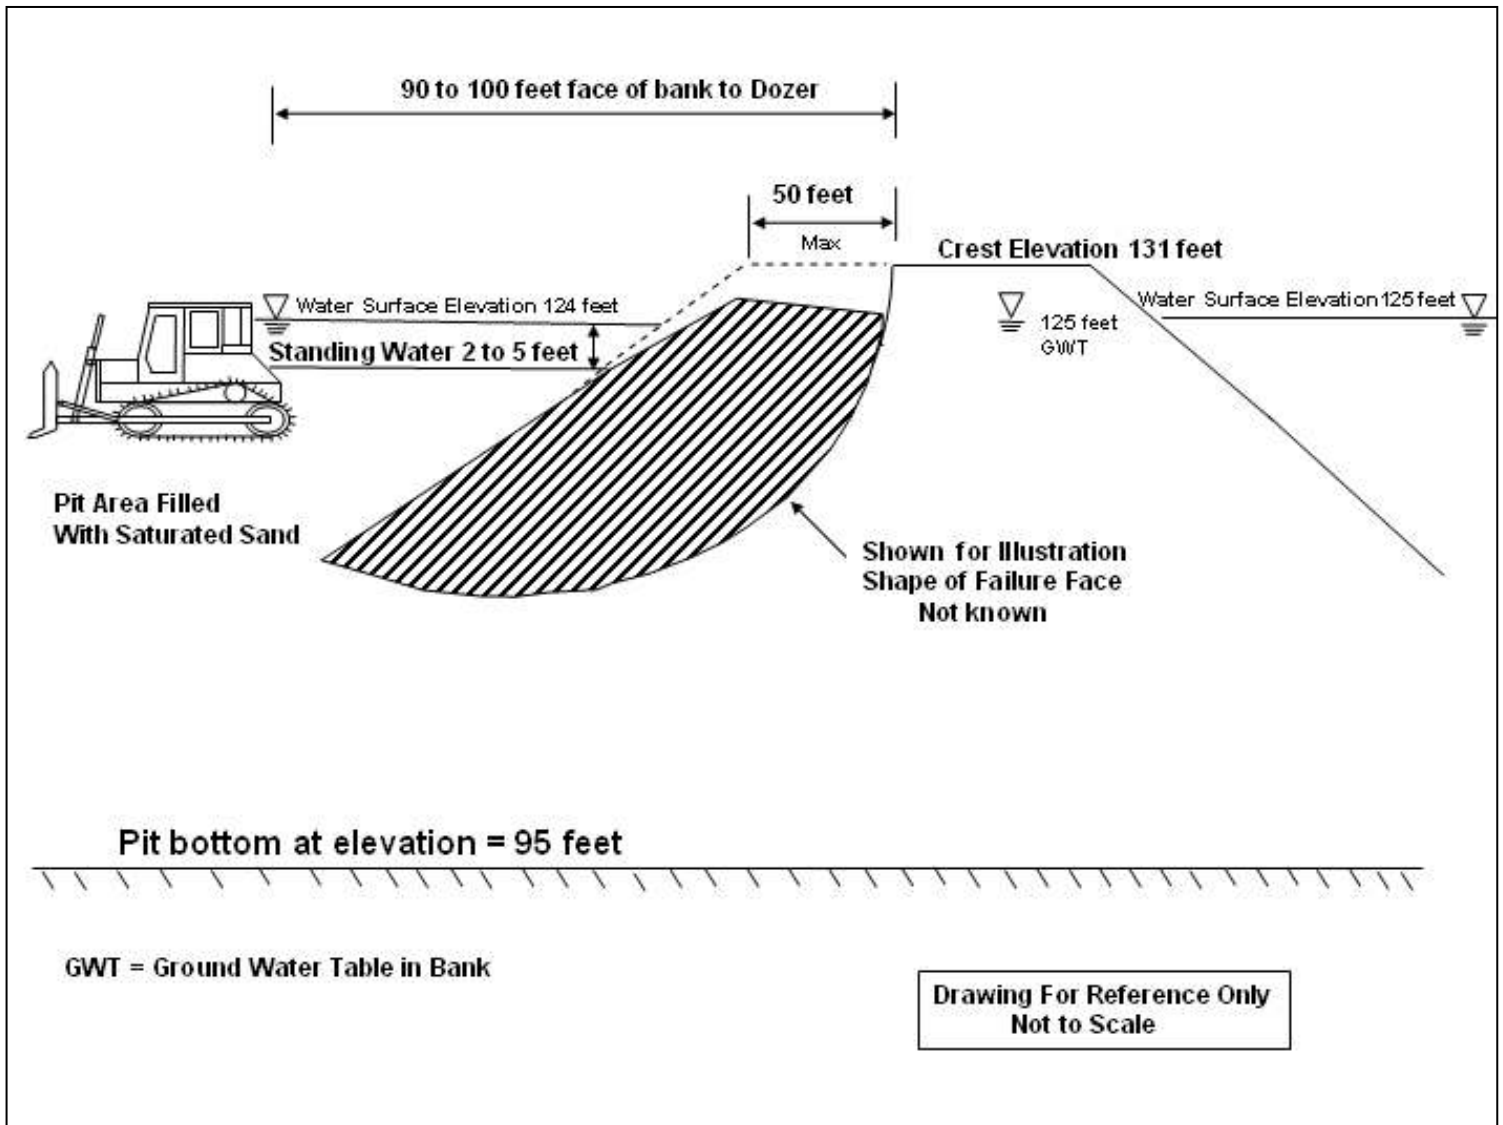
## Side View of the Bank After the Accident

On the day of the accident, the water level on the east side of the bank was one foot higher than the pond on the west side. This head differential was not significant enough to cause large seepage forces within the bank which could lead to slope failure. However, having water against both sides of the bank contributed to a larger area of the soil in the bank being saturated. The areas where the soil was saturated were more prone to sloughing.

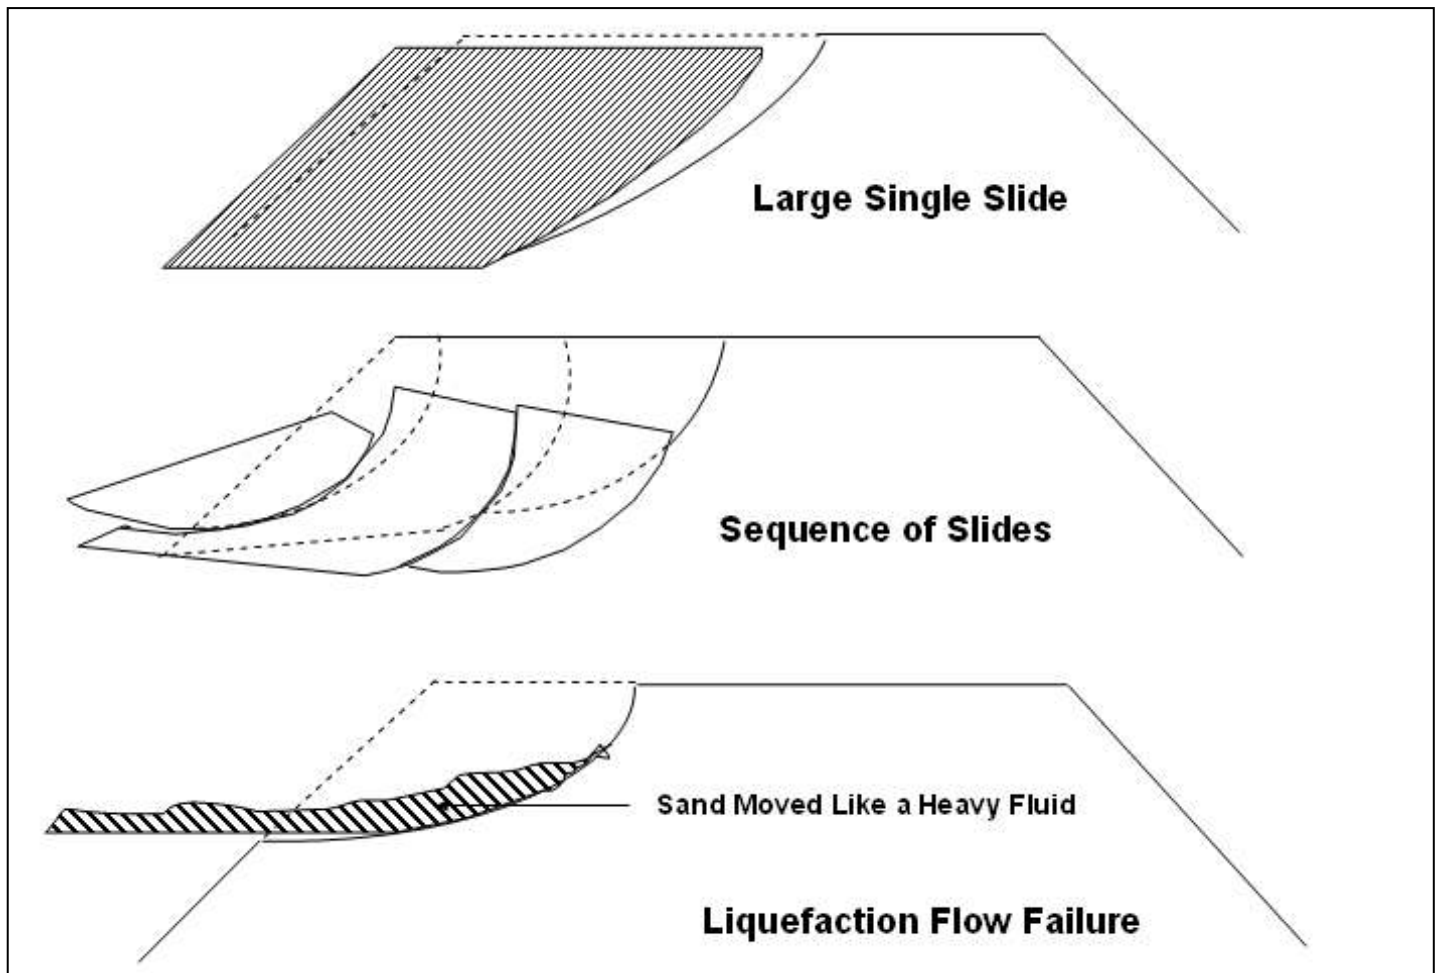
## Diagram of the Potential Failure Scenarios

The overburden material that formed the bank/pile consisted of sand with some silts. The sand was not dense, but was in a very loose state, which was consistent of sand placed by casting. The loose condition of the sand was verified by standard penetration testing performed by the operator during exploratory drilling of the accident area. The very loose condition of the sand made it very susceptible to sliding or sloughing from vibrations and the weight of the dozer. During recovery operations of the dozer, vibrations, generated from equipment working adjacent to, but not on the bank, appeared to have caused an additional 15-foot-wide portion of the crest of the failure face to slide or slough off of the eastern end of the bank.
