UNITED STATES
DEPARTMENT OF LABOR
MINE SAFETY AND HEALTH ADMINISTRATION
METAL AND NONMETAL MINE SAFETY AND HEALTH
REPORT OF INVESTIGATION

Fatal Fall of Person Accident
June 28, 2006

Tilden Mine
Tilden Mining Company L.C.
Ishpeming, Marquette County, Michigan
Mine I.D. No. 20-00422

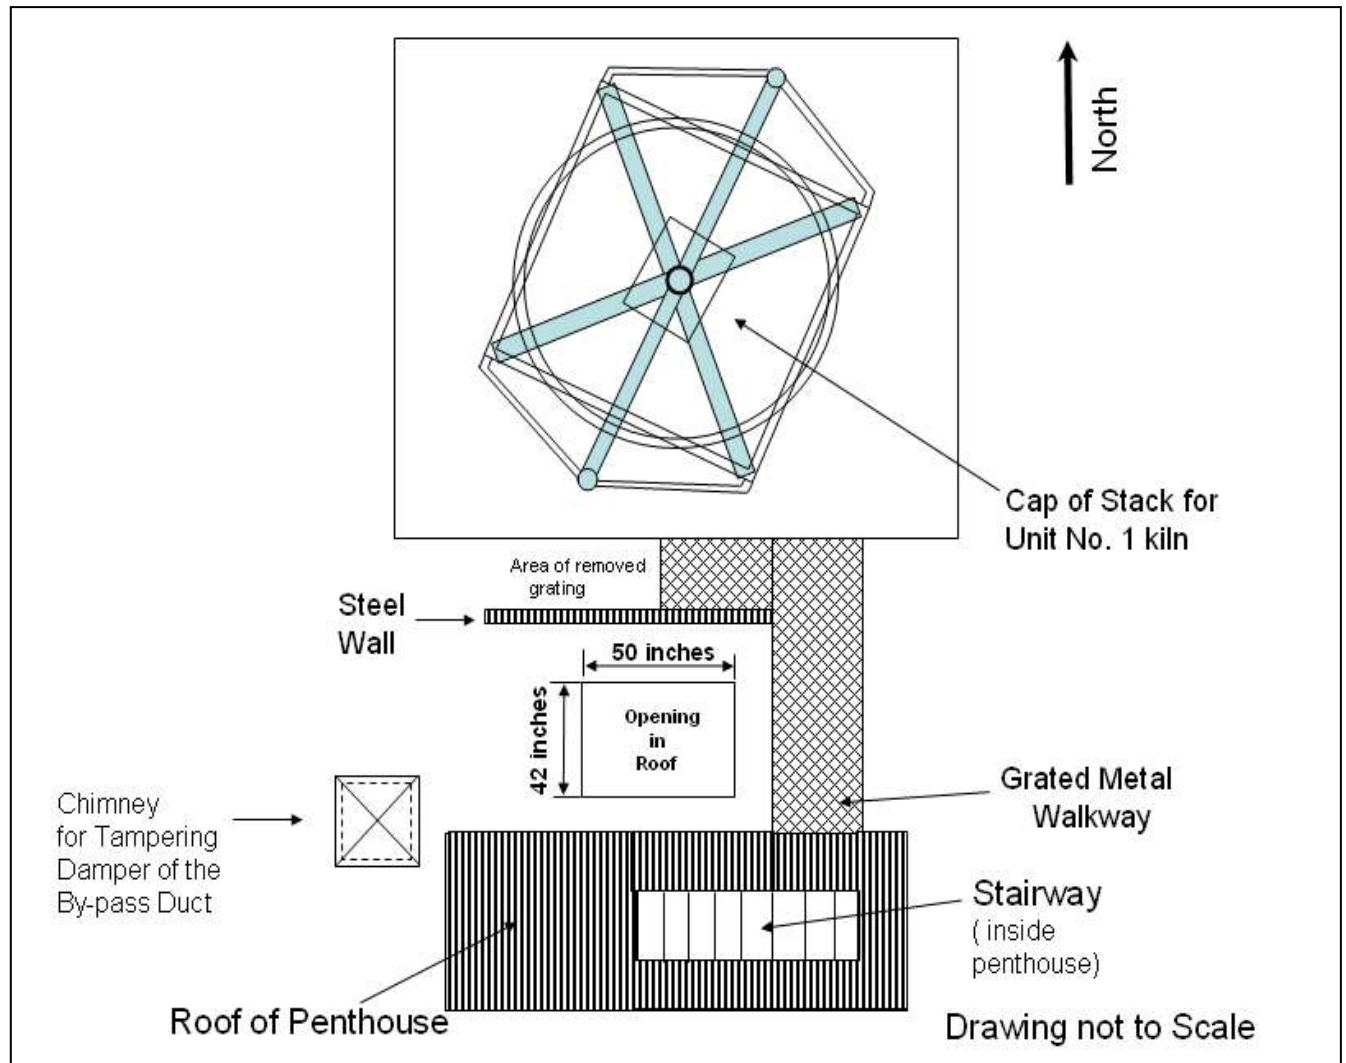
Diagram A

The opening in the #1 stack-cap roof was 42 inches wide and 50 inches long. This opening was used to transport tools and other materials to the roof (Diagram A). The last time the cover was determined to have been taken off the opening was when the #1 stack-cap roof was refurbished in 2000.

The failure of the roof opening cover occurred when Rintamaki inadvertently stepped on the cover. When Rintamaki stepped on the roof cover, his weight (230 pounds) would have induced high stresses in the area of the roof cover, causing the severely corroded metal to fail. Corrosion of the cover allowed sections of the sheet metal to detach from the frame. Once enough of the sheet metal was detached from the frame, it was no longer able to transfer the weight from the sheet metal to the frame. This caused Rintamaki to break through the sheet metal and fall through the opening.

Corrective Action: Procedures should be established to ensure a risk assessment is conducted prior to performing clean up tasks on the stack-cap roof area. Areas where hazards exist that are not obvious should be posted with warning signs or barriers.

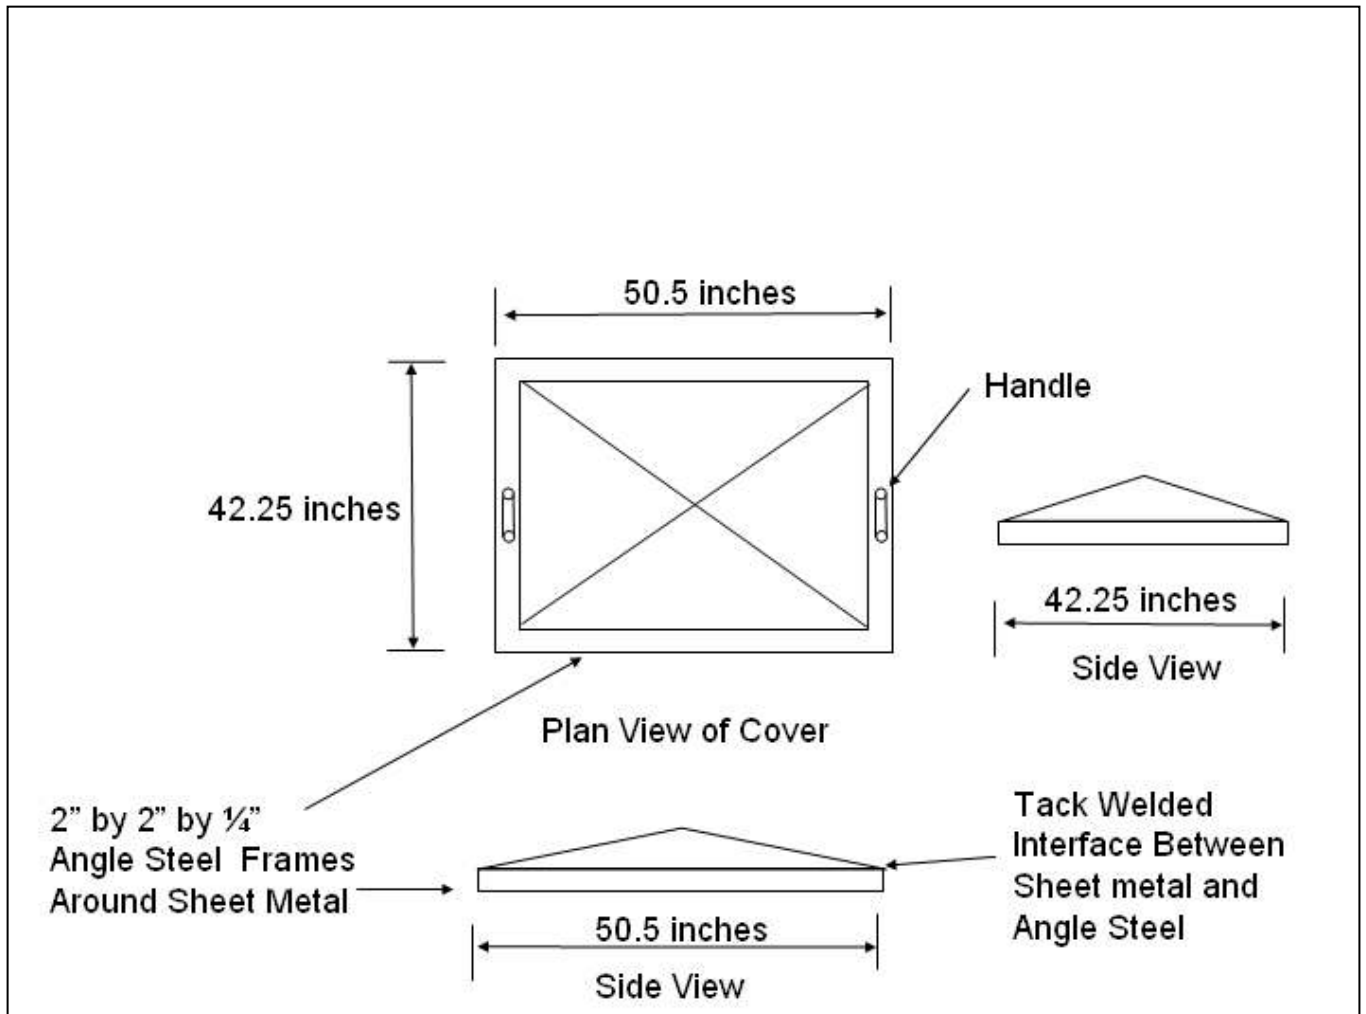
Diagram B

The cover of the opening was approximately 42.25 inches by 50.5 inches and constructed of four pieces of 2-inch by 2-inch by ¼-inch angle stock welded together to form a rectangular frame. The frame was covered with No. 16 gage, A36 sheet metal that was fastened to the frame with puddle welds along the perimeter. The sheet metal had two diagonal bends along the diagonal dimensions. The cover had two u-shaped handles that were 7.5 inches long and 4 inches high. These handles were welded to the angle stock frame (Diagram B). The sheet metal was severely corroded and contained corrosion holes.

About 8 to 9 inches of effluent dust had accumulated on the roof of the building. The accumulation of dust would have covered the roof opening cover, including the handles. The dust weighed approximately 120 to 145 pounds per cubic foot, creating a load on the cover of approximately 1,600 pounds. Investigators determined that the cover did not collapse under the weight of the dust because this weight was spread out over the entire area of the cover. This situation translated to a uniform load of approximately 90 to 110 pounds per square foot and possible bridging of the dust over the existing corrosion holes.

A post-accident assessment of the design of the roof opening cover showed that the cover, in a non-deteriorated condition, should have possessed enough stiffness and strength to have supported Rintamaki when he stepped on the cover.
