REPORT OF INVESTIGATION

Surface Nonmetal Mine  
(Sand and Gravel)

Fatal Machinery Accident  
October 10, 2006

American Aggregates of Michigan, Inc.  
Oxford Plant  
Oxford, Oakland County, Michigan  
Mine I.D. No. 20-02688

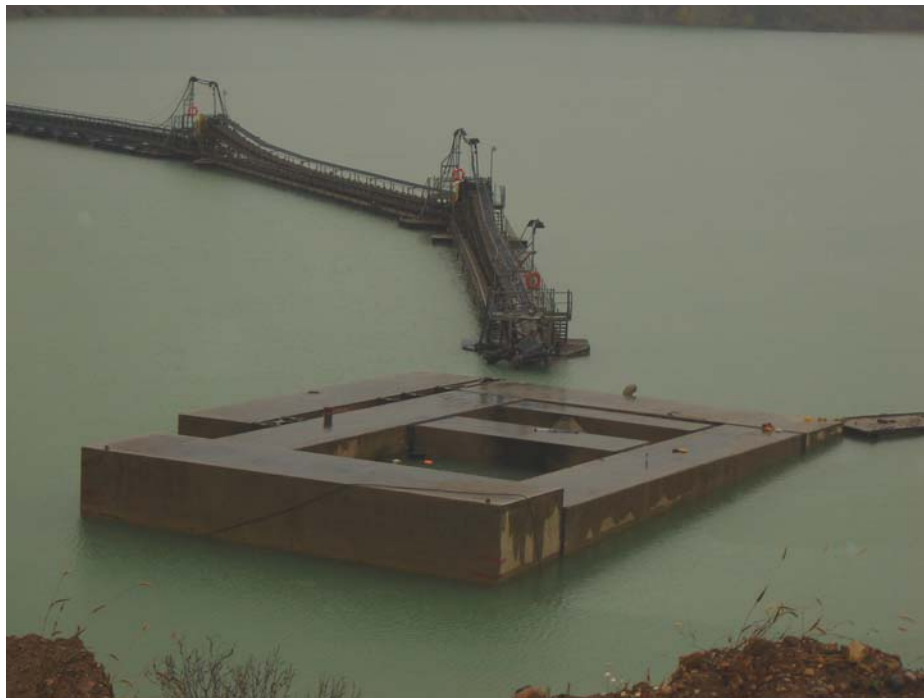
Picture # 1

The dredge was manufactured with rectangular shaped pontoons that were divided into 27 separate compartments or cells (Appendix B, Picture #1). During inspection of the capsized dredge, cracks were observed in the pontoon which supported the crusher on the conveyor side of the dredge (see Appendix B, Picture #2 and Overhead View of Dredge). Prior to the accident, unsuccessful

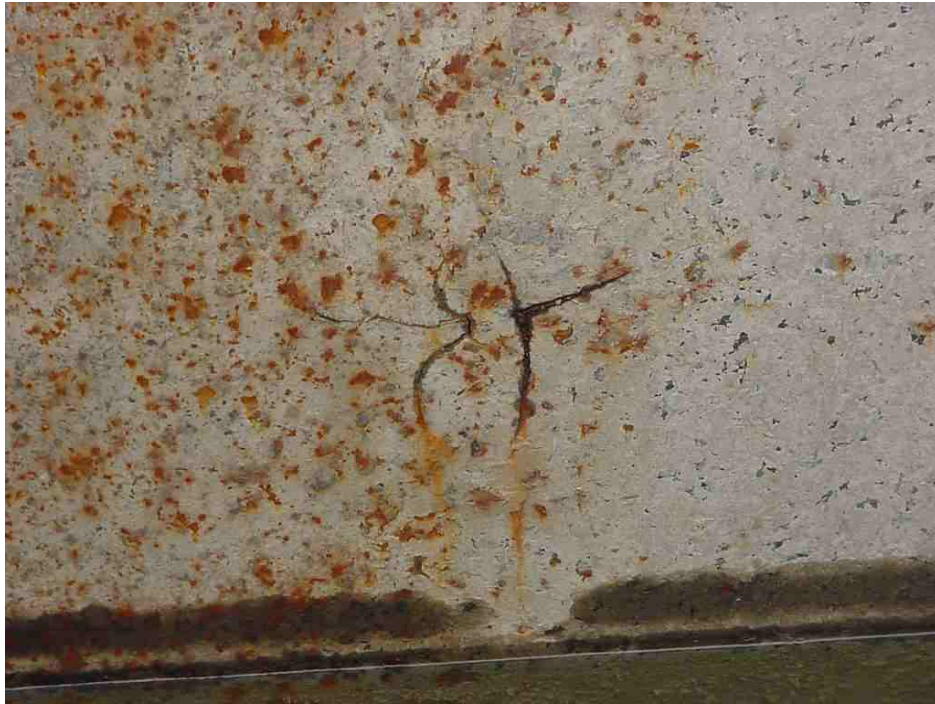
Picture # 2

attempts had been made to repair cracks from the inside of the pontoon cells. Five cells were determined to be leaking.

**Corrective Action:** Management should establish procedures for repairing the dredge pontoon cells when leaks develop.
