REPORT OF INVESTIGATION

Surface Nonmetal Mine  
(Sand and Gravel)

Fatal Falling Material Accident  
September 21, 2006

Ketchikan Ready Mix Crusher  
Ketchikan Ready Mix & Quarry Inc.  
Ketchikan, Ketchikan Gateway, Alaska  
Mine ID No. 50-00345

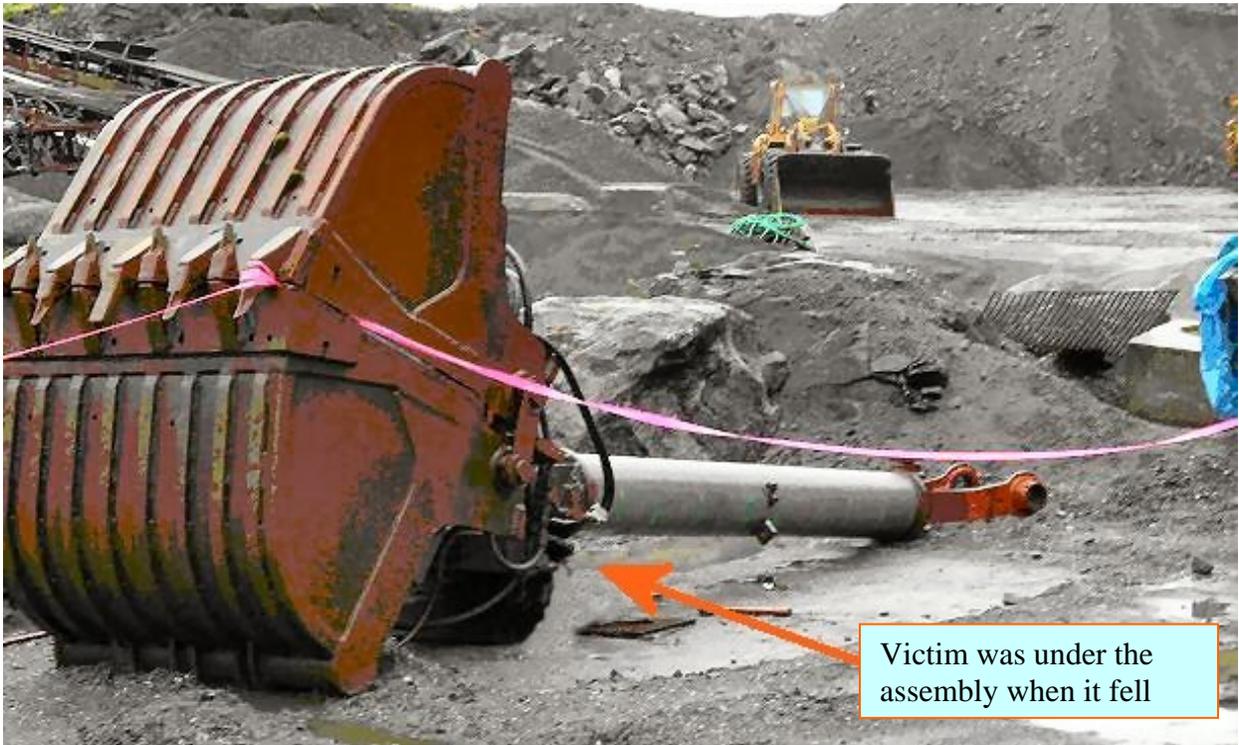
Victim was under the assembly when it fell

Leonard L. Dick, operator/welder, age 59, was fatally injured on September 21, 2006, when he was pinned under a boom extension and clamshell bucket assembly. Dick was lying under the assembly cutting steel bracing plates. When the final plate was cut free, the boom extension fell on him.

The accident occurred because no procedures were utilized to block the components against hazardous motion.

*Root Cause:* Management policies, standards, and controls were inadequate. Procedures failed to ensure that the victim had properly blocked the equipment against motion to prevent it from pivoting and falling.

The accident occurred because the assembly was not adequately blocked against hazardous motion.

*Corrective Action:* Management should develop and implement formal procedures to ensure that persons block machinery or equipment before they perform maintenance and repair work.
