REPORT OF INVESTIGATION

Fatal Underground Coal Burst Accidents
August 6 and 16, 2007

Crandall Canyon Mine
Genwal Resources Inc
Huntington, Emery County, Utah
ID No. 42-01715

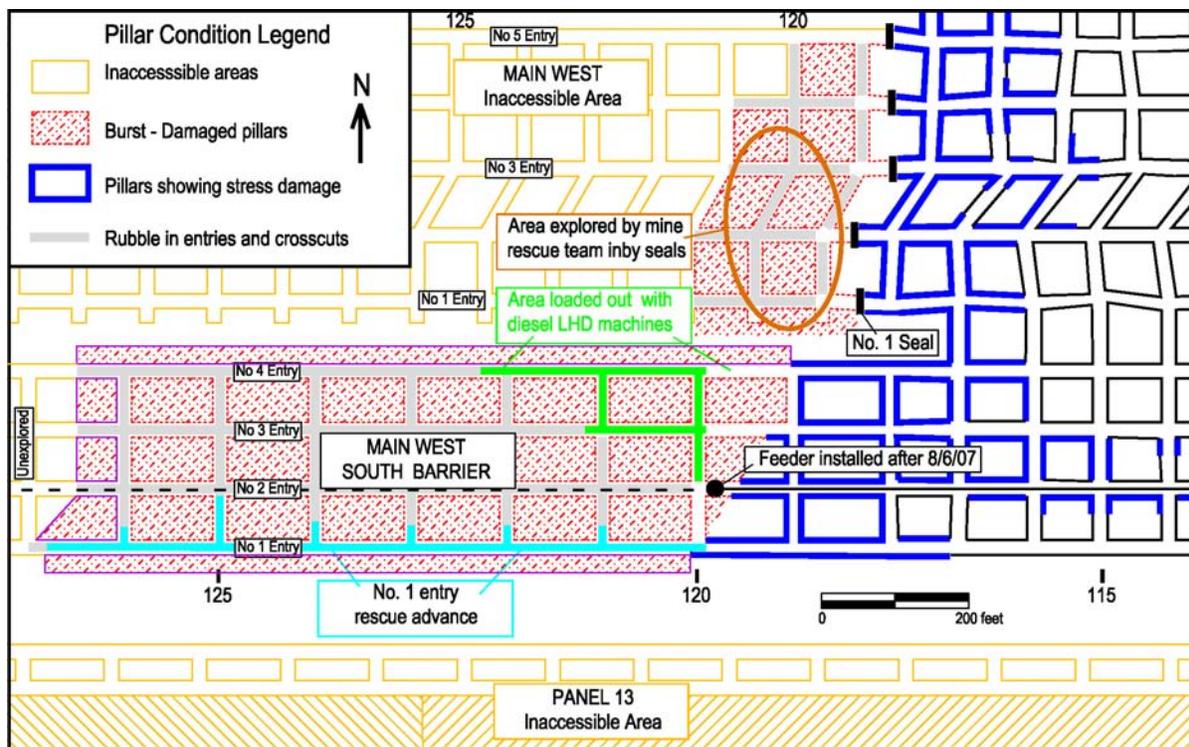
After 8:00 a.m., mine rescue team members from Energy West Mining Company also entered the mine. Grosely, Randy Gunderson (MSHA coal mine inspector), and a group of miners, including mine rescue team members, explored approaches to the South Barrier section by traveling back and forth between the Nos. 1 and 4 entries in an attempt to find a route to the entrapped miners. Entries and crosscuts were largely filled with debris, while intersections were less filled. They advanced to crosscut 126 where they encountered debris within inches of the roof and oxygen below 16%. A decision was made to retreat.

**Figure 3 - South Barrier Section Rescue Area
Showing Ground Conditions and Rescue Attempts.**

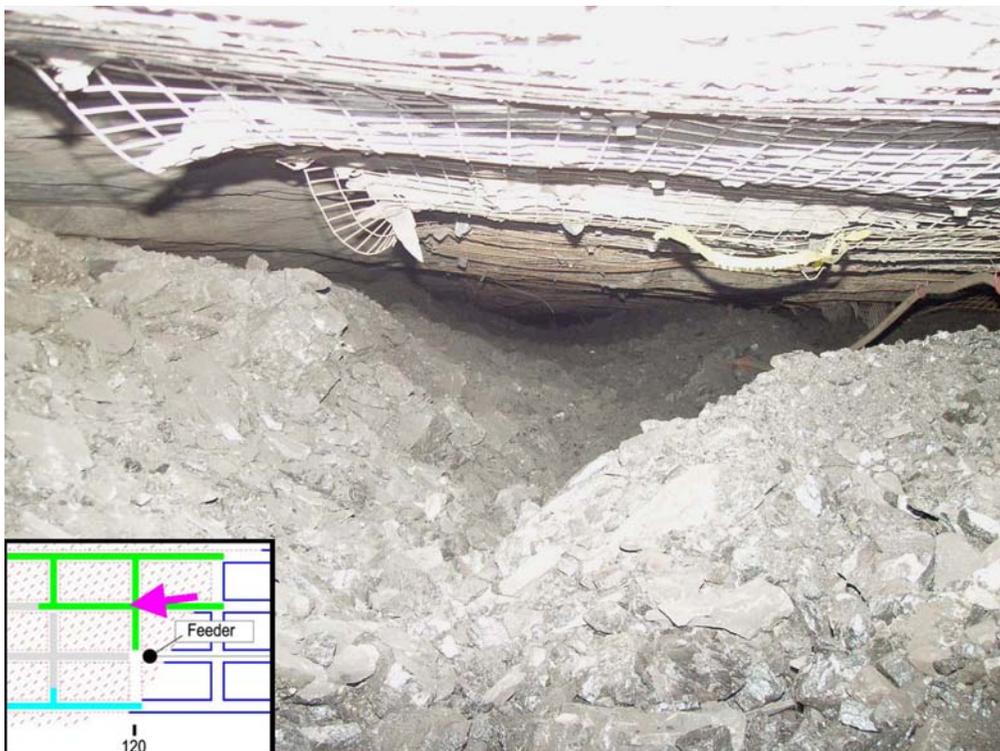
On August 7, 2007, a burst occurred in the clean-up area. UUSS registered a magnitude 2.8 seismic event at 1:13 a.m., which coincided with the approximate time of the burst. Ron Paletta (MSHA coal mine inspector) was standing near the feeder breaker with Benny Allred and Gale Anderson. The burst knocked Paletta to the ground and again damaged or destroyed ventilation controls to crosscut 93. The burst put a large amount of dust into suspension throughout the area and limited visibility to only a few feet. There were no injuries associated with this event. However, the burst partially refilled approximately 300 feet of entry that had been cleared (see Figure 4). Neither LHD was in the area refilled by burst material. One LHD was loading loose coal near the feeder between the Nos. 2 and 3 entries and the other LHD was outby the feeder in the No. 3 entry. All miners were withdrawn to crosscut 109 and accounted for.

Figure 4 - View of No. 3 Entry after August 7 Burst
Entry cleaned by diesel loaders refilled with rubble (view indicated by arrow in index map insert).

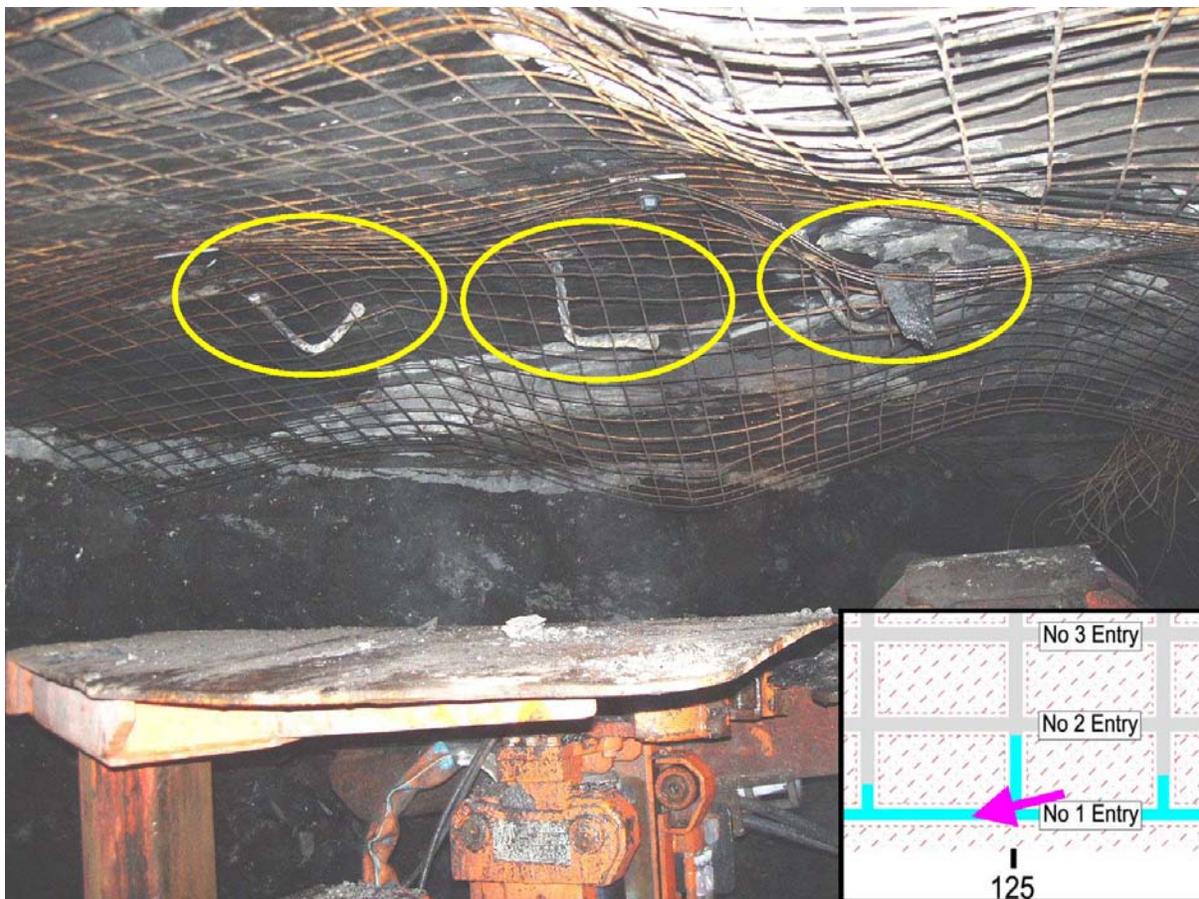
Figure 8 - Damaged Roof Bolts in No. 1 Entry after August 6 Accident Resulting from Northward Movement of Southern Barrier. Mesh shown was installed during rescue operations, over damaged original roof bolts. Camera view is indicated by arrow in index map insert.

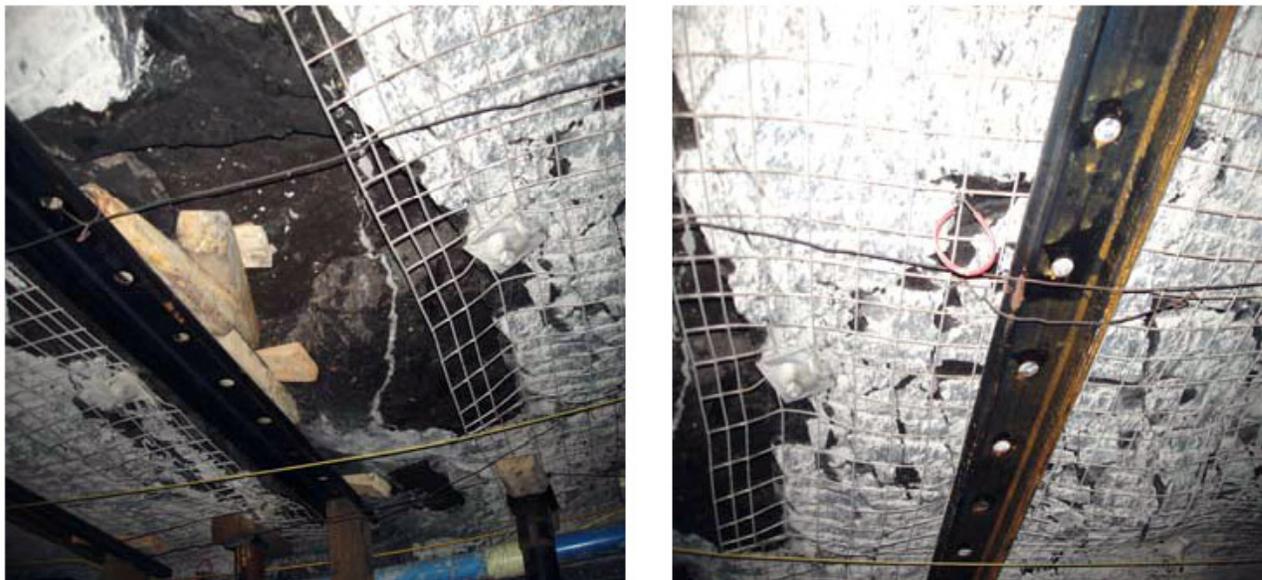
On August 12, roof deterioration was observed near crosscut 115 in the No. 1 entry. Steel channels were installed for additional support in this area (see Figure 9). The channels were supported on both ends with hardwood posts. At the time, clean-up in the No. 1 entry had advanced just inby crosscut 124. The No. 1 entry was packed with rubble the full width and height of the original mined opening. The continuous mining machine was loading from a rubble pile that resembled an unmined coal face (see Figure 10 and Figure 11). Observations of RocProps tilted from vertical prompted MSHA to install a measurement point to monitor horizontal movement between crosscuts 123 and 124.

Figure 9 - Steel Channels Installed in No. 1 Entry to Support Deteriorated Roof

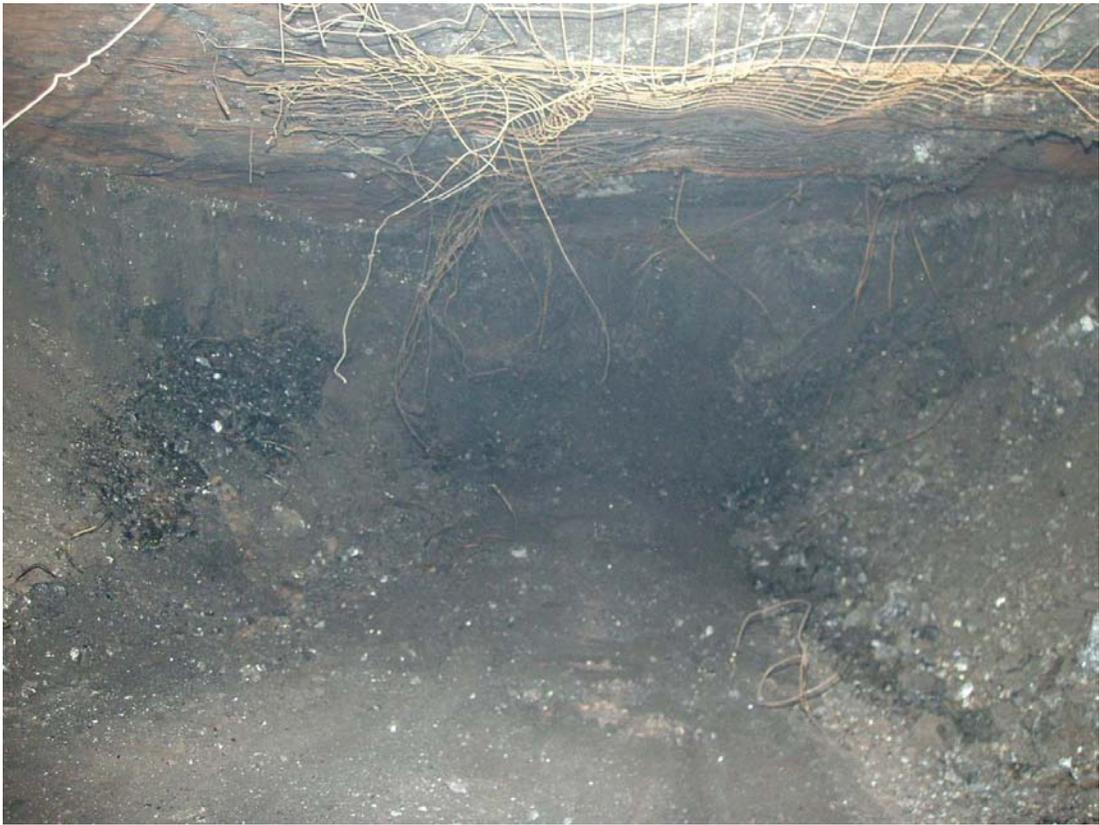
Figure 10 - No. 1 Entry Packed with Coal Rubble Inby Crosscut 124

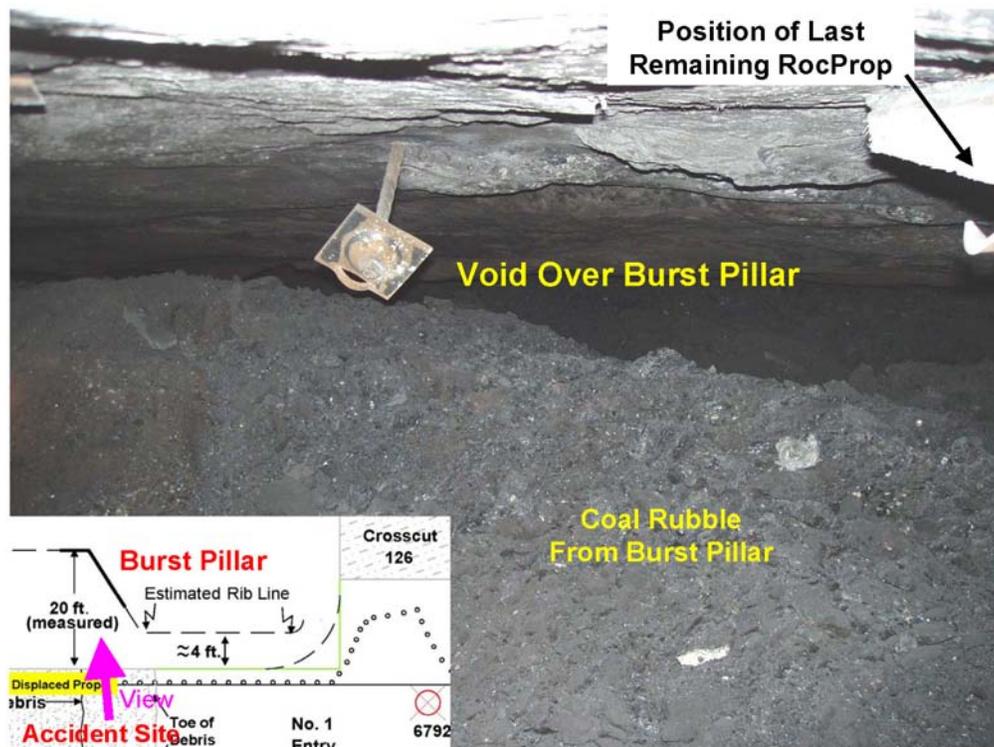
Figure 13 - 20-foot Deep Void over Pillar on Right Side of No. 1 Entry following August 16 Accident

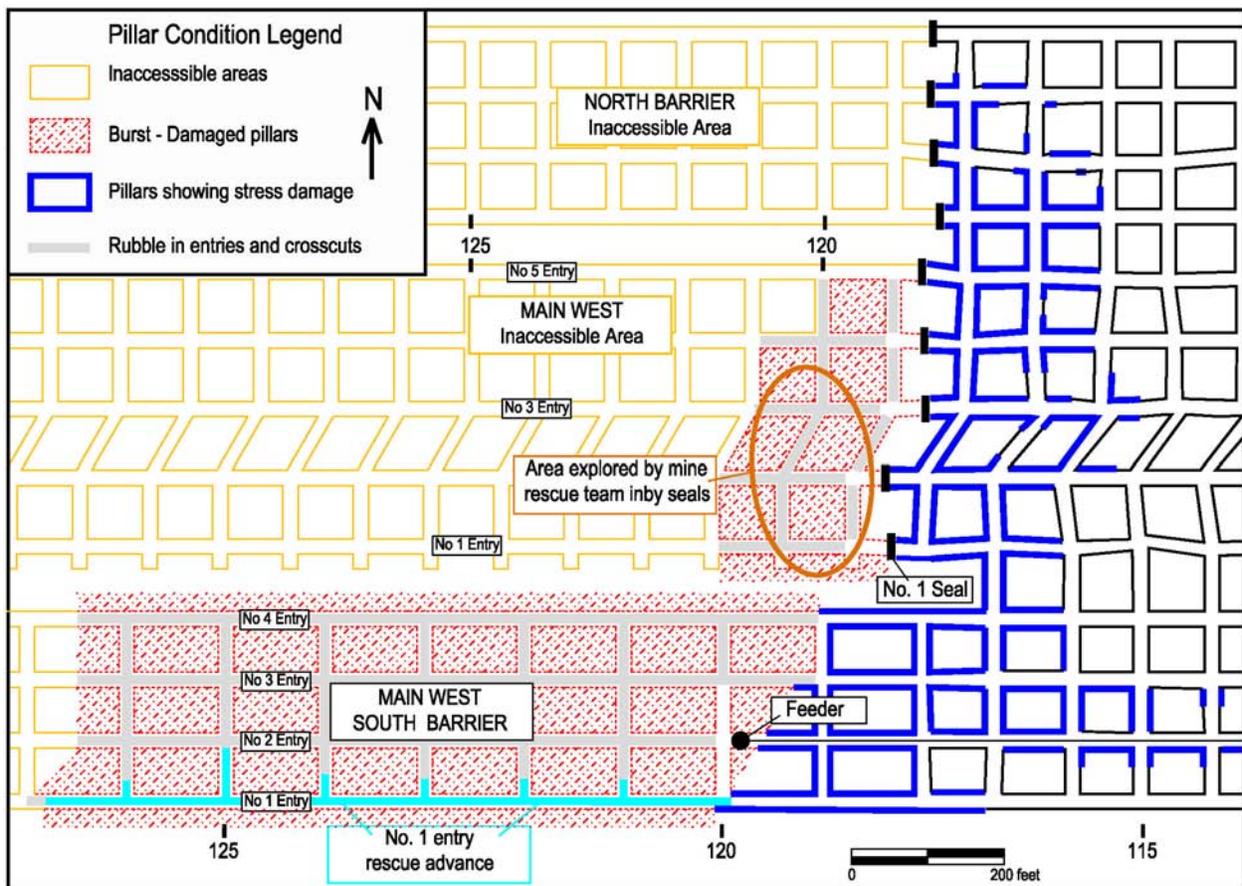
Within minutes of the accident, mine workers attempted to reach the South Barrier section to assist their coworkers. These initial efforts and additional attempts in the following days demonstrated that bursting had damaged pillars as far outby as crosscut 119, approximately ½ mile outby the entrapped miners. Debris from the outburst blocked access to all South Barrier entries inby crosscut 126 (see Figure 26). Attempts to reach the miners by breaching a seal and entering the Main West entries revealed poor ground conditions there as well. Inby the seals at Main West crosscut 118, the ground was working and bounces were occurring. Pillar deterioration (rib sloughage) had narrowed walkways to no more than 2 to 3 feet. Roof bolts were showing signs of excessive loading.

Figure 26 - Extent of Pillar Rib Damage Outby Crosscut 119

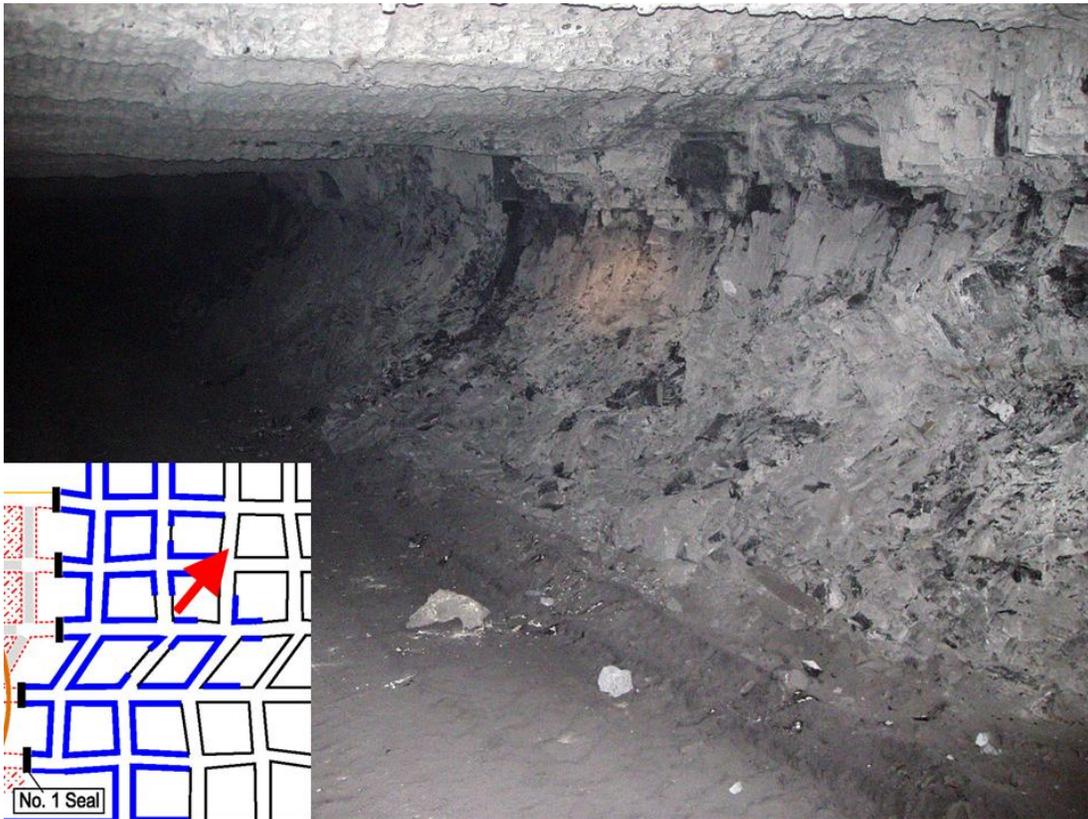
Figure 27 - Normal Main West Pillar Rib Conditions

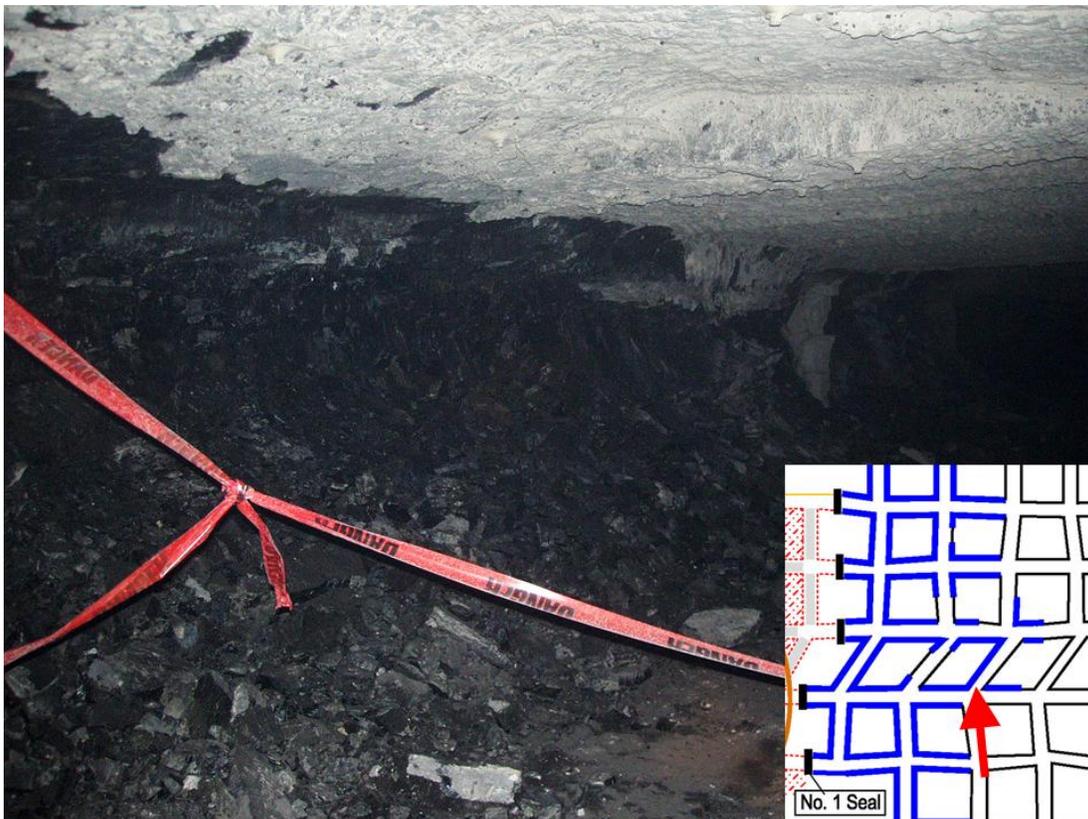
On August 11, 2007, ground conditions were mapped in the Main West entries and the North and South Barrier workings outby crosscut 119. Pillar damage was noted up to three crosscuts outby the seals (see Figure 26). The damaged ribs did not appear to be the result of bursting. Rather, the damage appeared to be associated with abutment stress transferred from inby the seals. Figure 27 and Figure 28 illustrate the difference between damaged and undamaged pillar rib conditions. Figure 27 shows normal Main West pillar rib conditions and Figure 28 shows recent pillar rib sloughage from abutment stress.

Figure 28 - Main West Pillar Rib Condition showing Recent Sloughage from Abutment Stress

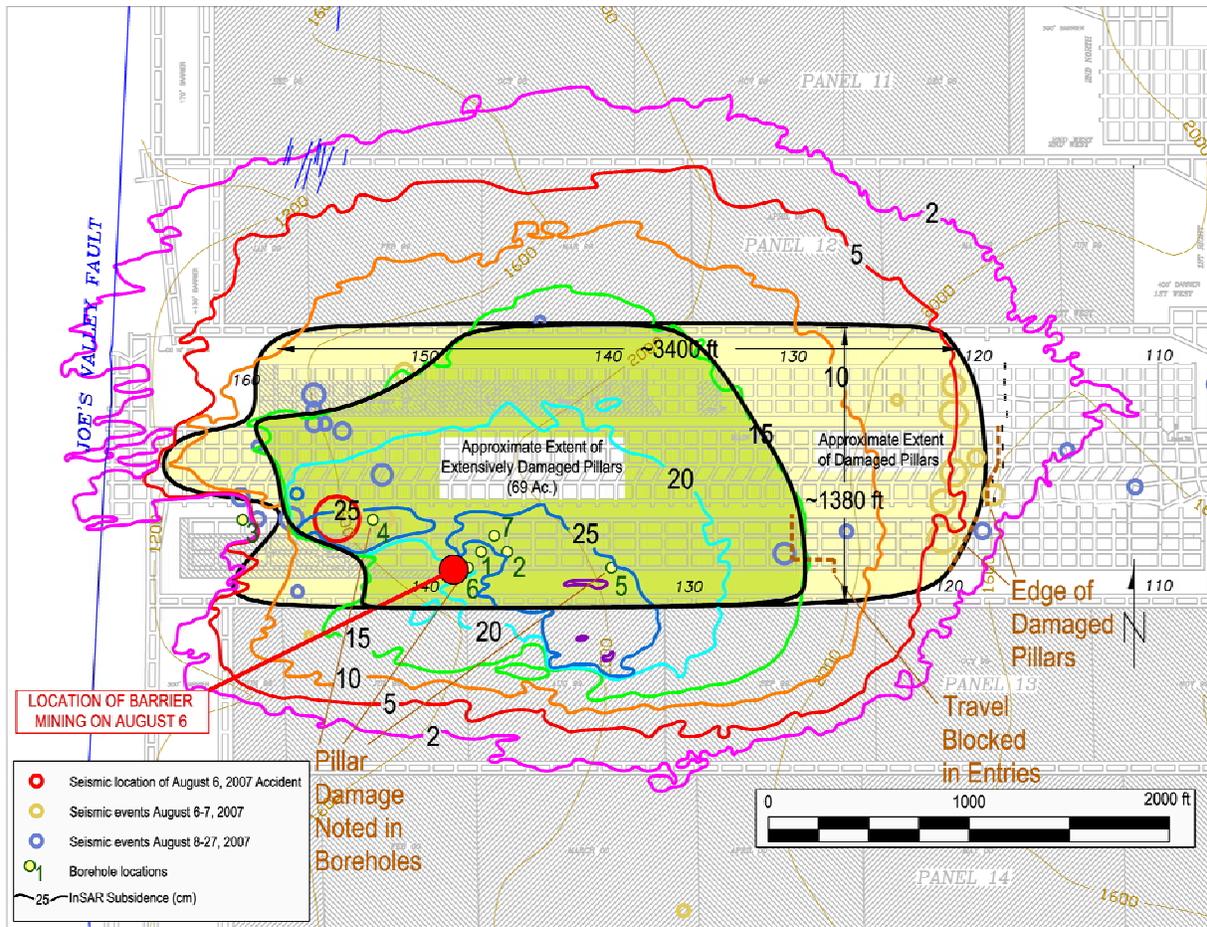
Figure 33 superimposes a variety of data used to determine the extent of the collapse, including: the seismic data from the time of the August 6 accident to August 27, 2007, the borehole locations, the InSAR subsidence contours, and the likely extent of damaged pillars. The eastern boundary of the pillar failures was based on the underground observations and InSAR subsidence data and is consistent with residual seismic activity. The western edge of the pillar failures was based on the borehole observations and InSAR subsidence data and is consistent with the seismic location of the accident and the additional seismicity later in August 2007.

Figure 33 - Combined Data and Likely Extent of Collapse

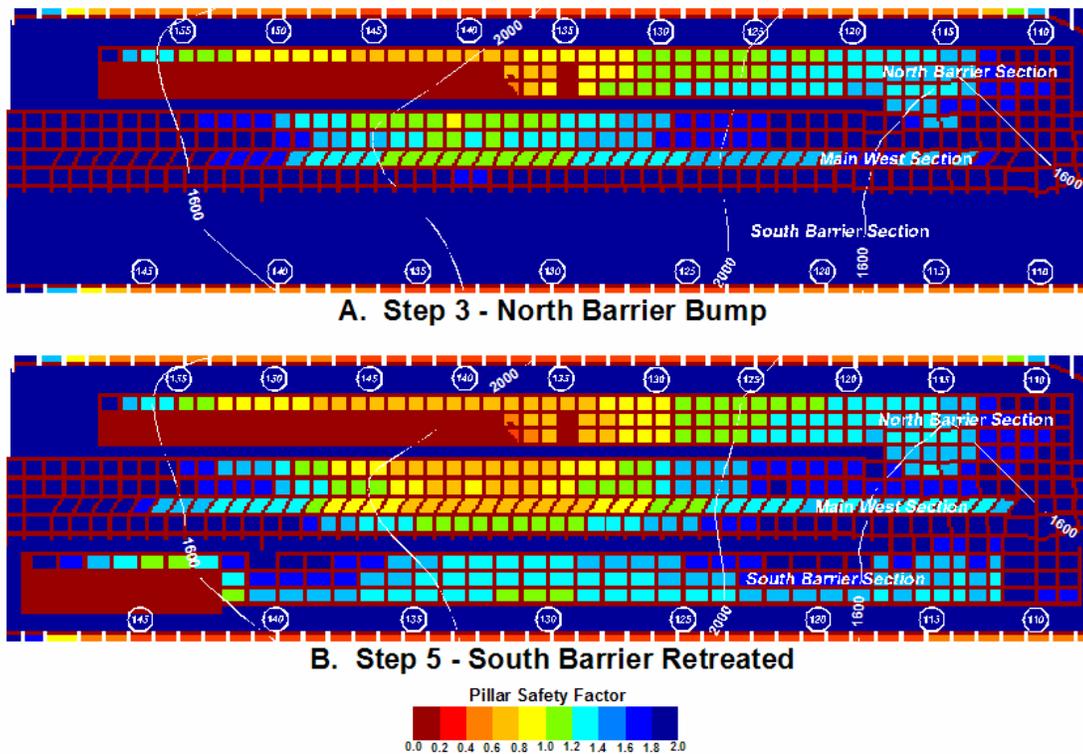
In Figure 54A, model results correlate reasonably well with conditions observed after the March 2007 bursts. For example, failure in the North Barrier section correlates well with observed damage. In this illustration, only one pillar appears to have failed in the Main West at the time of the burst. Figure 54B shows the development and retreat to crosscut 142 of the South Barrier section. In this illustration, safety factors for pillars in the South Barrier section remain above 1.0, although 42 pillars have failed in the Main West. Figure 55 demonstrates the catastrophic pillar failure propagation consistent with the August 6 collapse. In this simulation, 106 additional pillars fail in the Main West and 59 pillars fail in the South Barrier section. The failed area extends from crosscut 123 in the South Barrier section inby to crosscut 146 in the bleeder area. This optimum model simulates most of the critical observations of ground behavior at the Crandall Canyon Mine reasonably well.

Figure 54 - Optimum Model Before and After South Barrier Section Mining

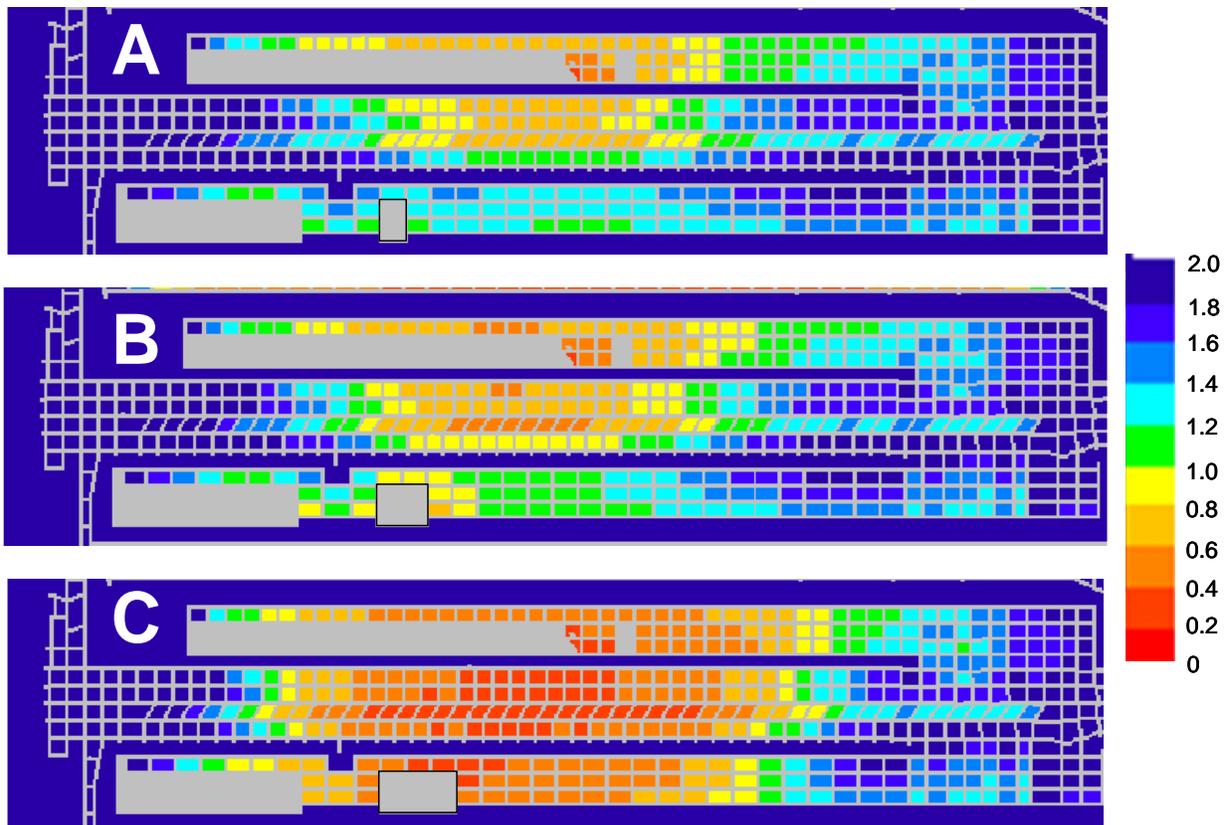
Steps were added to Dr. Heasley’s model to simulate the planned pillar recovery outby crosscut 139 (with the barrier intact between crosscuts 139 and 142). Pillar safety factors associated with pillar extraction in the rows between crosscuts 139 and 136 are shown in Figure 59. These results indicate that even if the barrier had not been mined between crosscuts 139 and 142, pillars in the South Barrier section likely would have failed if pillar mining continued in the next several pillar rows. After one row of pillars is recovered, pillar SF’s are still above 1.0 as indicated by the blue and green colors in Figure 59A. When the next row of pillars is recovered (Figure 59B), failure occurs near the pillar line (yellow and orange) and with recovery of the third row, failure propagates outby over a broad area as indicated by the red and orange colors in Figure 59C.

Figure 59 - Pillar Safety Factors for Pillar Recovery Outby Crosscut 139

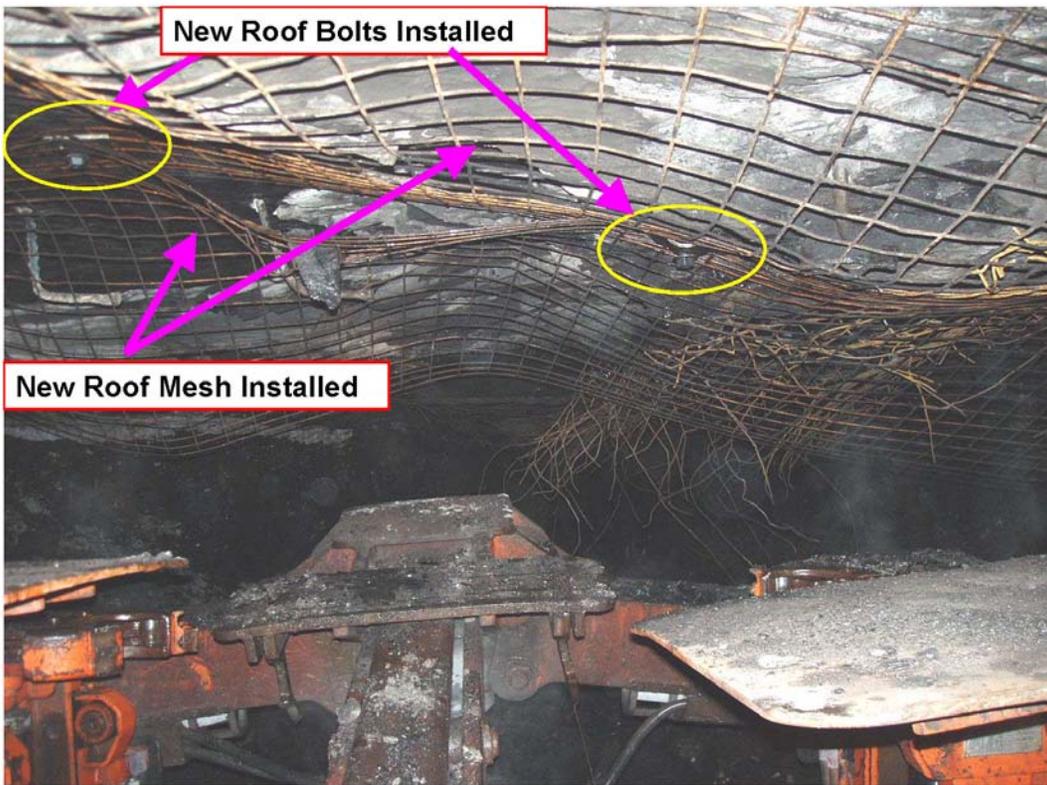
Figure 89 - New Roof Bolts and New Wire Mesh Installed in the No. 1 Entry
