Coal Mine Fatal Accident 2007-02 & 03

Operator:	Brooks Run Mining Company, LLC
Mine:	Cucumber Mine
Accident Date:	January 13, 2007
Classification:	Fall of Roof
Location:	Dist. 4, McDowell County, West Virginia
Mine Type:	Underground Coal Mine
Employment:	138
Production:	6,000 Tons/Day

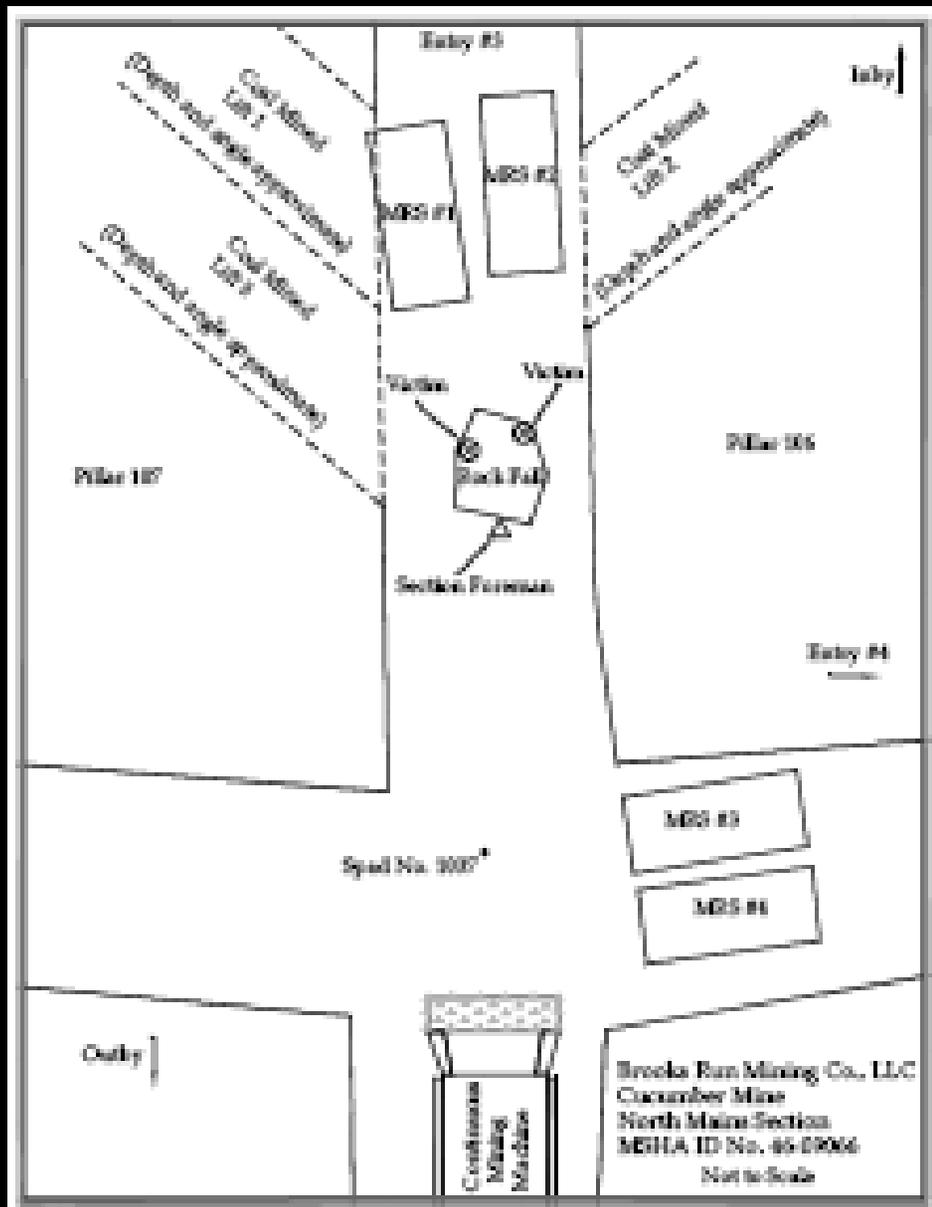
At approximately 10:40 a.m. on Saturday, January 13, 2007, two mobile roof support (MRS) machine operators, were fatally injured when a portion of the mine roof collapsed, pinning both individuals. The two victims had 12 years and 2.5 years of mining experience respectively. The miners were repositioning MRS machines after the completion of the third lift in the #3 entry while performing retreat mining on the North Section. The slicken-sided portion of the mine roof that collapsed measured approximately 8 feet in width by 9 feet in length and was up to 18 inches thick.
