MNM Fatal 2007-11

- Machinery Accident
- June 8, 2007 (Minnesota)
- Iron Ore Operation
- Technician/Utility Heavy Equipment Operator
- 49 years old
- 30 years experience

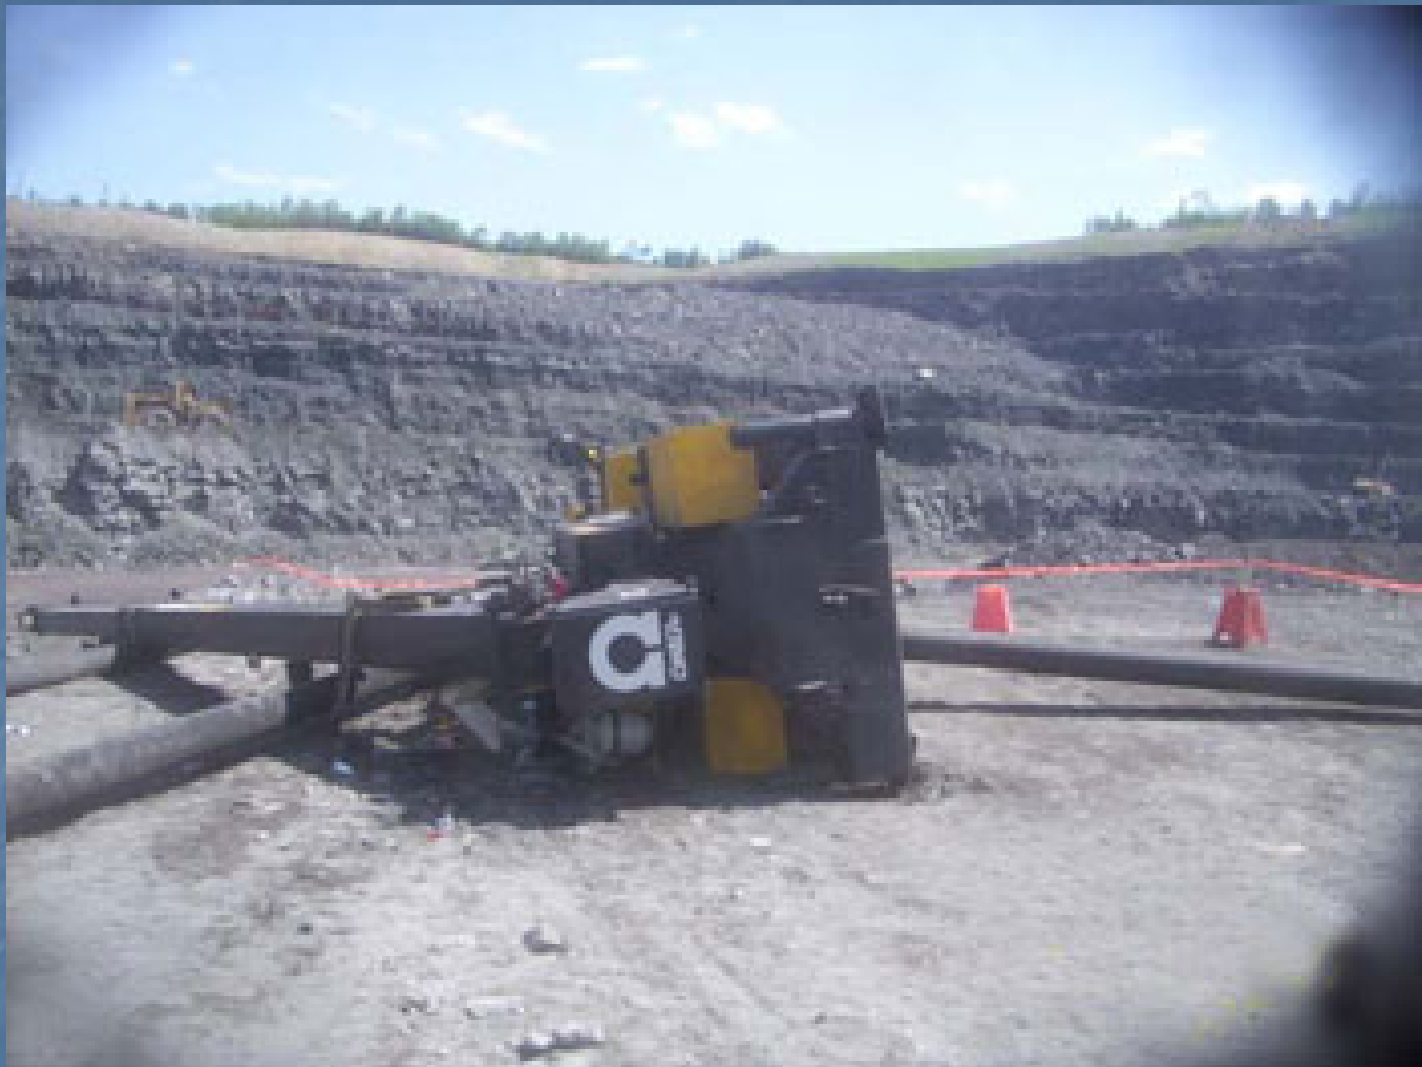
The victim was fatally injured when the rubber-tired crane he was operating overturned. He either jumped or fell from the cab and was pinned under the crane. At the time of the accident, the victim was being trained to operate the crane.

- Management procedures and controls were ineffective and failed to ensure the task trainer remained in the immediate area to closely supervise the trainee during task training sessions.
- Management policy and controls were inadequate and did not ensure that crane operators followed correct procedures when making a lift. The crane was positioned on a grade without the outriggers and stabilizer jacks being deployed and with under-inflated tires.

- Ensure that crane operators understand the crane controls and are trained to use the load chart.
- Train personnel to recognize and understand safe procedures, including those in the equipment operator's manual, prior to operating the crane.

- Extend and set stabilizers prior to lifting or moving a load.
- Securely rig a load prior to lifting or moving it.
- Always wear a seatbelt if it is provided.
