MNMM Fatal 2007-16 & 17

- Machinery Accident
- July 19, 2007 (Alaska)
- Gold Operation
- Contactor Iron Worker
 - 28 years old – 3 years experience
- Contractor Iron Worker
 - 19 years old – 44 weeks experience

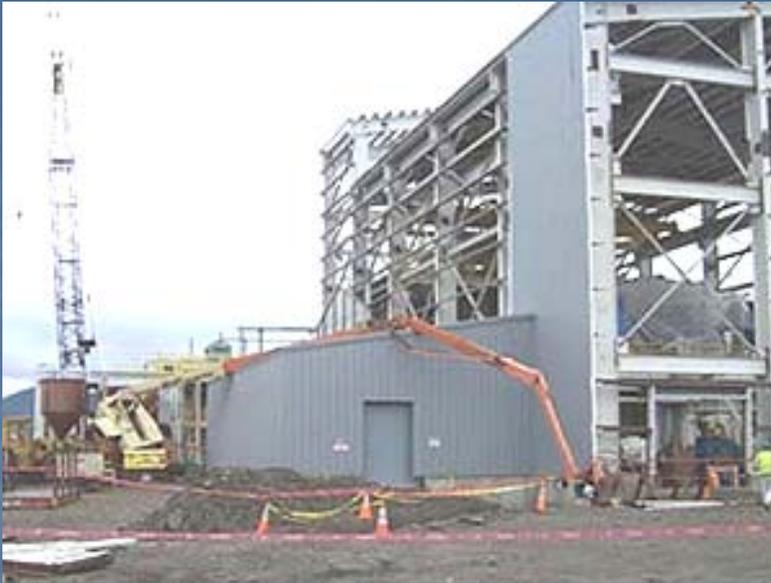
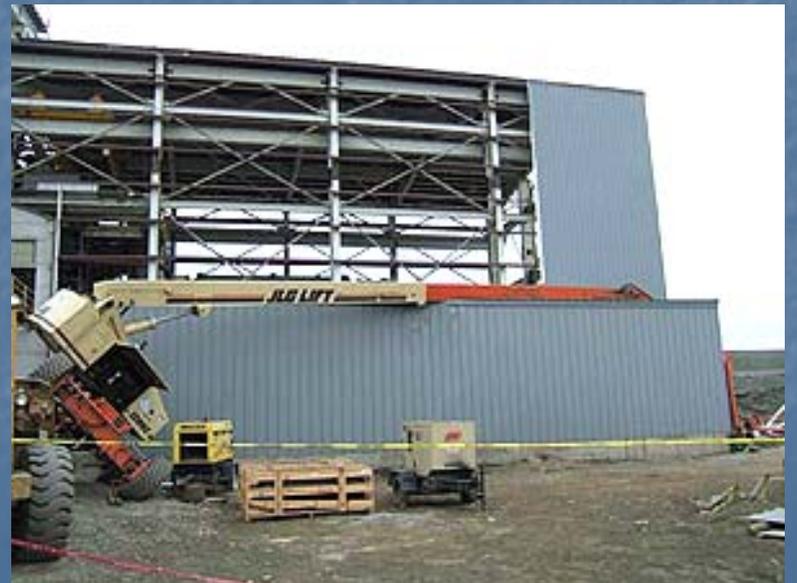
The victims were fatally injured when a manlift they were operating toppled over. They were descending from an elevated location with the boom extended when the unit became unstable and toppled on its side.

- Management policies and procedures were inadequate. The task training provided to the persons assigned to operate the JLG 120HX manlift did not identify the specific safe operating procedures and limitations of the load management system that were critical to safely operate this machinery. Management failed to ensure the training addressed all safe operating procedures.
- Management policies, procedures, and controls were inadequate. The manlift was used beyond the design capacity intended by the manufacturer creating a hazard to persons. The rear center jack on the manlift was being used as a stabilizer or outrigger and the manlift was not positioned on a solid and level surface during use. Management failed to conduct an assessment of the risk when they allowed the equipment to be positioned on a surface that was not solid and level.

- Ensure that persons are properly task trained regarding safe operating procedures before allowing them to operate mobile equipment.
- Ensure that all operating systems and safety features on mobile equipment are maintained and functional at all times.

- Use the manufacturer's operator's manual and ensure that required tests are performed on equipment.
- Park equipment on level and stable ground and operate it within the design specifications of the manufacturer.
