MNMM Fatal 2007-21

- Fall of Ground Accident
- August 28, 2007 (Nevada)
- Gold Operation
- Bolter Operator
- 36 years old
- 4½ years experience

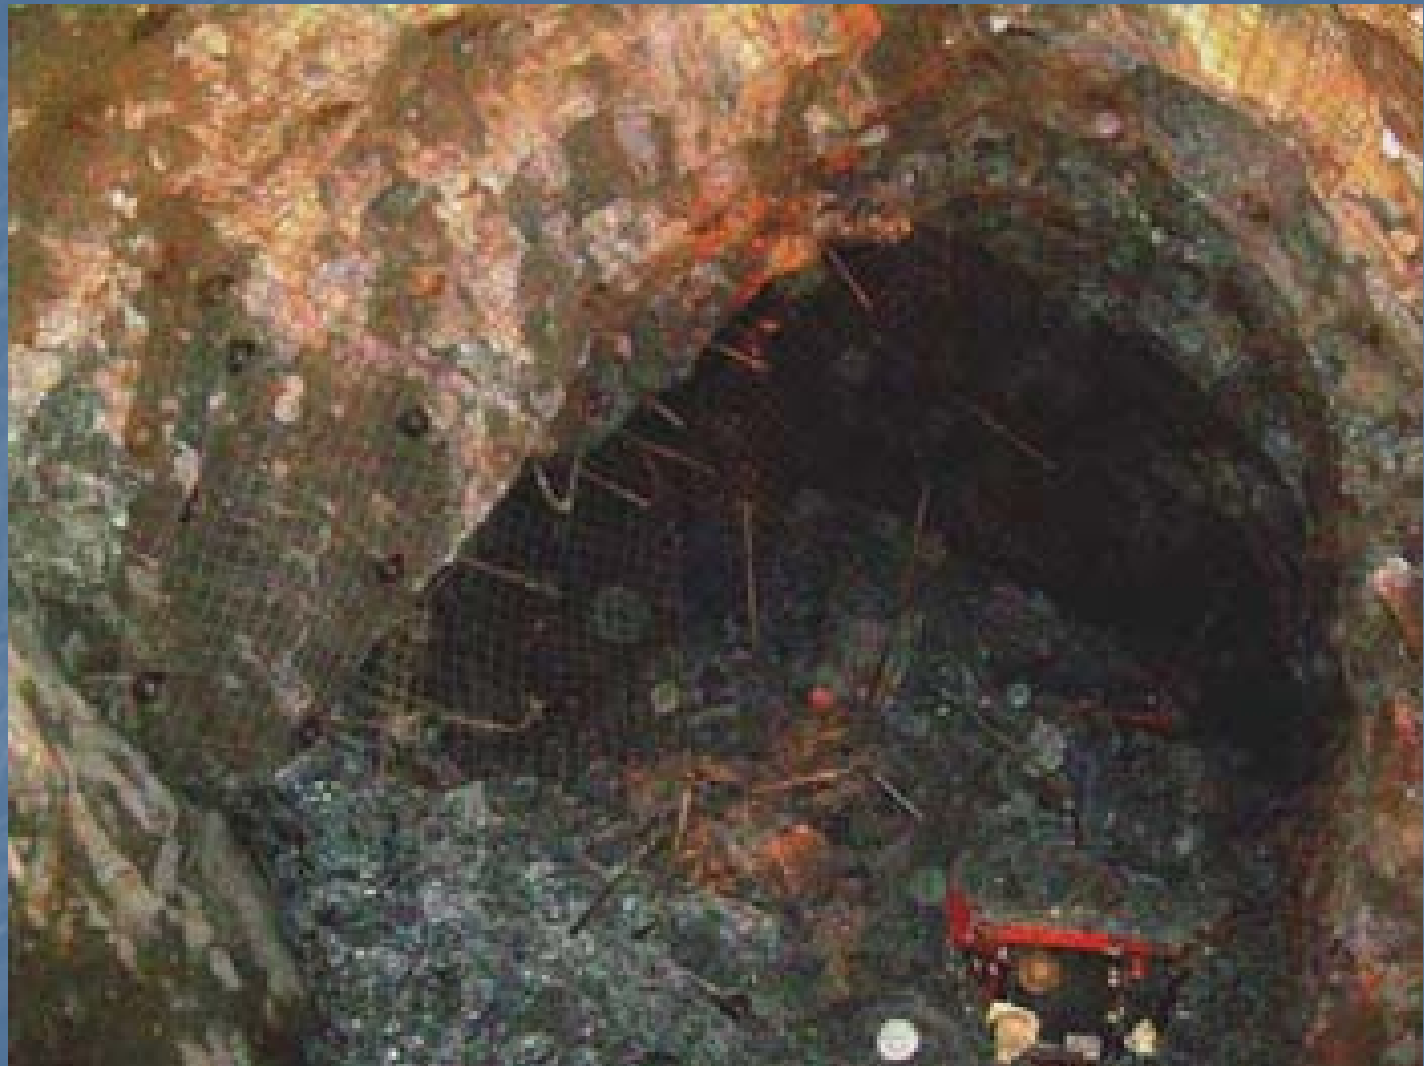
The victim was fatally injured while working in a development drift. He completed bolting the roof of the drift when the left rib and part of the roof fell covering him and the roof bolter.

Management policies and procedures were inadequate and failed to ensure that persons could safely install ground supports. The mine's ground control plan was not followed when ground conditions were encountered that required additional support. Persons were not trained to evaluate and support adverse ground conditions.

- Design, install, and maintain a supplemental support system to control ground where additional support is necessary.
- Train person to examine and test ground conditions where persons work or travel.
- Promptly initiate action to install additional support when adverse ground conditions are identified.
