REPORT OF INVESTIGATION  
Shaft Construction for Underground Mine  
Fatal Fall of Persons  
August 10, 2007

Frontier-Kemper Constructors Inc. (A01)  
Evansville, Indiana

Gibson Mine  
Gibson County Coal, LLC  
Princeton, Gibson County, Indiana  
ID No. 12-02215

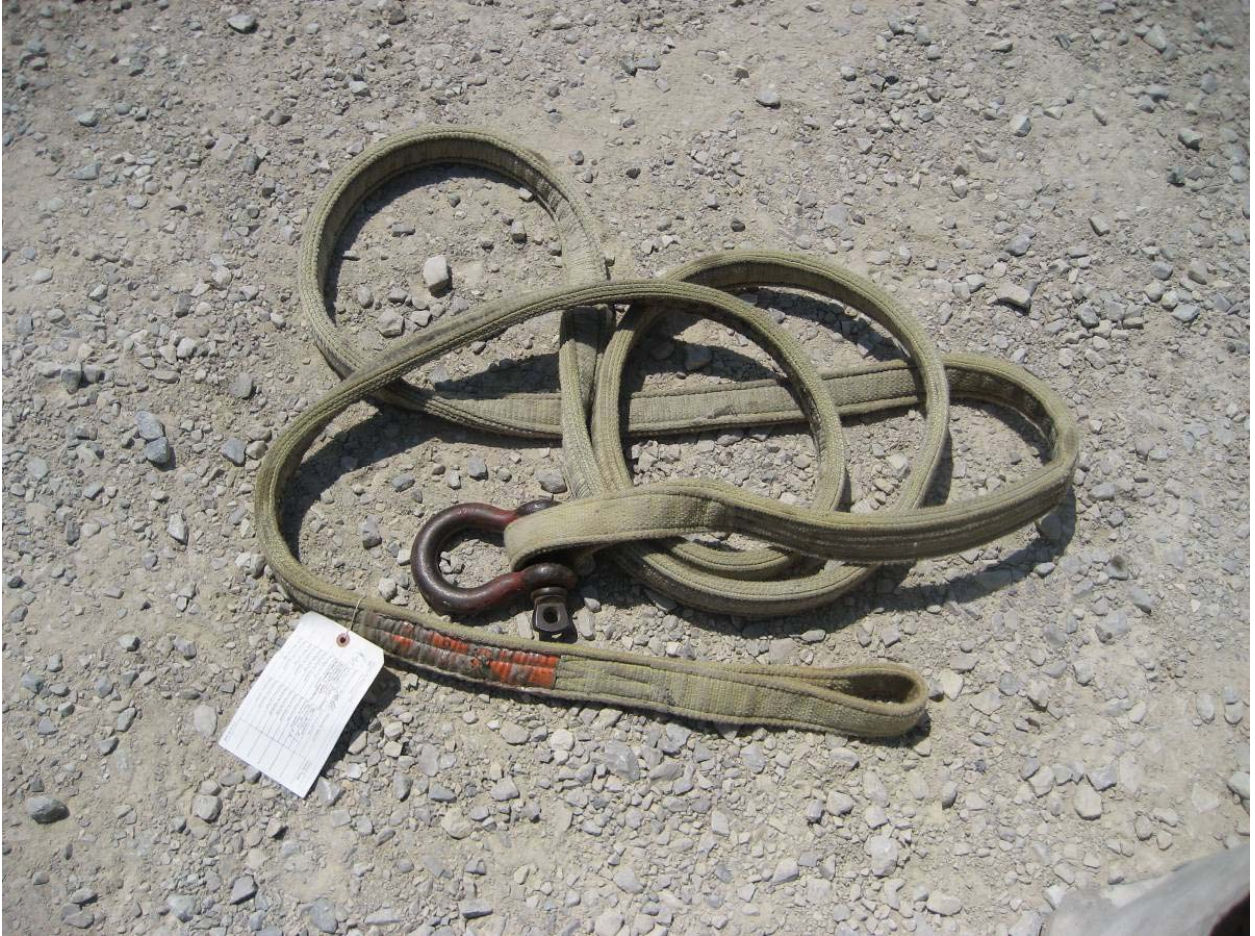
**EXHIBIT 1**  
**PHOTO OF NYLON SLING AND SHACKLE**

1. *Root Cause:* A nylon sling and shackle used for lowering supplies were left attached to the sinking bucket while transporting persons. The lack of an effective administrative control to assure that extraneous objects were not attached to the bucket when transporting persons contributed to the loss of control of the hoist.

*Corrective Action:* The independent contractor's approved shaft sinking plan has been revised to include provisions that persons will not be transported with anything attached to the bucket.

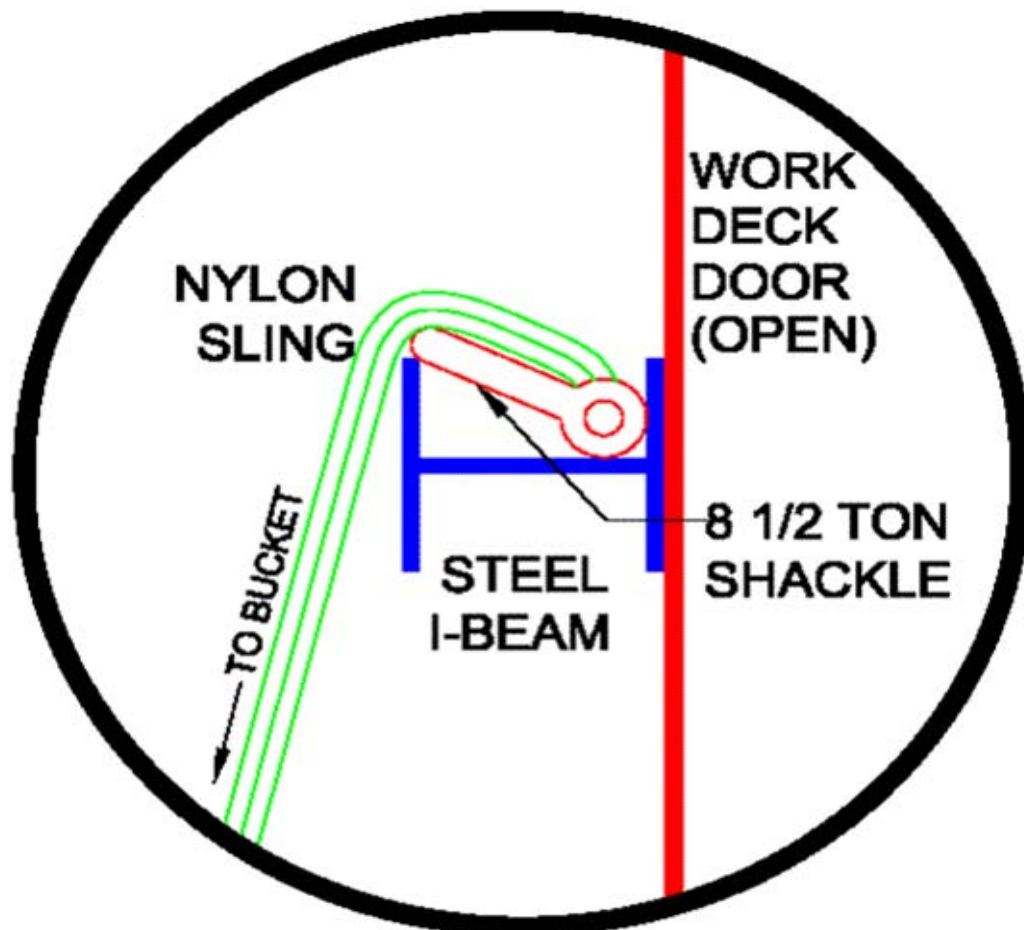
EXHIBIT 2  
DRAWING OF SLING/SHACKLE IN COLLAR DOOR

In order to determine the actual manner in which the sling/shackle combination could have lodged in the collar doors, several configurations were tested. The collar doors were moved to the open position, and the nylon sling and shackle were attached to the sinking bucket, as on the day of the accident. The arrangement shown in the drawing labeled Exhibit 2 and the photograph, labeled Exhibit 3, (with the shackle pin end down at the floor side of the Wide Flange section (I-beam) and the rounded end atop the lower end of the I-beam, with the sling coming over the top) would bind tightly with downward pressure and release easily with upward pressure. This confirmed witness' statements that the sling/shackle tightly engaged with downward pressure and released easily when the bucket was raised. No other tested arrangement produced this result.

## DETAIL OF SHACKLE IN WORK DECK DOOR

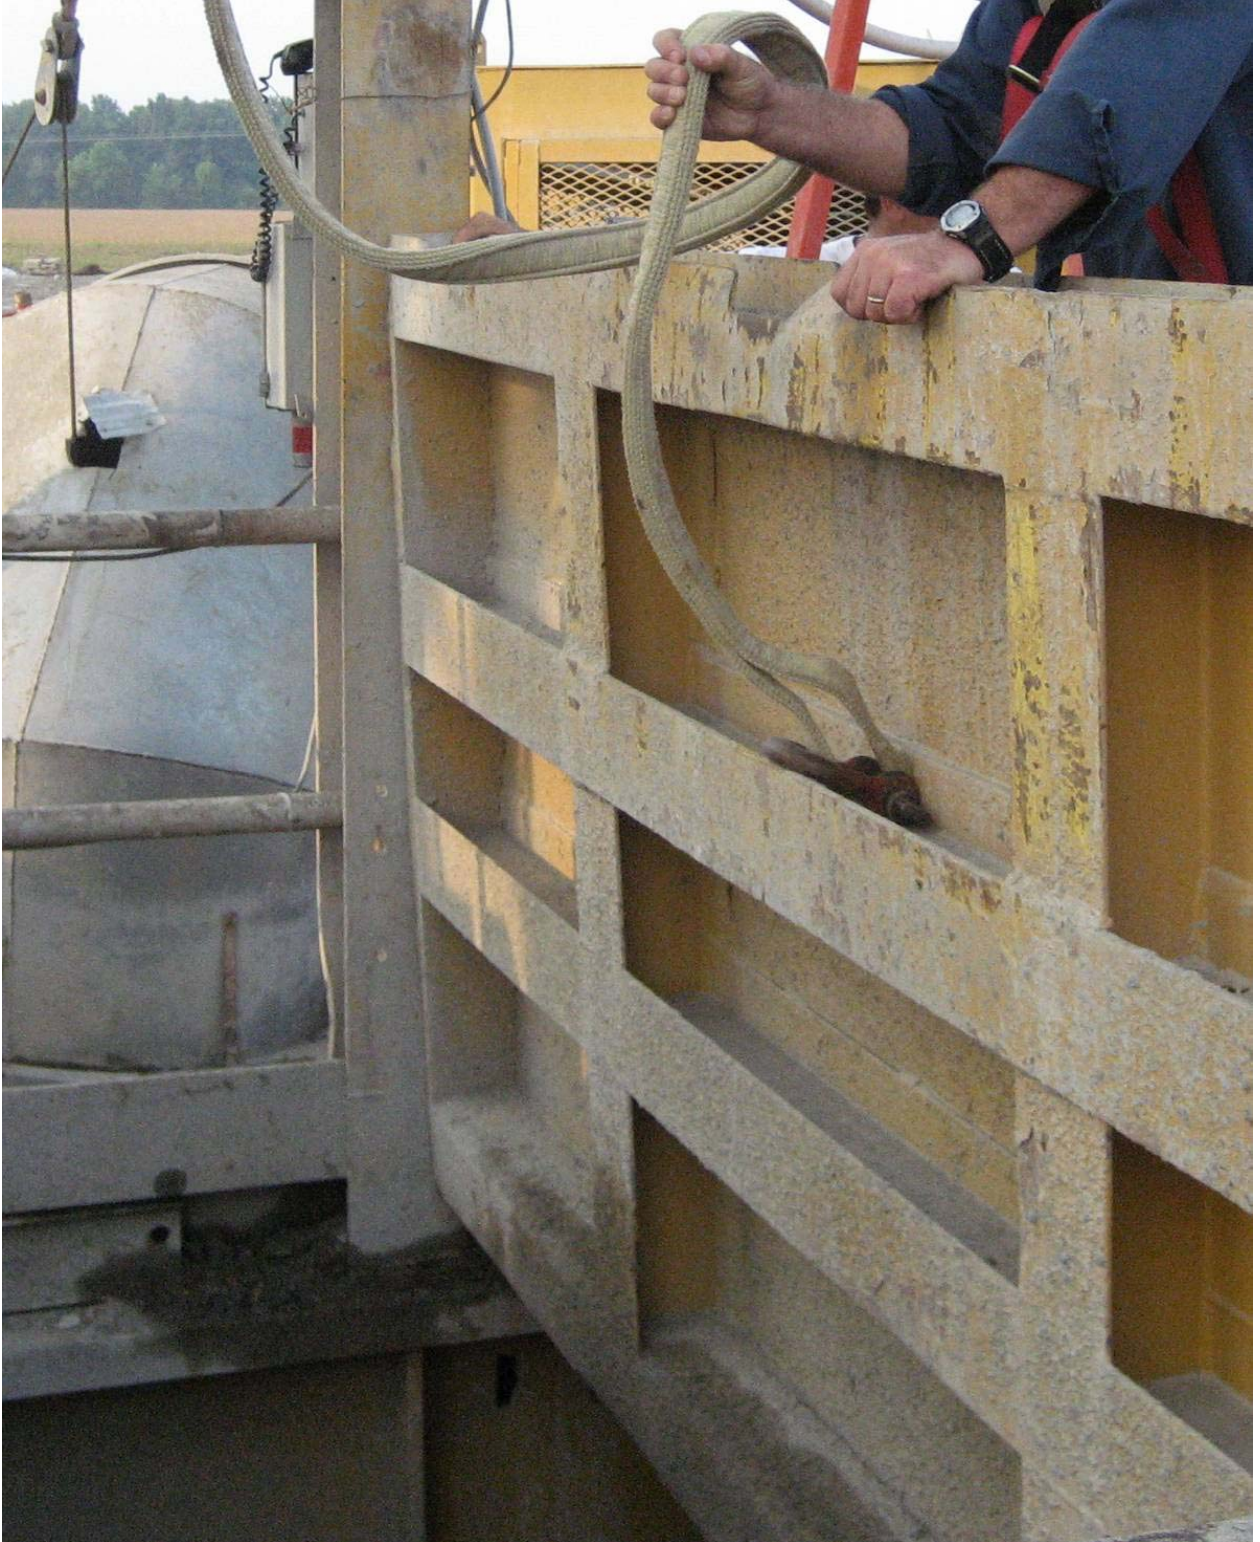
**EXHIBIT 3**  
**PHOTO OF NYLON SLING AND SHACKLE IN COLLAR DOOR**

- 6) **SHACKLE POSITION IN COLLAR DOORS:** Based upon eyewitness accounts, the shackle attached to the end of the 20-foot nylon sling (free end) was found in one of the collar door horizontal beams immediately after the accident. Given the geometry of the shaft opening and assuming

the bucket is oriented in the center of this opening when entering the shaft, a range of horizontal distances and swing angles necessary for the shackle to become caught in the collar door structure was determined. The shackle would have to travel between 20 <sup>5</sup>/<sub>8</sub> and 68 <sup>1</sup>/<sub>2</sub> -inches with swing angles between 4.9 and 16.5 degrees (from vertical) to come to rest in the collar door structure. MSHA investigators used the interview information and examined several positions of the shackle in the door in an attempt to recreate a possible final position of the shackle. Three positions of the shackle were examined in the collar doors. They are shown in Exhibits 4-6. For each of the shackle positions examined, a force was applied to the sling in the up and down direction to simulate the travel direction of the bucket. Forces applied in the up and down direction to the sling as shown in Position 1 (Exhibit 4) caused it to pull out of the beam. Forces applied in the down direction to the sling shown in Position 2 (Exhibit 5) caused it to pull out of the beam, while forces applied in the up direction caused the shackle to wedge itself into the beam, causing the sling to tighten. Forces applied in the up direction to the sling shown in Position 3 (Exhibit 6) caused it to pull out of the beam, while forces applied in the down direction caused the shackle to wedge itself into the beam, causing the sling to tighten. Based on these tests, it is consensus of the accident investigation team that the sling was in Position 3, causing the bucket to tip or overturn as it was lowered.
