REPORT OF INVESTIGATION

Fatal Fall of Roof Accident
September 3, 2007

Bronzite Mine
Consol of Kentucky, Inc
Williamson, Mingo County, West Virginia
MSHA I.D. No. 46-08892

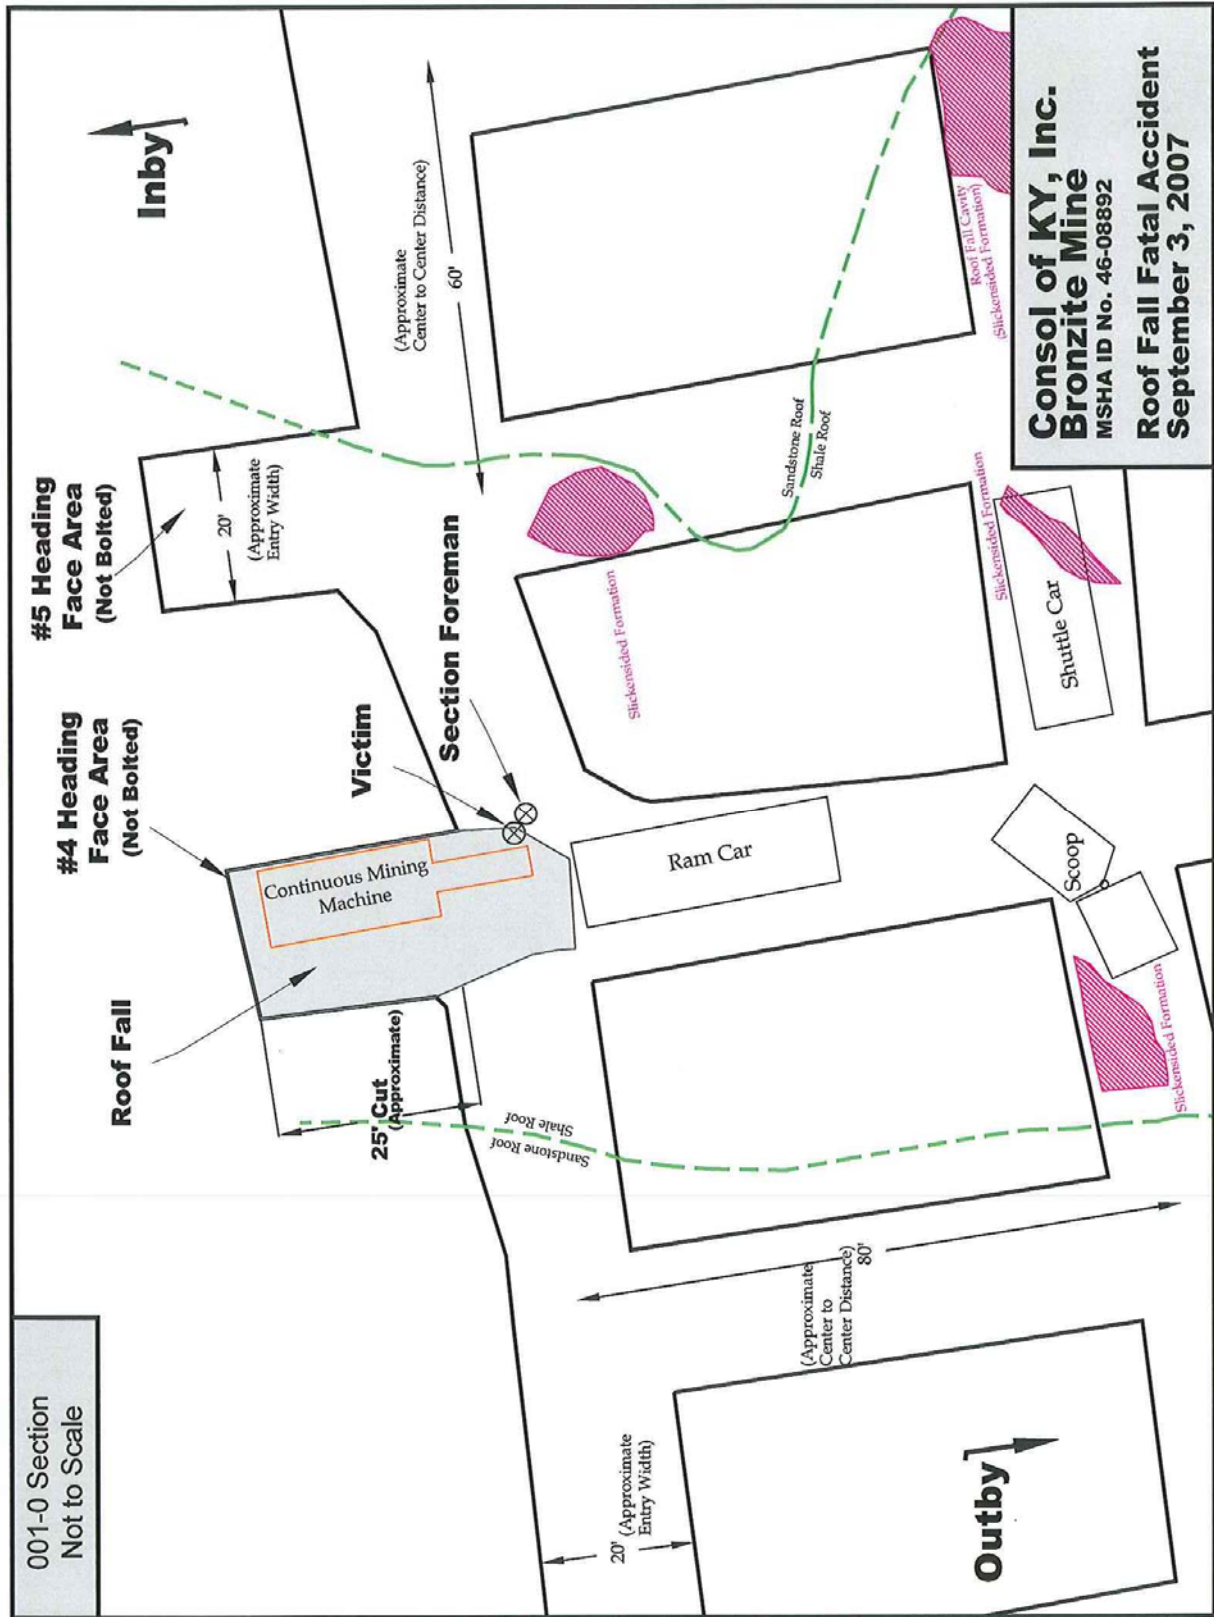
Appendix B

The roof fall was approximately 45 feet long, approximately 18 feet wide and approximately 5 feet thick. The roof fall material consisted of layers of shale and siltstone with intersecting slickensided formations. Slickensided formations are polished rock masses within the mine roof which are prone to falling if they are not provided with adequate supplemental support. The fall cavity extended nearly rib to rib in the entry in by the intersection, which had just been mined and was not yet bolted. The roof fall extended outward approximately halfway into the four-way intersection, and bounded against a slickensided formation. The part of the fall cavity that occurred in the intersection was localized along a horseback, a hazardous mass of rock with a slippery surface in the roof.

The right run extracted out of the face of the No. 4 working face measured 30 $\frac{1}{2}$ feet from the deepest point of penetration to the first row of permanent roof supports. The left run measured 18 feet 6 inches from the deepest point of penetration to the first row of permanent roof supports. This unsupported span of roof caused the initial fall, which subsequently exceeded the anchorage capacity of four rows of the installed permanent roof support.

Root cause: In the area of the fall where 3 rows of 4-foot fully grouted roof supports were installed, a 4-inch coal seam (rider seam) was present. The effect of the presence of the existing coal seam (rider seam) and the slickensided claystone in the immediate mine roof in the last open intersection in the No. 4 entry while performing roof bolting operations was not recognized. After the recovery work was completed and the area of the fall was re-bolted, several 1-inch holes were present in the immediate roof, indicating that a portion of the 4-foot fully grouted roof bolts only penetrating through the rider seam into the immediate roof a depth of 1 inch.

Corrective Action: The mine operator submitted a revision to the roof control plan to the District Manager on September 10, 2007. The revision requires: 1) The minimum length of fully grouted resin bolts are to be 72 inches, bolt diameter is to be 3/4" and 7/8" and 60 minimum grade steel; 2) At the beginning of each newly mined cut of coal, a test hole will be drilled to a depth of 10 feet; 3) Prior to turning a new cross-cut, six cable bolts, ten feet in length will be installed in each intersection. The cable bolts will be installed in the approximate locations shown in the roof control plan.
