METAL AND NONMETAL MINE SAFETY AND HEALTH  
REPORT OF INVESTIGATION

Fatal Machinery Accident  
March 23, 2007

Glass Rock Plant  
Oglebay Norton Industrial Sands, Inc.  
Glenford, Perry County, Ohio  
Mine I.D. No. 33-01354

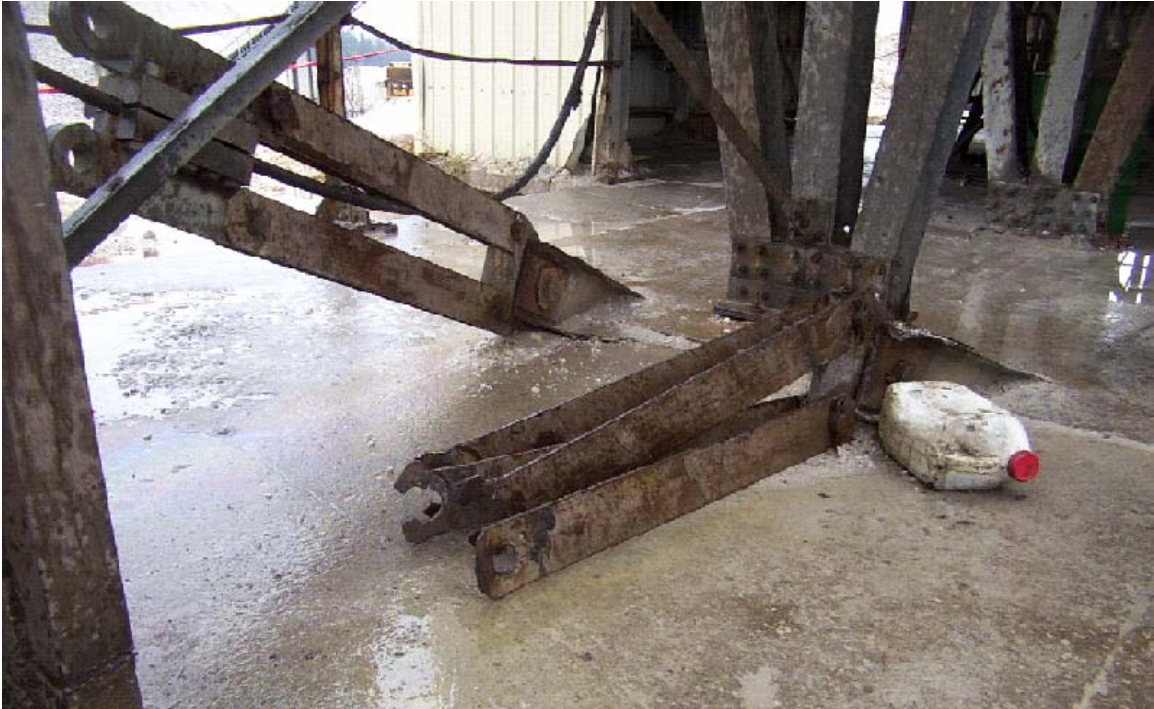
Three of the anchor arms failed due to block shear rupture, which allowed the steel to tear between the end of the arm and the pinhole (Appendix B, Photos 1 and 2). The exception was the bottom-left arm where the pin slid out instead of tearing through the pinhole (Appendix B, Photo 2). Based on the physical evidence, the anchor arms released in the sequence of bottom-right, top-right, top-left, then bottom-left. When the first three arms failed, the pin holding the bottom-left arm was able to pivot and slide free.

The end of the anchor arms had been thermally cut to address clearance problems between the anchor arms and the holding grip. This reduced the amount of steel available to resist the pin load and increased the shear stresses in the anchor arm. Investigators determined that three of the arms had been cut twice. The rough surfaces left by the cuts created stress concentrations at notches in the material, further reducing the capacity of the arms.

The anchor arms were coated with silver paint over red paint or primer. The coating was worn and corrosion was observed across the anchor arms. Deformation of the anchor arms formed a crack pattern in the paint around the pinholes. A similar pattern was engrained in the corrosion indicating that the arms had been previously overloaded.

Photo 1 – Empty cable anchor arm assembly and failed load cable anchor arms.

Corrective Action: Management should ensure that component stresses and anchorage loads are analyzed so the tramway can support all loads imposed on its components.

This citation was terminated on August 14, 2007. The operator redesigned the anchor arms, cable grips, divider bars, and steel pins. The cable pulling assembly was rebuilt, new pressure gauges were installed, and the pressure relief valve was replaced. The hydraulic power supply and jacks were tested. The gauges and pressure relief valve functioned properly. All miners involved in the cable tensioning process were trained and indicated that they understood how to monitor the hydraulic pressure for excessive output forces and to set the pressure relief valve.

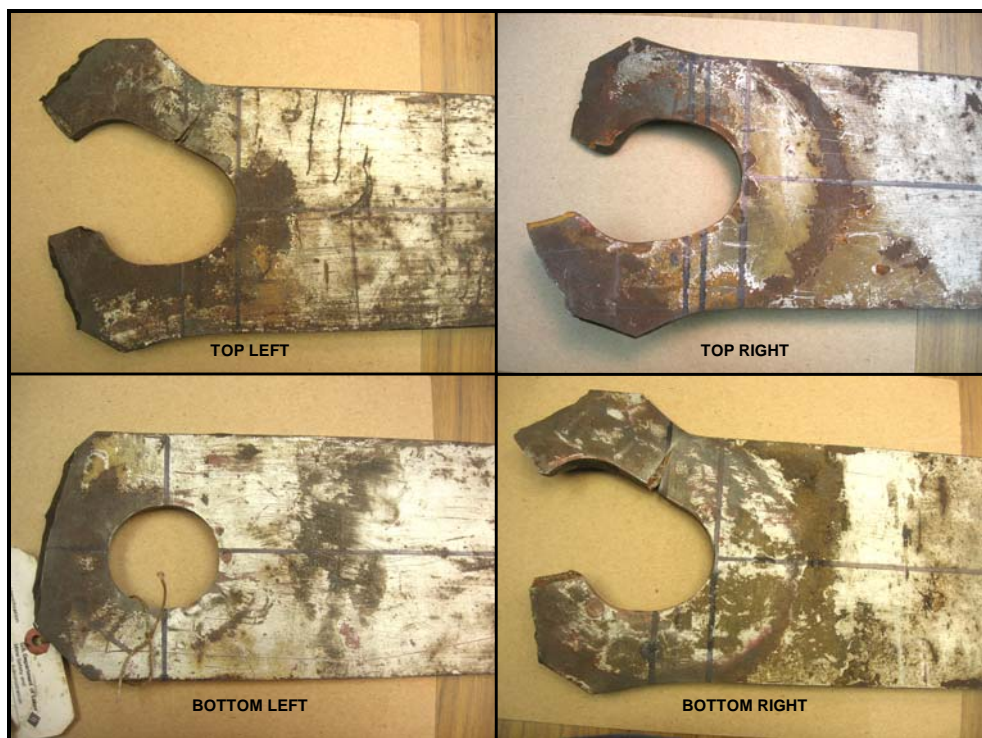
The connection of the anchor arms to the holding grip were continuous with little space between the connecting plates. The connection of the anchor arms to the divider plate had gaps between the plates causing play and uneven loading in these connections. Additional play was caused by wear and corrosion of the pinholes which allowed 1/16 inch to 7/32 inch clearance between the pin and the pinhole.

Photo 2 - Anchor arm conditions after pin connection failed.

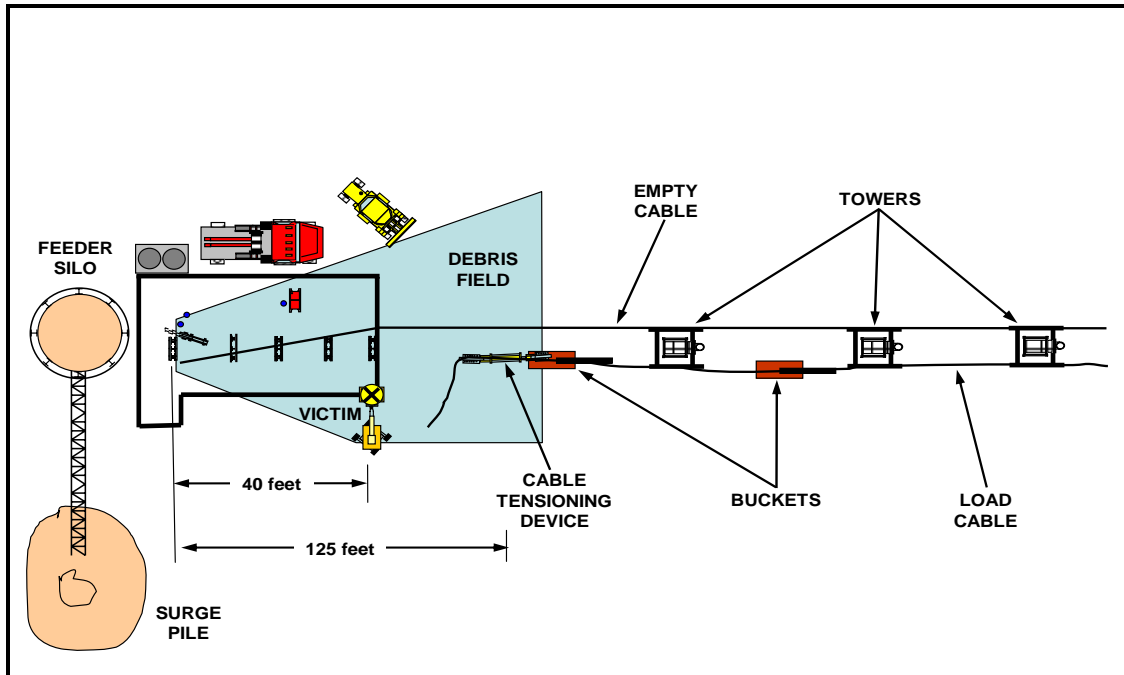
The accident occurred at the aerial tramway loading terminal (Appendix C, Figure 1). The victim was positioned in a manlift, approximately 7 feet above the ground, under the cable saddle where the loaded buckets left the loading terminal rail and transitioned onto the load cable.

Figure 1 – Overview of the accident scene.

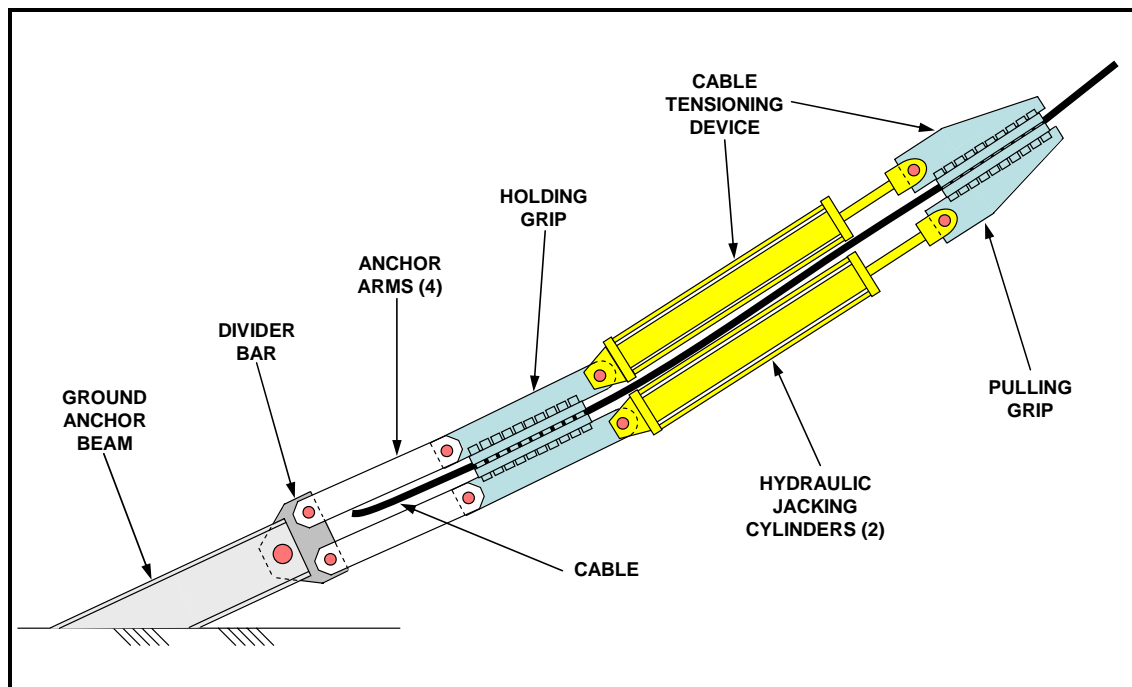
The static cable anchors consisted of a double-channel beam, set in a concrete anchor block, buried in the ground. A pinned divider bar served as the connection between the ground anchor beam and the four anchor arms. The other end of the anchor arms were pinned to a cable holding grip that secured the tramway cable to the anchor arm assembly (Appendix C, Figure 2). The four anchor arms were configured as two pairs. The arms were designed using ¾ inch steel plate, 47½ inches long, and 5 inches wide, with two, 2-1/32 inch diameter pinholes centered 2¾ inches from the ends of the plate. One pair was positioned above the cable and the other pair was positioned below the cable. For clarification and orientation, the two pairs were described as top and bottom. The arms were noted as left and right oriented with respect to the cable running from the loading terminal to Tower 12. The anchor arms were referenced as top-left, top-right, bottom-left, and bottom-right.

Figure 2 – Illustration of anchor arm assembly and cable tensioning device.
